BAY AREA REGIONAL  
EARTHQUAKE PREPAREDNESS  
PROJECT

Case Study

### Seismic Retrofit of a Wood Frame Building

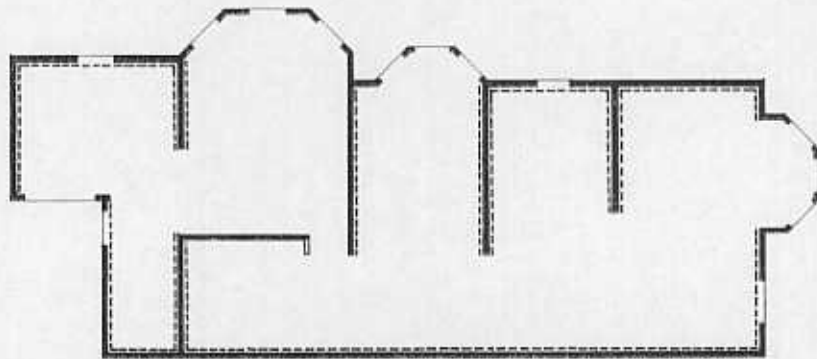
FLOOR PLAN

Earthquake-resisting lateral force bracing was improved in the building by adding plywood sheathing to some of the inside walls on the first and second floors, creating shear walls. On long walls and floor diaphragms where the existing straight sheathing was adequate, re-nailing was provided. Steel bracing was added around the garage door in the basement to strengthen the door opening, and to the entry foyer in order to avoid sagging or distortion from the newly-imposed vertical wall loads above these openings.

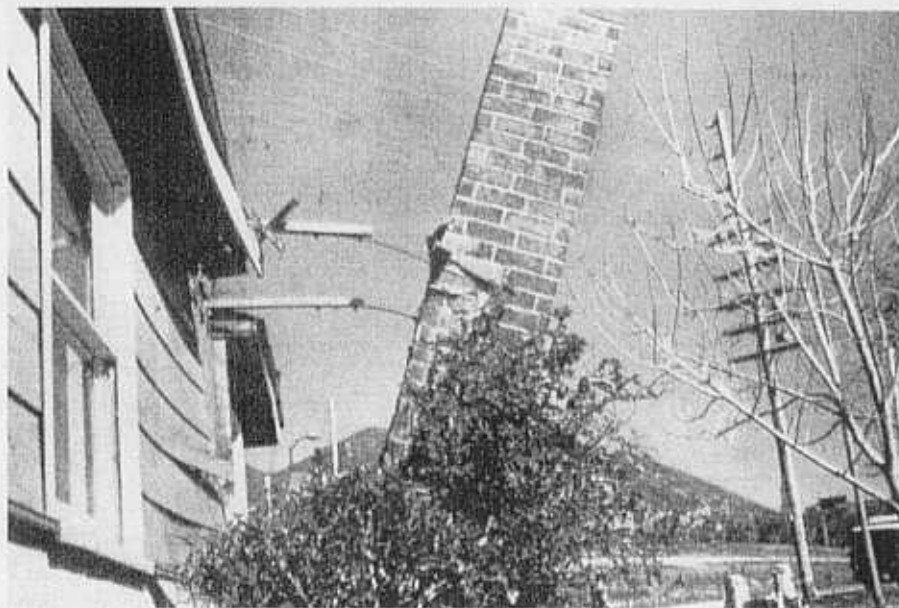
4. *Unreinforced masonry chimneys are not tied to the building.* Combining tall, stiff, brittle masonry fireplaces and chimneys with more flexible wooden structures can result in severe damage if connections between the two types of materials are not properly designed. A tall and stiff chimney, and a shorter and more flexible wood frame building will behave as two separate structures during an earthquake. As a result, chimneys frequently snap off at the roof, or foundation line, dropping brick through the roof into the house or onto the ground, causing damage and, potentially, injury or loss of life.

*Failure of a chimney tie caused this chimney to fall away during the 1983 Coalinga earthquake.*

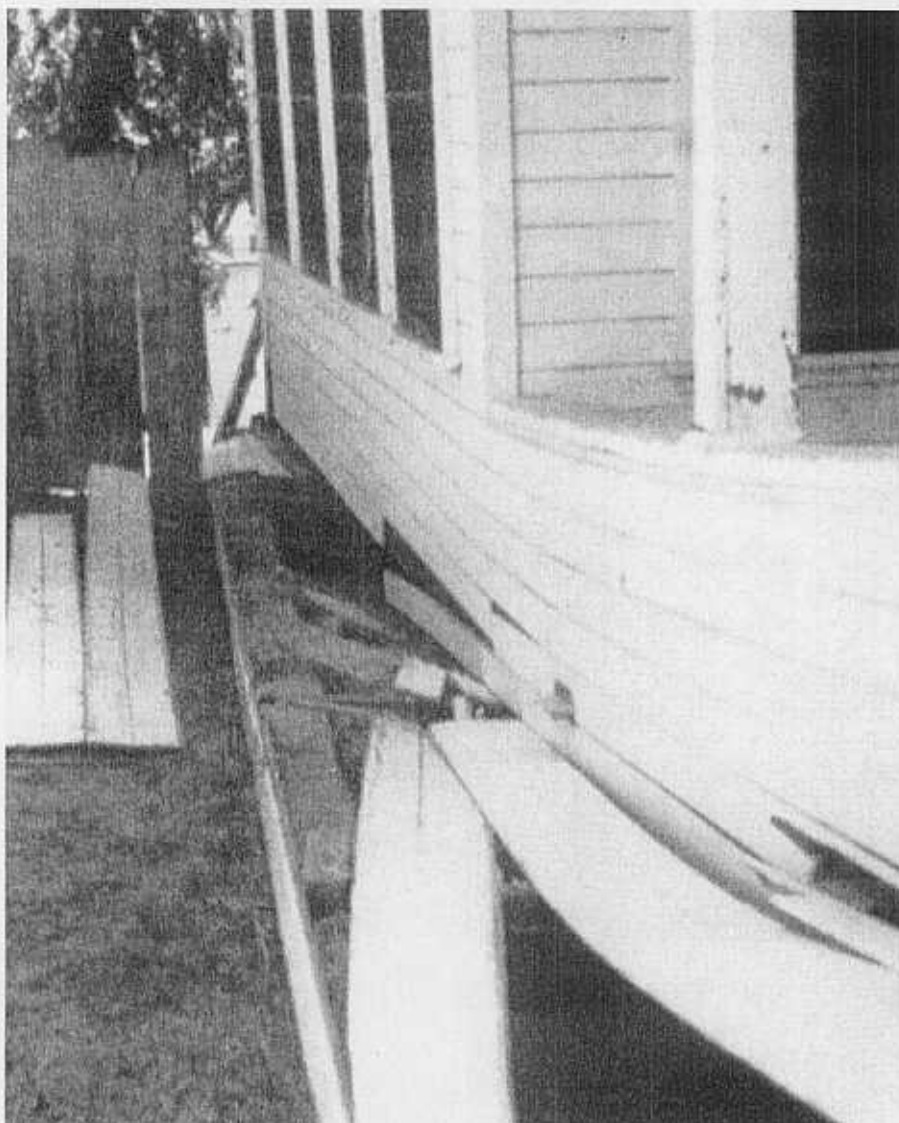
2. *Cripple walls are not braced.* Many houses have a crawl space below the first floor, with a short perimeter cripple wall supporting the first floor joists. If this cripple wall is not braced, it may fail, in which case the building will slide sideways in an earthquake even if it is bolted to the foundation.
3. *Lack of rigidity and resistance to lateral forces.* Where large window

*Failure of unbraced cripple walls caused this building to slide to the right and collapse downward in the 1983 Coalinga earthquake.*
