**Aceh & Nias Post
Tsunami
Reconstruction**

Review of Aceh Housing
Program

April 2006

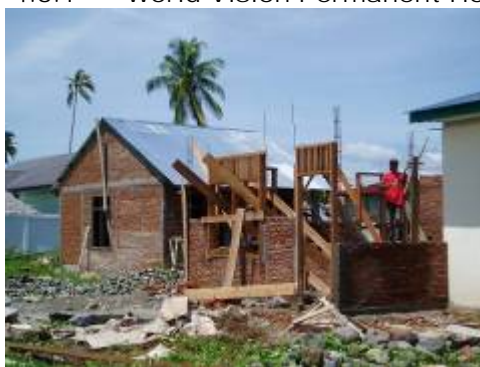
4.3.1 World Vision Permanent House, Meulaboh

Permanent 36m² RC frame with masonry infill walls.

- Foundation appears to be a ring beam which is good.
- RC beams and columns are small 100x100mm, have smooth 10mm reinforcement bars and 6mm links at about 300mm spacing.
- Masonry is single skin and of poor quality, including masonry gables. There appeared to be a crude attempt at adding vertical reinforcement around openings which is unlikely to provide any structural integrity.
- The window and door openings are too large for wall panels and generally not symmetrically spaced. No lintel beams are provided above openings.
- Construction quality is generally very poor.

This house will not meet life safety criteria.

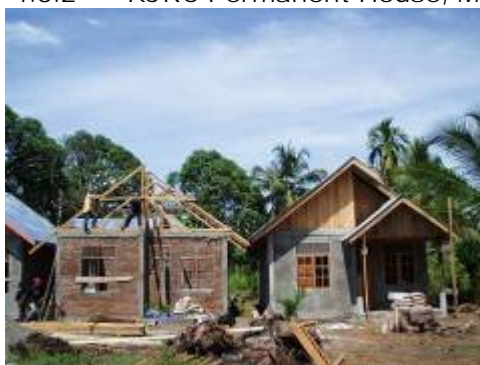
4.3.2 KJRC Permanent House, Meulaboh

Permanent 36m² RC frame with masonry infill walls.

- Foundation is a RC ring beam.
- Beams and columns are larger than World Vision house, though it is not clear what reinforcement details were used.
- Gable is timber rather than masonry, therefore reduced falling hazard.
- Masonry walls are single skin and do not look to be reinforced.

Due to the use of unreinforced masonry walls this house will not meet life safety criteria.

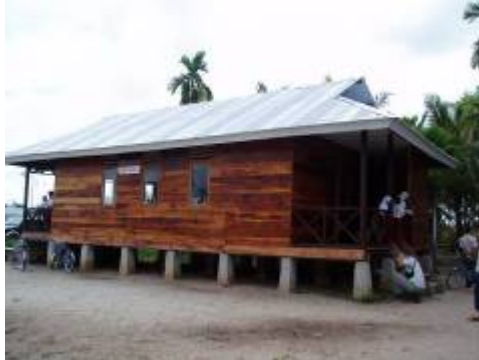
4.3.3 Caritas Traditional House, Singkil

Traditional 45m² timber house.

- Structure rests directly onto individual concrete plinths.
- It is not clear how the timber connections between columns and beams are meant to work.
- Construction quality appears reasonable.

This house probably meets life safety criteria, though some connection details may need to be changed.

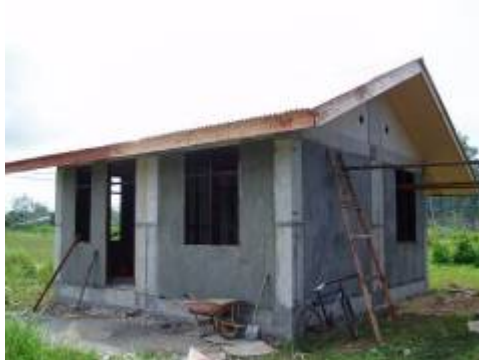
4.3.4 IOM Permanent House, Singkil

Permanent 36m² precast RC frame houses with unreinforced brick masonry walls.

- Foundation is a RC ring beam.
- Precast elements ensures good quality concrete.
- The structure relies on the strength of steel bolts in tension. Their failure could lead to a non-ductile collapse of the frame.
- The frame probably works well with the light weight panels, but it is not clear how will it perform with unreinforced masonry walls.

This house may meet life safety criteria, though the use of unreinforced masonry is questionable.

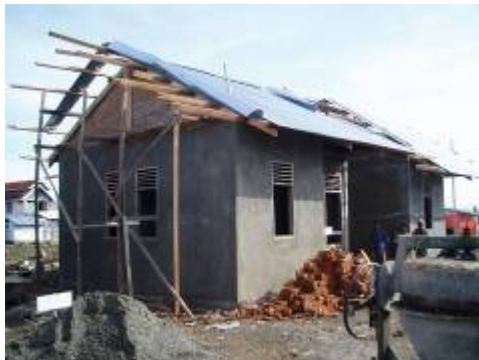
4.3.5 CRS Permanent House, Meulaboh

Permanent 45m² RC frame masonry infill walls

- Columns are 250x150mm with six 12mm bars and 8mm links at 150mm centres.
- The main reinforcement uses deformed bars.
- Windows and doors are generally small and lintel beams are provided.
- There is evidence that limited reinforcement is provided within the masonry panels.
- Construction quality is good and there is a supervisor on site ensuring the contractors achieve the design requirements.
- The cost is R75million.

This house probably meets life safety criteria.

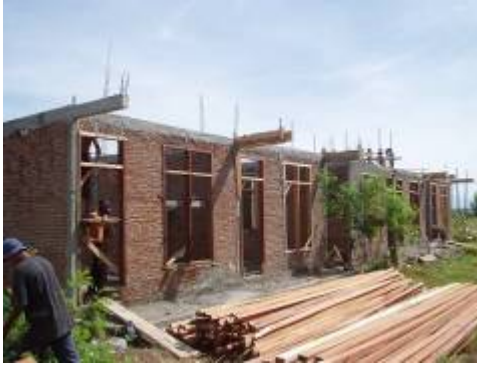
4.3.6 BRR Permanent House, Meulaboh

Permanent 36m² RC frame masonry infill walls

- Columns and beams are 100x100mm with 10mm plain bars and 4mm links at 250mm spacing.
- Generally masonry panels are large, and no lintel beams are provided.
- Internal ply walls to reduce cost.
- Windows and doors are very large compared to the wall panel.
- Windows with nails round frames to supposedly tie into masonry. This is ineffectual
- Construction quality average.
- The cost is R38million.

This house will not meet life safety criteria.

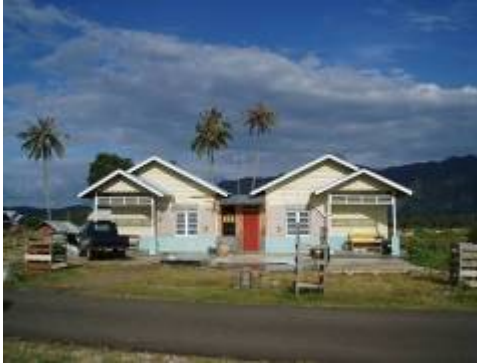
4.3.7 Mercy Malaysia Semi-Permanent House, Banda Aceh

Semi-permanent 36m² house.

- Foundation is a RC ring beam.
- Due to the nature of the construction, low masonry walls and timber frames and walls, the building should be life safe in an earthquake.

This house probably meets life safety criteria.

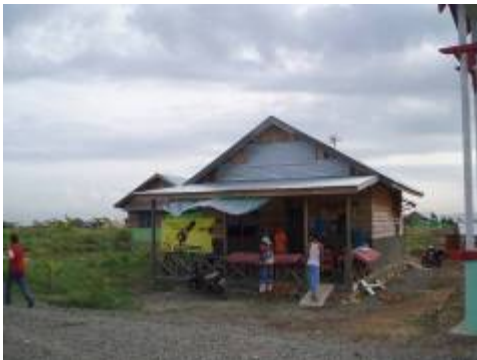
4.3.8 Oxfam Semi-Permanent House, Banda Aceh

Semi-permanent 36m² house.

- Foundation is a RC ring beam.
- Due to the nature of the construction, low masonry walls and timber frames and walls, the building should be life safe in an earthquake
- Showing significant signs of termite attack in the timber walls.

This house probably meets life safety criteria.

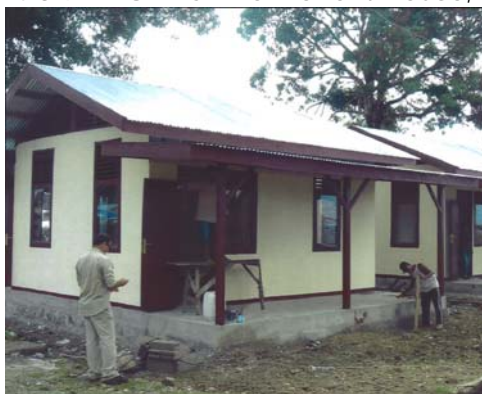
4.3.9 UNHCR Permanent House, Chalang.

Permanent 36m² reinforced blockwork “core” house.

- Foundation is a RC ring beam.
- The structure is designed to survive a zone 6 earthquake and a 1.3m high tsunami wave.
- Windows and doors are generally small and symmetrically spaced.
- Gable ends are timber, so falling hazard is reduced.
- Construction quality is good.

This house probably meets life safety criteria.

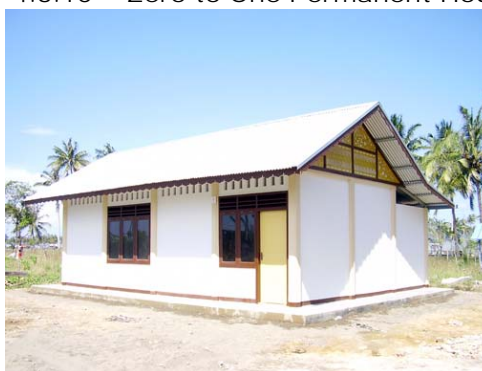
4.3.10 Zero-to-One Permanent House, Nias

Permanent 36m² precast RC “core” house.

- Foundation is a RC ring beam.
- This is a precast RC structure using columns and wall panels with steel roof trusses. They are interlinked using grooves in the columns.
- Certified for zone 6 earthquakes. This appears to be a well thought out design, and better than concrete frame and masonry both in terms of build time (5days/house) and structural integrity.
- The system can be adapted for schools and clinics.

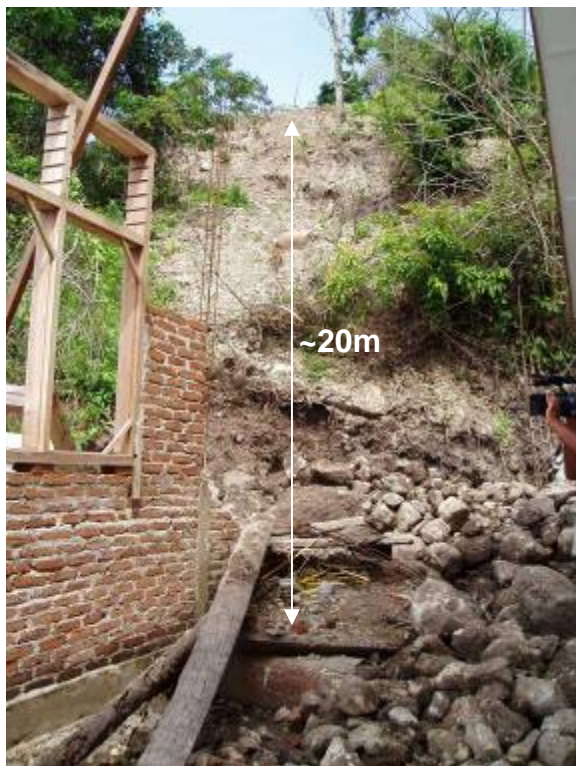
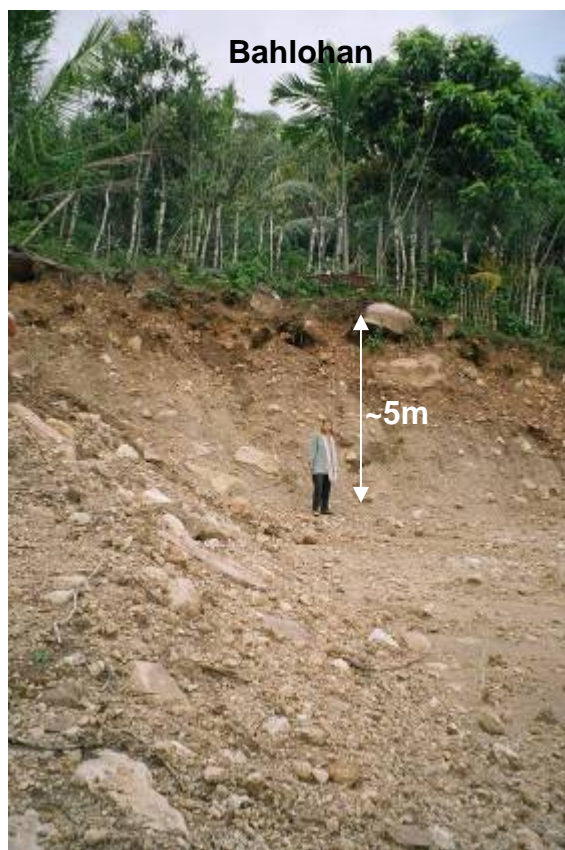
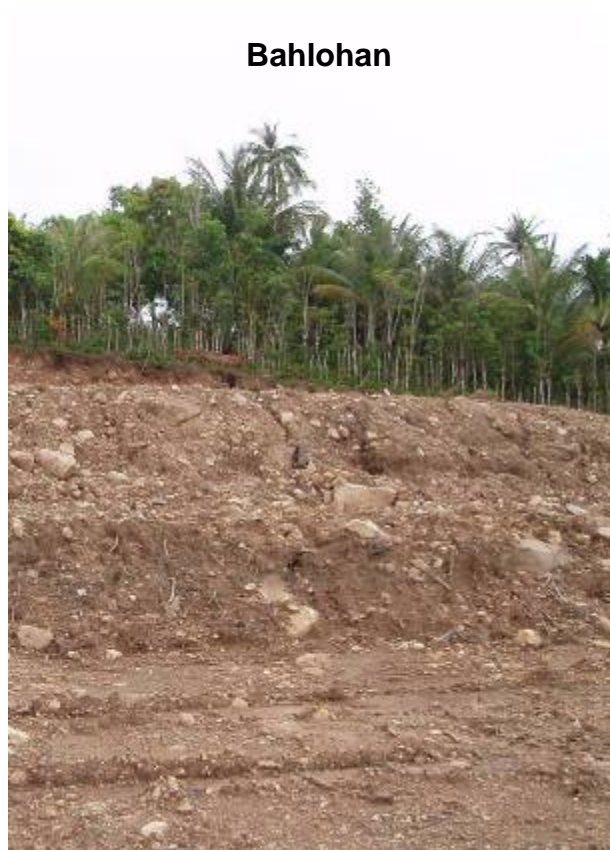
Figure 2.6 Flood Prone Unstable Slopes, Sabang Island

Where developments are to be built on slopes, it is important that terraces and drainage channels are sufficiently engineered to ensure their stability. Figure 2.6 shows two development sites on Sabang Island, where this has not happened. The first has already been subject to one significant landslide, whilst the second is considered to be highly unstable, due to the apparent uncontrolled manner of land clearance and subsequent earthworks. It is noted that the cost of properly designed engineering works to create suitable sites for housing development from steep hillsides, is very significant.

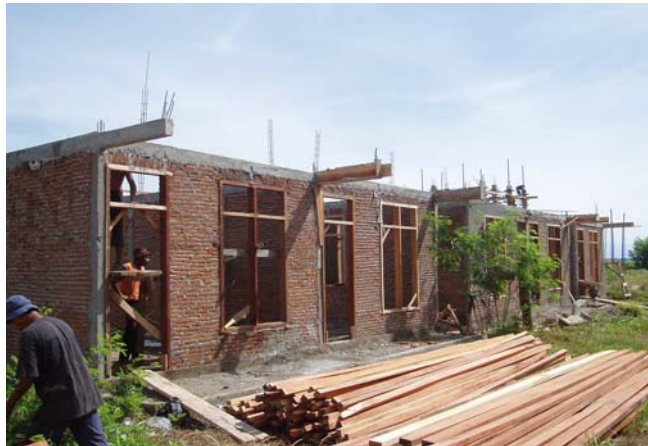
SOIL TYPE						OTHER HAZARDS			
A	B	C	D	E	F	Falling Hazards	Flooding	Liquefaction	Slopes
Hard Rock	Rock	Dense Soil	Stiff Soil	Soft Soil	Poor Soil				
BASIC SCORE, MODIFIERS, AND FINAL SCORE									
Building Type	W1	W2		C1 (MRF)	C2 (SW)	C3 (URM INF)	RM1 (FD)	RM1 (RD)	URM
Basic Score	4.4	3.8		2.5	2.8	1.6	2.8	2.8	1.8
Mid Rise (4 to 7)	N/A	N/A		0.4	0.4	0.2	0.4	0.4	0
High Rise (>7)	N/A	N/A		0.6	0.8	0.3	N/A	0.6	N/A
Vertical Irregularity	-2.5	-2.0		-1.5	-1.0	-1.0	-1.0	-1.0	-1.0
Plan Irregularity	-0.5	-0.5		-0.5	-0.5	-0.5	-0.5	-0.5	-0.5
Ductile Yes	2.4	2.4		1.4	2.4	N/A	2.8	2.6	N/A
Ductile No	0.0	-1.0		-1.2	-1.0	-0.2	-1.0	-0.8	-0.2
Soil Type C	0.0	-0.4		-0.4	-0.4	-0.4	-0.4	-0.4	-0.4
Soil Type D	0.0	-0.8		-0.6	-0.6	-0.6	-0.6	-0.6	-0.6
Soil Type E	0.0	-0.8		-0.8	-1.2	-0.8	-0.8	-0.8	-0.8
Final Score, S						0.8			
Comments

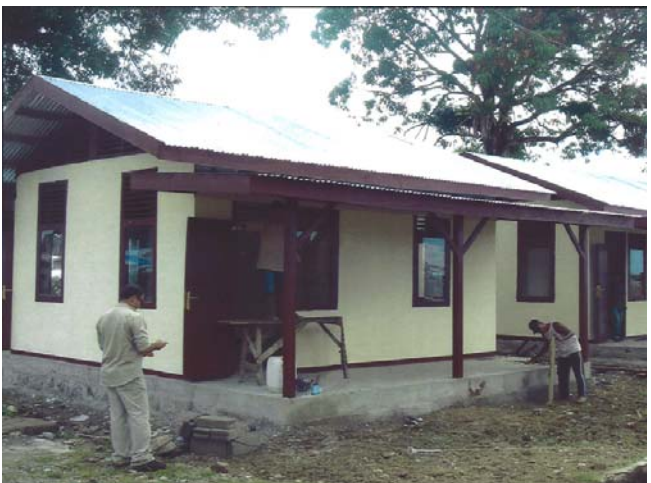
SOIL TYPE	
A Hard Rock	B Rock
C Dense Soil	D Stiff Soil
E Soft Soil	F Poor Soil
OTHER HAZARDS	
Falling Hazards	Flooding
Liquefaction	Slopes
BASIC SCORE, MODIFIERS, AND FINAL SCORE	
Building Type	W1
Basic Score	4.4
Mid Rise (4 to 7)	N/A
High Rise (>7)	N/A
Vertical Irregularity	-2.5
Plan Irregularity	-0.5
Ductile Yes	2.4
Ductile No	0.0
Soil Type C	0.0
Soil Type D	0.0
Soil Type E	0.0
Final Score, S	4.8
Comments	
OK	
YES

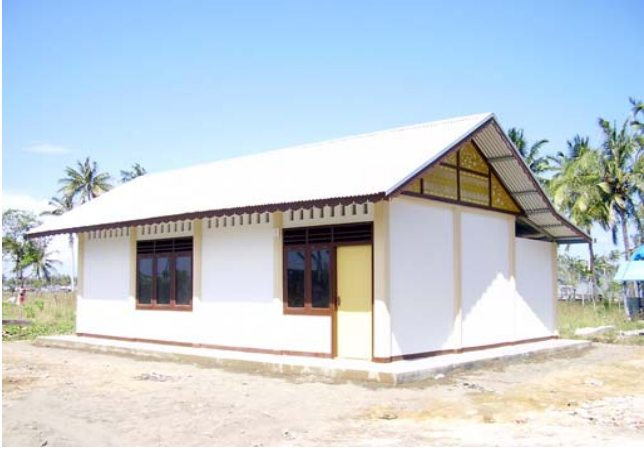
<p>ELEVATION</p>											
<p>SOIL TYPE</p>											
A	Hard Rock	B	Rock	C	Dense Soil	D	Stiff Soil	E	Soft Soil	F	Poor Soil
<p>OTHER HAZARDS</p>											
<p>BASIC SCORE, MODIFIERS, AND FINAL SCORE</p>											
Building Type		W1	W2	C1 (MRF)	C2 (SW)	C3 (URM INF)	RM1 (FD)	RM1 (RD)	URM		
Basic Score		4.4	3.8	2.5	2.8	1.6	2.8	2.8	1.8		
Mid Rise (4 to 7)		N/A	N/A	0.4	0.4	0.2	0.4	0.4	0		
High Rise (>7)		N/A	N/A	0.6	0.8	0.3	N/A	0.6	N/A		
Vertical Irregularity		-2.5	-2.0	-1.5	-1.0	-1.0	-1.0	-1.0	-1.0		
Plan Irregularity		-0.5	-0.5	-0.5	-0.5	-0.5	-0.5	-0.5	-0.5		
Ductile Yes		2.4	2.4	1.4	2.4	N/A	2.8	2.6	N/A		
Ductile No		0.0	-1.0	-1.2	-1.0	-0.2	-1.0	-0.8	-0.2		
Soil Type C		0.0	-0.4	-0.4	-0.4	-0.4	-0.4	-0.4	-0.4		
Soil Type D		0.0	-0.8	-0.6	-0.6	-0.6	-0.6	-0.6	-0.6

Soil Type E		0.0	-0.8	-0.8	-1.2	-0.8	-0.8	-0.8	-0.8		
<p>Final Score, S</p>					<p>4.6</p>						
<p>Comments</p>											
										<p>OK</p>	
										<p>YES</p>
