**Collocation Impacts
on the
Vulnerability of Lifelines During
Earthquakes with Applications
to the
Cajon Pass, California

Earthquake Hazard Reduction Series 59

COLLOCATION IMPACTS ON LIFELINE EARTHQUAKE VULNERABILITY
AT THE CAJON PASS, CALIFORNIA

STUDY OVERVIEW

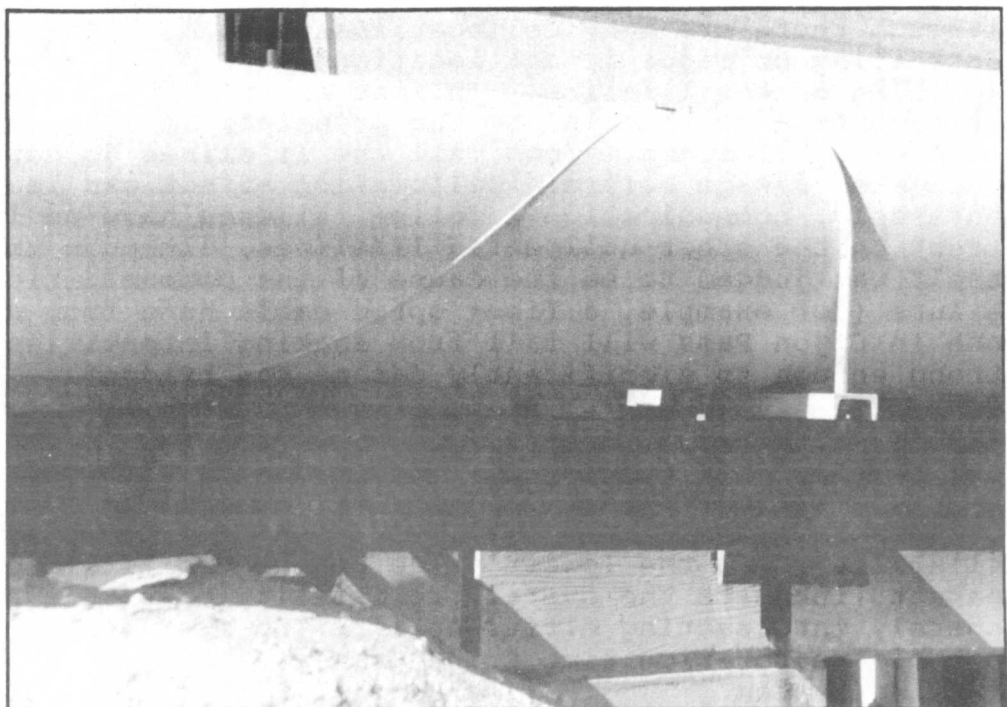
Figure 3 Fiber Optic Conduits Hung Under a Water Distribution Pipe on a Bridge Over a Railroad

At the bridge locations along the Cajon Blvd. extension, the fiber optic conduits are brought to the surface and hung from the bridges, using light anchoring systems. The practice of hanging the fiber optic cables from bridges and other lifeline structures is common throughout the Cajon Pass area, they are on bridges over railroads (see Figures 3 and 4) and on the bridges over the California Aqueduct. They are routed at the foot of a crib wall used to retain the I-15 road bed, after which they are brought to the surface and hung from the wall of a concrete culvert that passes under I-15. Figure 5 shows the details of the typical light wall anchors and supports that are used.

The communication lifelines (the fiber optic cable systems) had no impact on increasing the probable time to restore service for any of the other lifelines. The fact that all four cable conduits are routed together for much of their routes through the Cajon Pass increases the potential that these valuable lifelines will be lost during an earthquake event. The practice of hanging the conduits from bridges and other lifeline structures using very light anchor supports increases the risk of failure of these communication lifelines at earthquake shaking intensities which would not impact them if they had been buried or supported by more robust anchors.

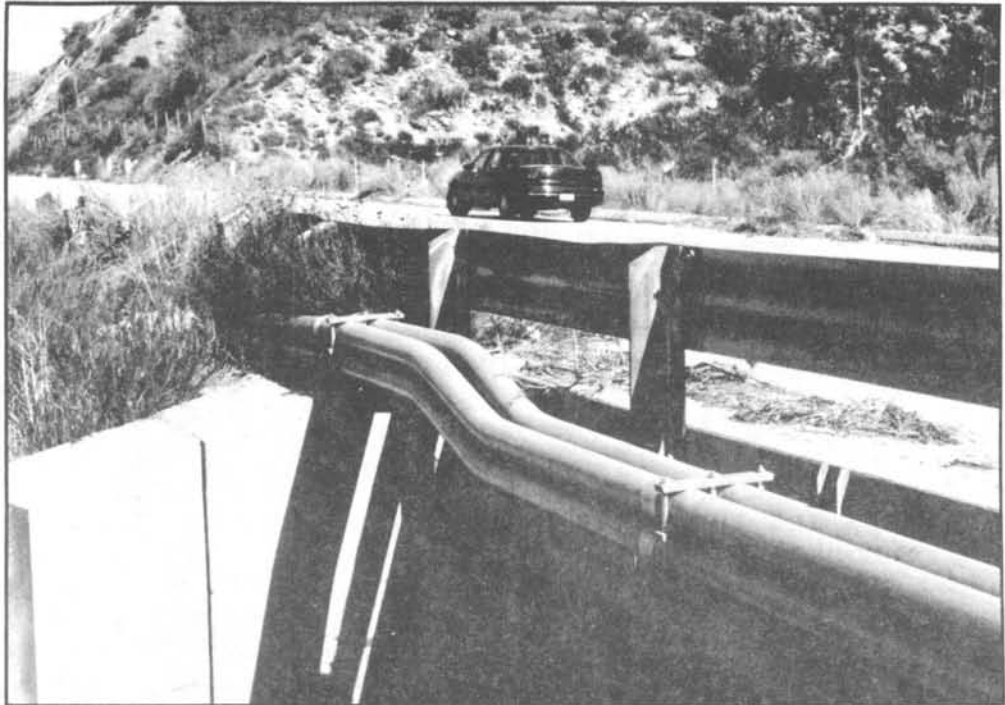
Figure 4 Fiber Optic Conduits on a Bridge on an Abandoned Portion of Highway 66

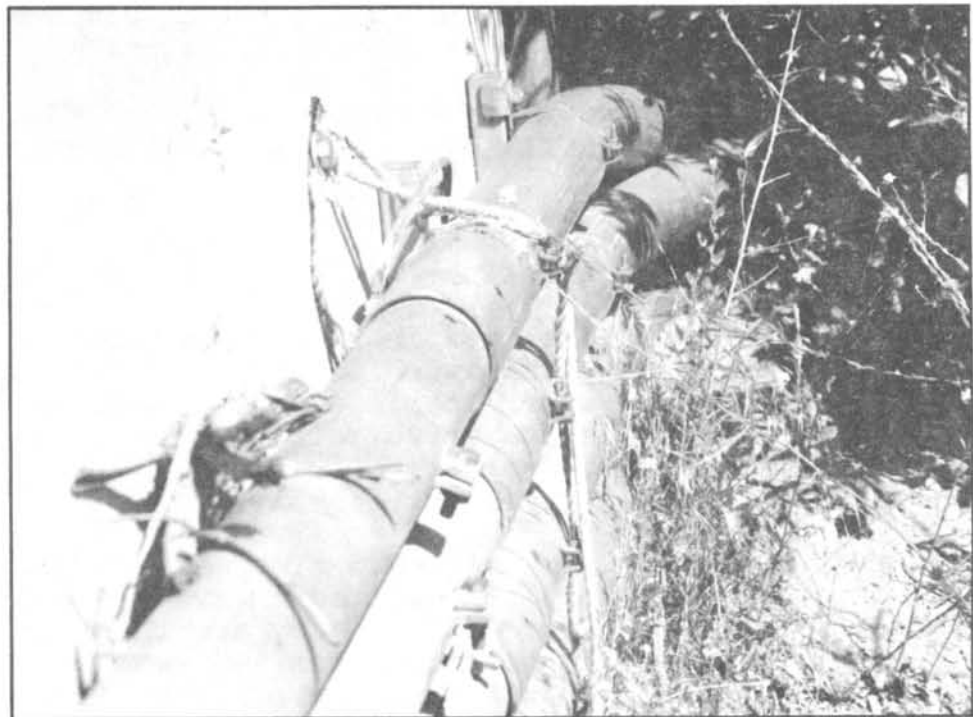
Figure 5 Details of Fiber Optic Conduit Supports on a Highway Culvert Wall

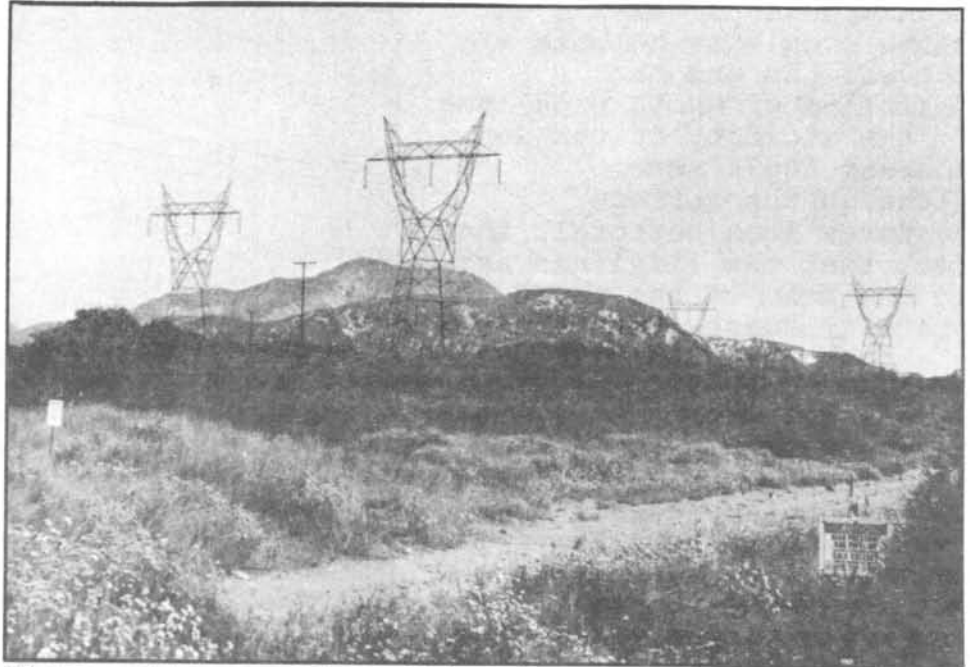
Figure 6 Power Line, Natural Gas and Petroleum Products Pipelines Over the San Andreas Fault

Figure 6 shows the location where the two separate electric power

transmission lines are in close proximity to both a natural gas and the petroleum products pipelines in the vicinity of the San Andreas fault zone.

Although the surface features look pastoral, the fact that the lifelines are in the zone of the fault trace increases both their risk and the potential magnitude of the damage that could be induced. Figure 7 is a photograph in the opposite direction to the one shown in Figure 6. It shows an electric power transmission tower located at the edge of a steep embankment, suggesting that a foundation failure may also be a contributing factor to causing the power lines to drop to a height where they could readily interact with spilled fuel.

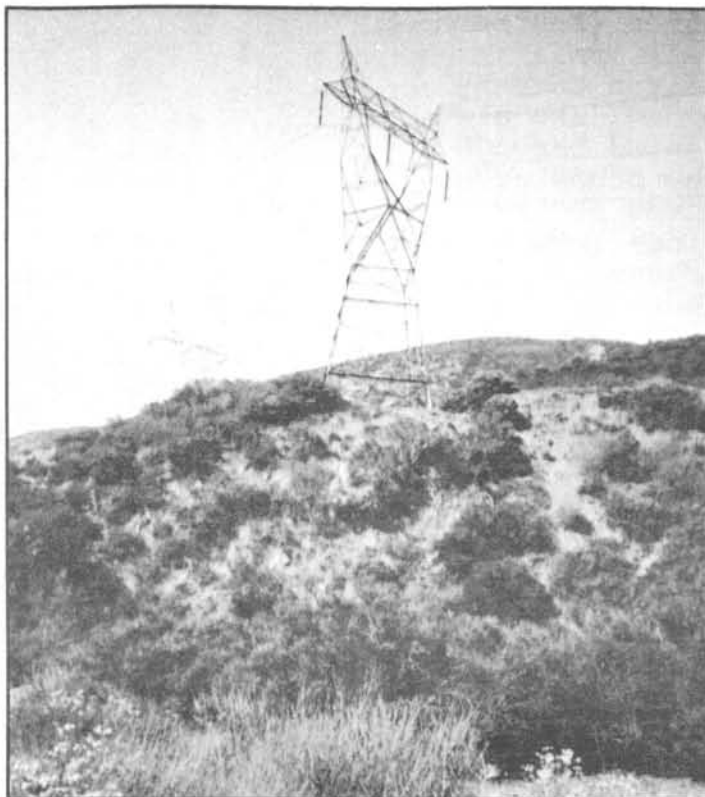
Figure 7 Power Lines At a Ravine Edge at the San Andreas Fault

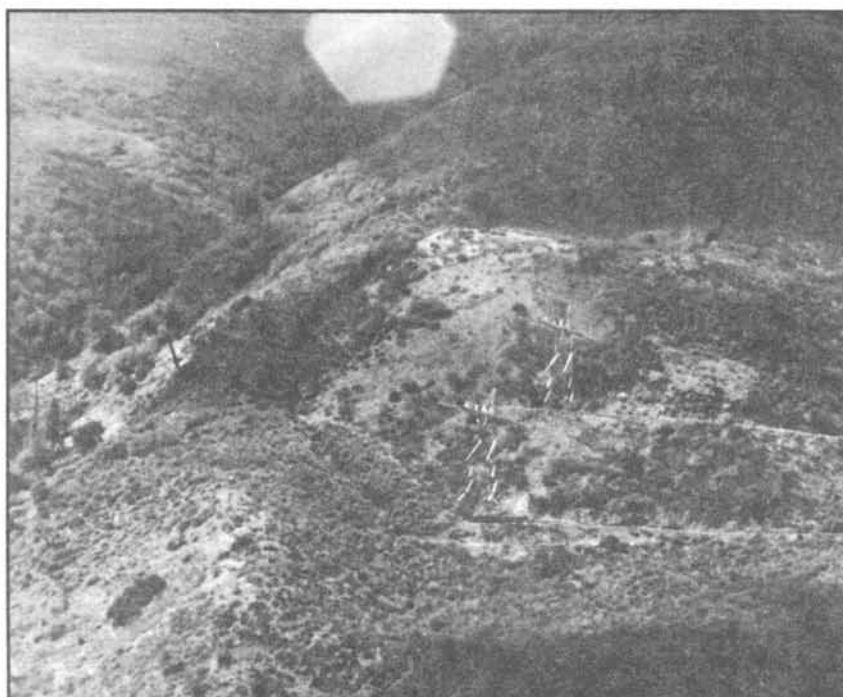
South of the San Andreas fault zone there are two additional areas where the electric transmission lines pass through a region susceptible to landslides and where there are nearby railroad and buried natural gas pipeline lifelines. Figure 8 shows two transmission towers that were rebuilt when the prior ones were damaged by a local landslide. Not shown at the bottom of the figure are a buried natural gas pipeline and a railroad.

Figure 8 Electrical Towers on a Landslide Scar (Directly Above a Fuel Pipeline & a Railroad)

The collocation impacts at the landslide locations included increasing the damage state when there was a fuel pipeline present as well as increasing the time delay to initiate repairs due to the general congestion and the need to allow for debris removal from collocated railroad beds or environmental cleanup to remove the hazard from spilled fuels.

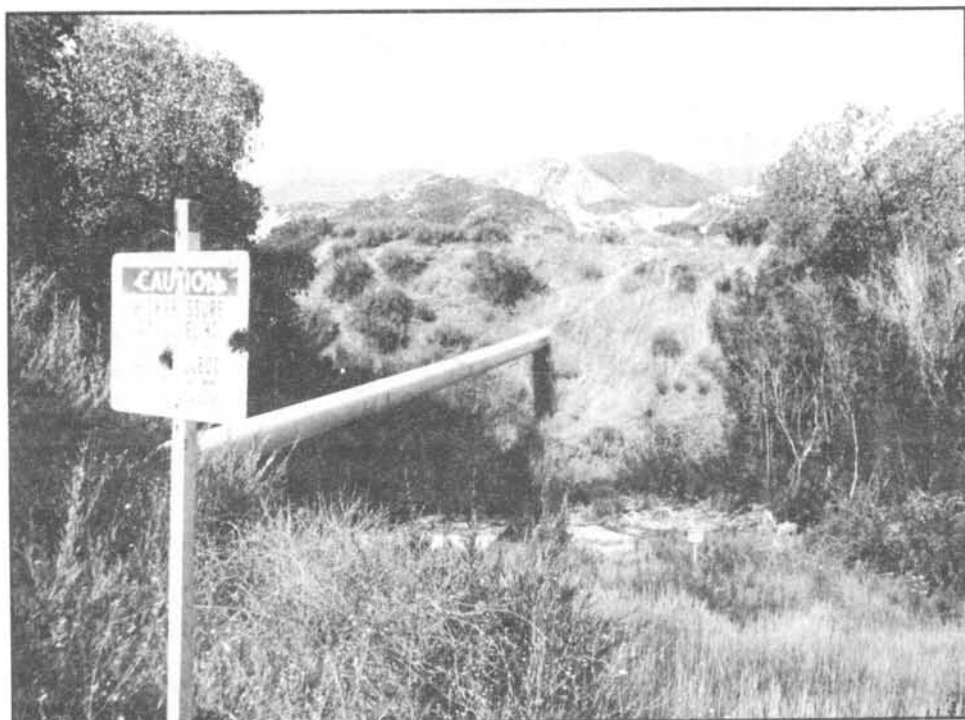
Figure 9 shows a section (north of Cajon Junction and next to Highway 138) where the two pipelines are routed parallel to each other. A 1990 realignment of Highway 138 (to remove curves) placed the exposed section of the one pipeline about 40 feet from the road bed. The gas line markers shown in the figure identify the route of the buried pipeline.

Figure 9 Two Natural Gas Pipelines, One Exposed One Buried, Next to Highway 138

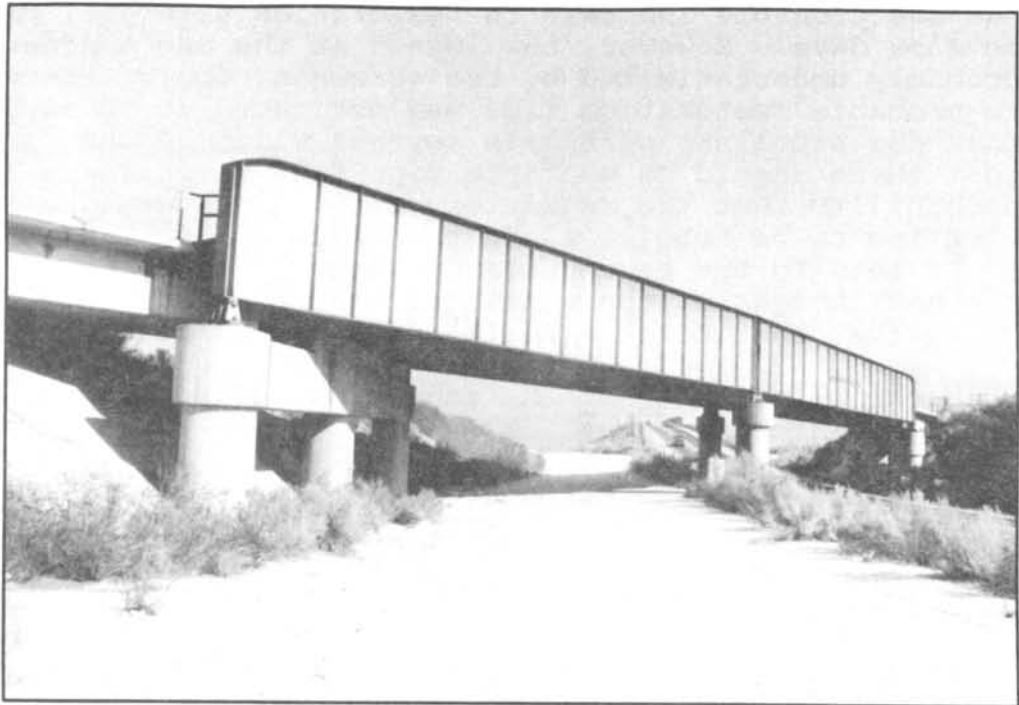
The highway bridges and road beds, in general, are not subjected to damage from other nearby lifelines. The exception is when a railroad bridge crosses over a highway. At such locations, the failure of the bridge has a direct impact on the highway. Figure 10 shows one such bridge. Because of its skew and simple supports, the bridge was estimated to collapse onto Highway 138, effectively removing that segment of the road as a bypass or detour route for

traffic past I-15's damaged sections. It is noted that the bridge span that crosses Highway 138 is the right span in the Figure. Very close to this bridge was a highway bridge over the railroad. Even though it had the same amount of skew with respect to the road alignment, its

Figure 10 A Railroad Bridge Estimated to Collapse Onto Highway 138 (Highway 138 is located under the right span)

continuous column design is more robust and it was not estimated to collapse onto the railroad. None of the highway bridges were predicted to completely collapse, although partial collapse is possible. Fortunately, the "diamond" interchange design used in the Pass provides a direct detour route (although one with reduced capacity compared to the I-15 road beds) past any partially damaged bridge.

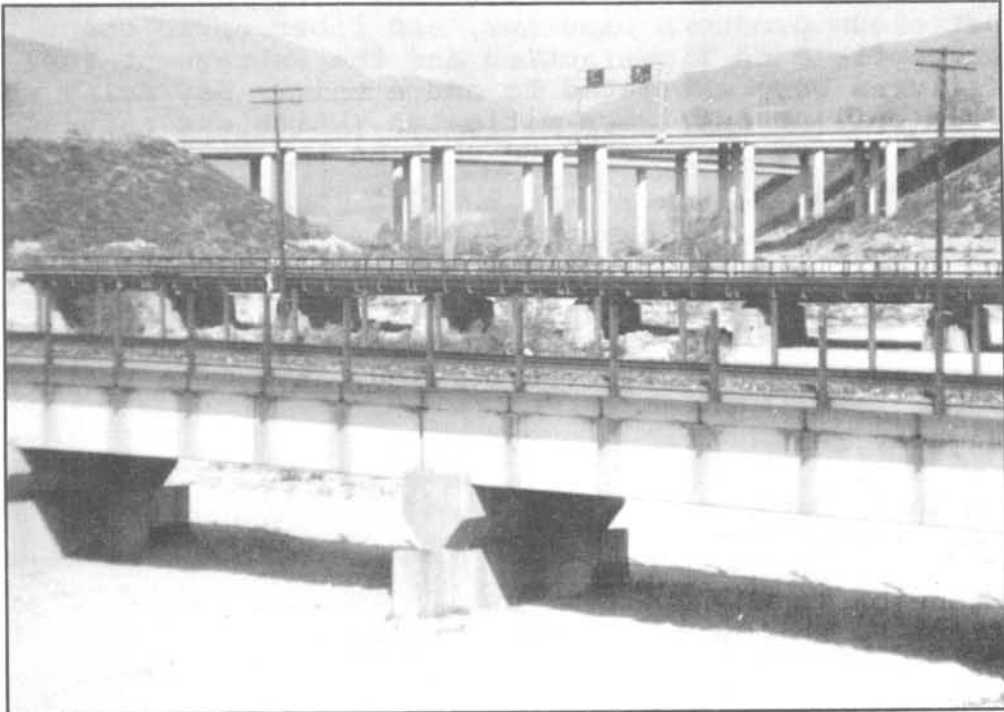
Figure 11 Railroad and I-15 Bridges in Cajon Wash Subject to Liquefaction Damage
