# Building Better

## New Building Code & Upgraded Power System

# Case Studies

U.S. VIRGIN ISLANDS

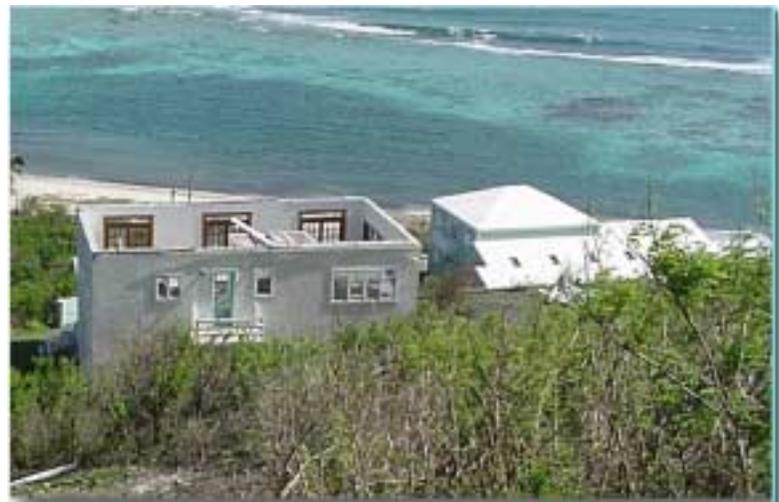
*House on right was built after previous hurricane beyond the building code standards that were adopted by the VI Government. Recommended mitigation measures were used throughout the house.*

With FEMA support, a new building code was written and implemented. This code requires anchoring systems, hurricane clips, shutters and other measures intended to hold buildings together and prevent flying debris during storms.

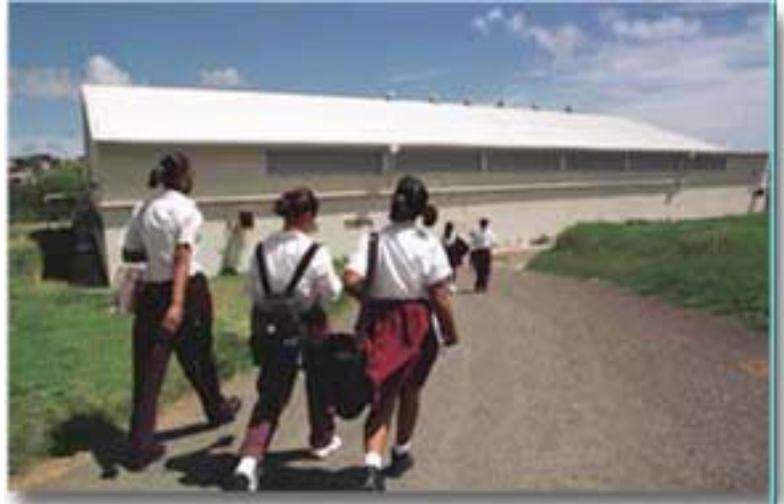
*St. Croix's Central High School students walk to the gymnasium that was part of an initiative to strengthen the roofs of public buildings on the island to withstand sustained winds of 110 mph.*
