# **Report On Mitigation Activities In the US Virgin Islands**

**FEMA-DR-1248-VI**

**Prepared by:  
FEMA Region II  
October, 1998**

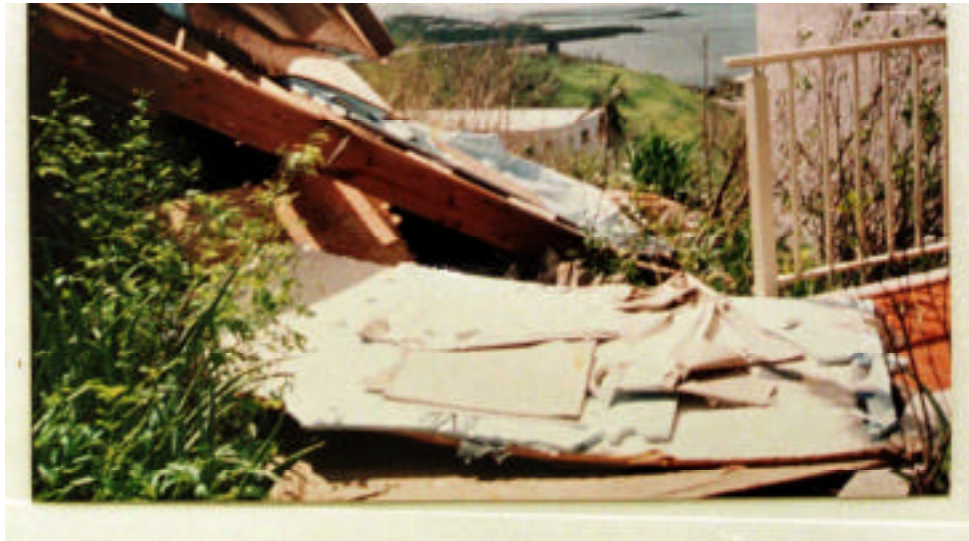
High winds generated by Hurricane Georges caused a partial collapse of this building.

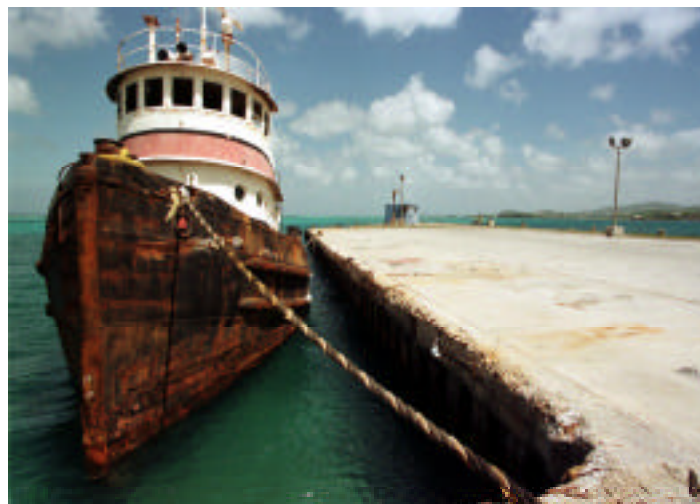
New fuel pier at Richmond Substation on St. Croix

### **St. Croix Fuel Pier**

Construction of new pier facility to permit the safe delivery of fuel oil to the St Croix Power Generation Plant.

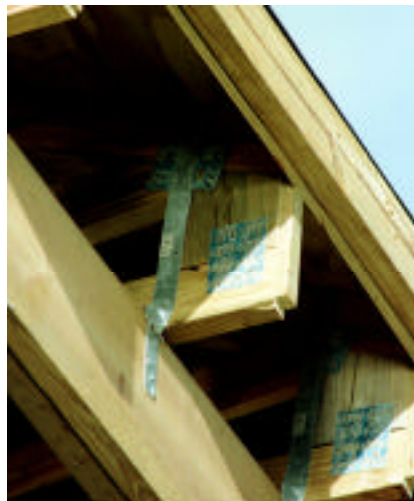
Proper building techniques used by residents.

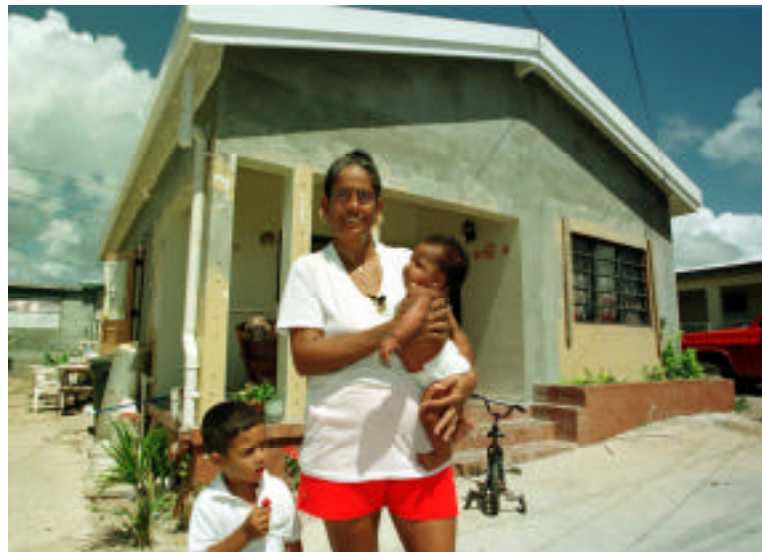
Immediately following Hurricane Georges, HPRP sites that were under construction and HPRP sites that had previously been completed on St. Thomas, St. Croix and St. John were inspected. Hurricane Georges did minimal damage to HPRP sites from the immediate external damage perspective. Some guttering was lost and some temporary protective measures taken by contractors to protect their construction sites were damaged but on the whole, the HPRP sites were visibly undamaged by the hurricane.

Homeowner stands in front of a newly constructed roof .

Following Hurricanes Marilyn and Bertha, the Government of the US Virgin Islands initiated a comprehensive program to repair damaged roofs.organized an effort to expedite a solution to the unresolved roof problem. This effort is known as the Home Protection Roof Program (HPRP). The Home Protection Roofing Program (HPRP) is providing nearly 400 homeowners with roofs designed to stay on through a category 2 storm.
