**Aceh & Nias Post
Tsunami
Reconstruction**

Review of Aceh Housing
Program

April 2006

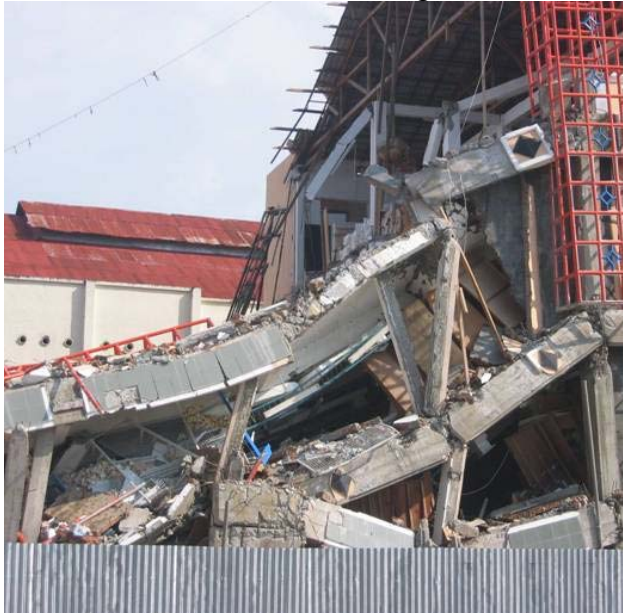
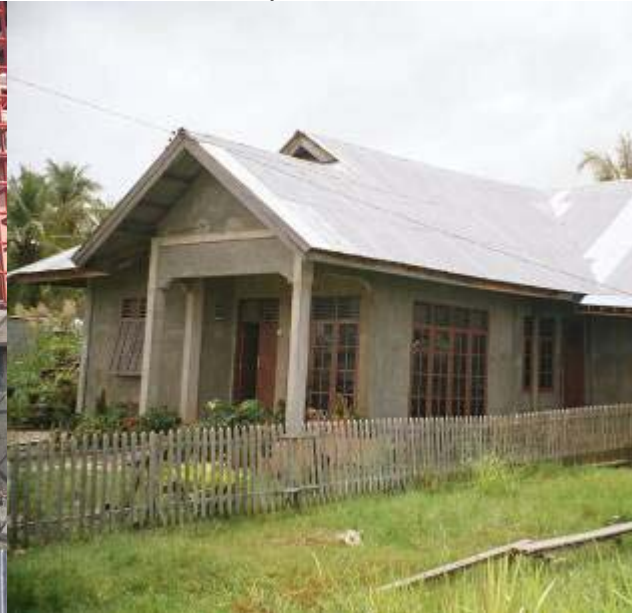
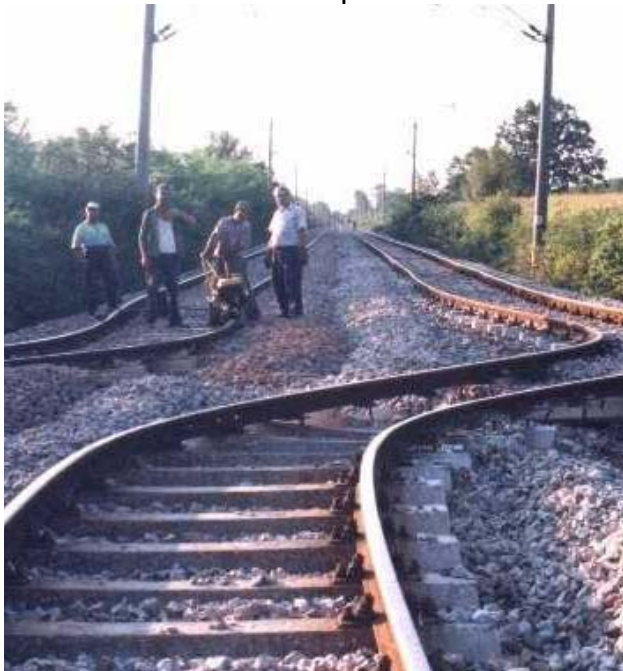
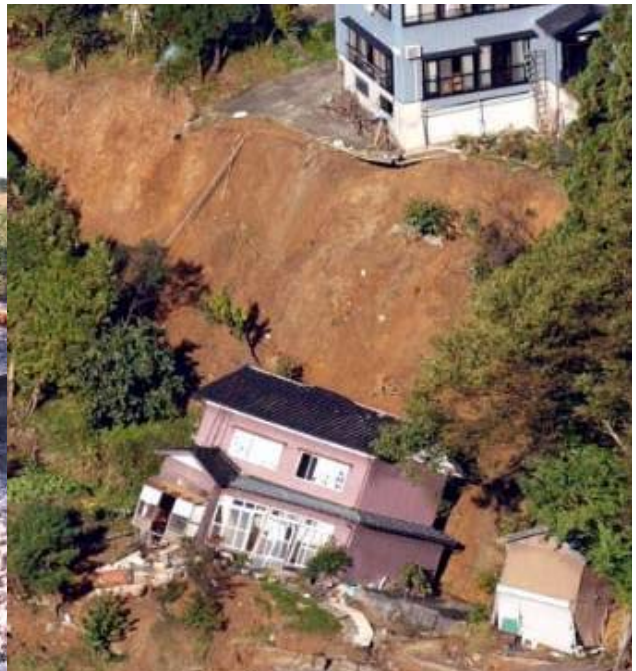
Figure 2.4 **Direct Earthquake Hazards**

There are four principal hazards which can result from an earthquake. Examples are shown in Figure 2.4 and their consequences are explained below:

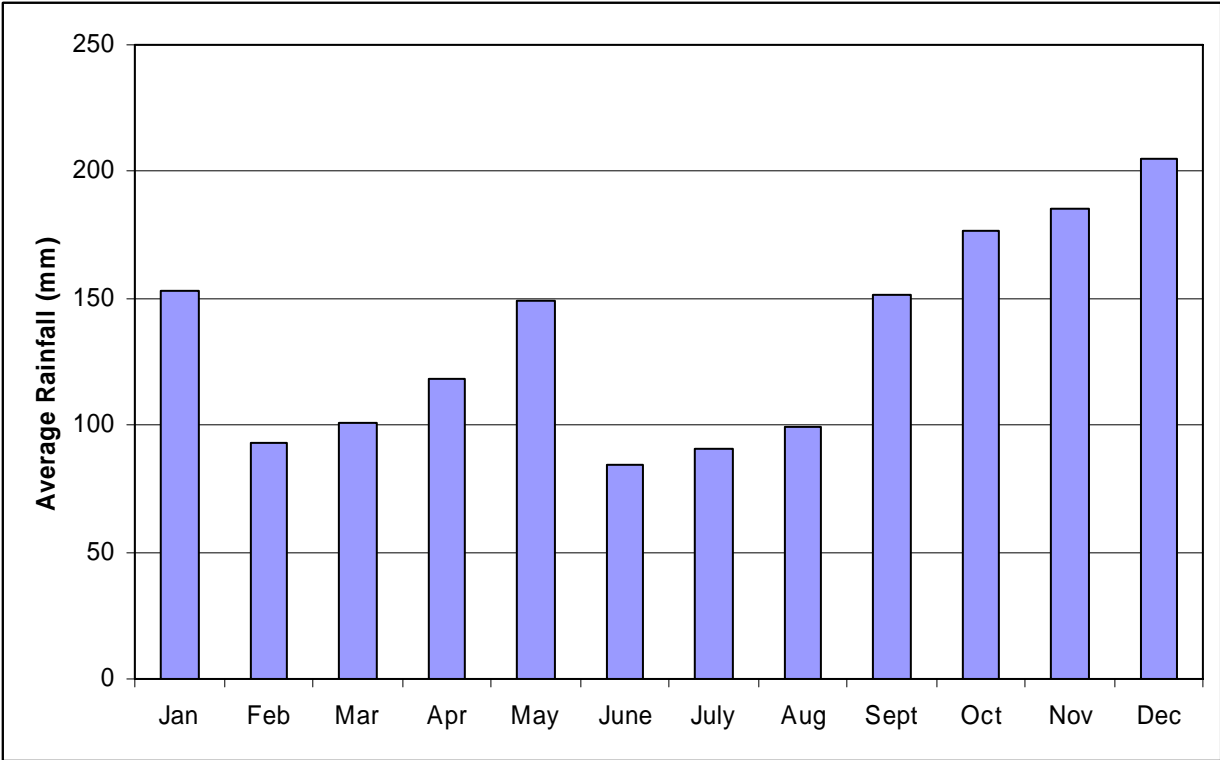
Figure 2.7 Average Yearly Rainfall for Banda Aceh

Figure 2.7 shows the average rainfall for Banda Aceh, taken from www.worldclimate.com. This equates to about 1.6m in a year, with the principal rainy season being between September and January. The region is therefore susceptible to large water run-off that could lead to flash flooding.

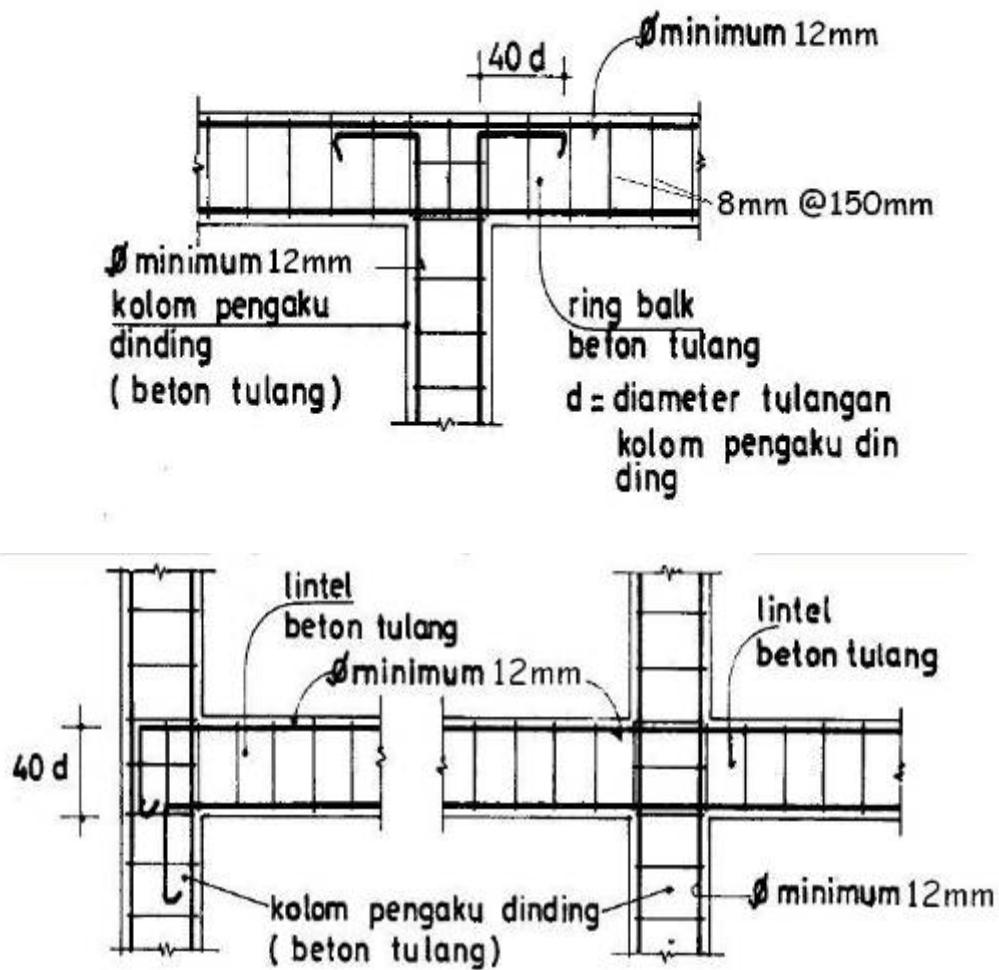
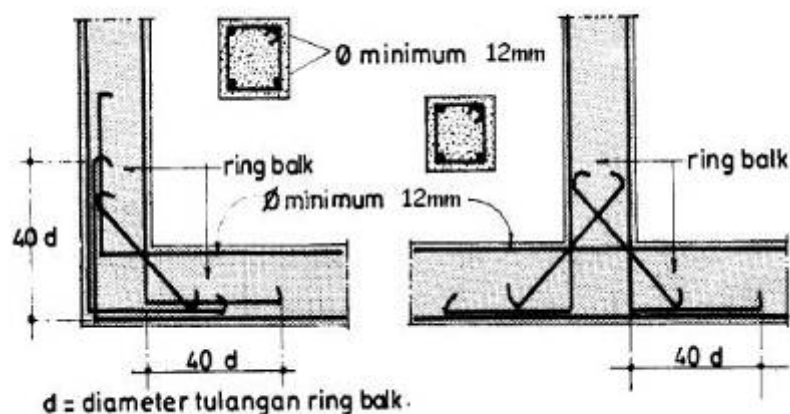
**Figure 3.2 Typical Reinforcement Details**

Alternative details for items 2, 10 and 11 are shown in Figures 3.2, 3.3 and 3.4.

This document is intended to provide the community with examples of good and poor construction. It is a useful document, though it may be more beneficial to architects, design engineers and contractors rather than the community. It could be improved by adding typical reinforcement details such as those in the UN Habitat checklist and Figures 3.2, 3.3 and 3.4.

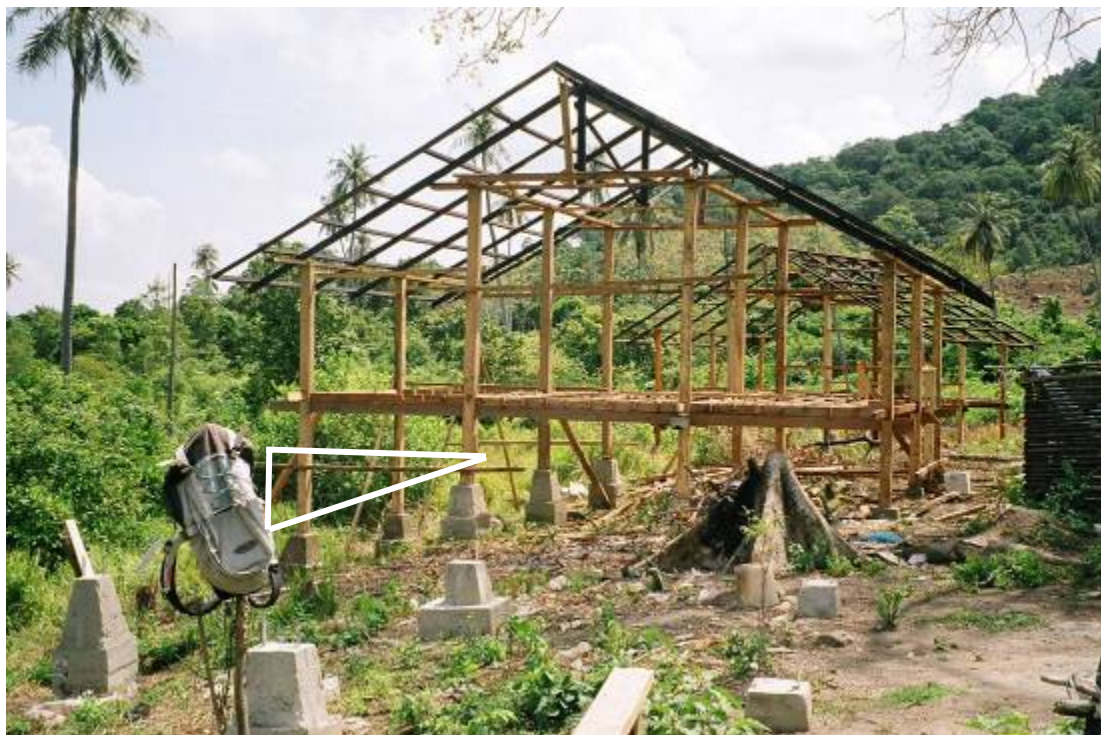
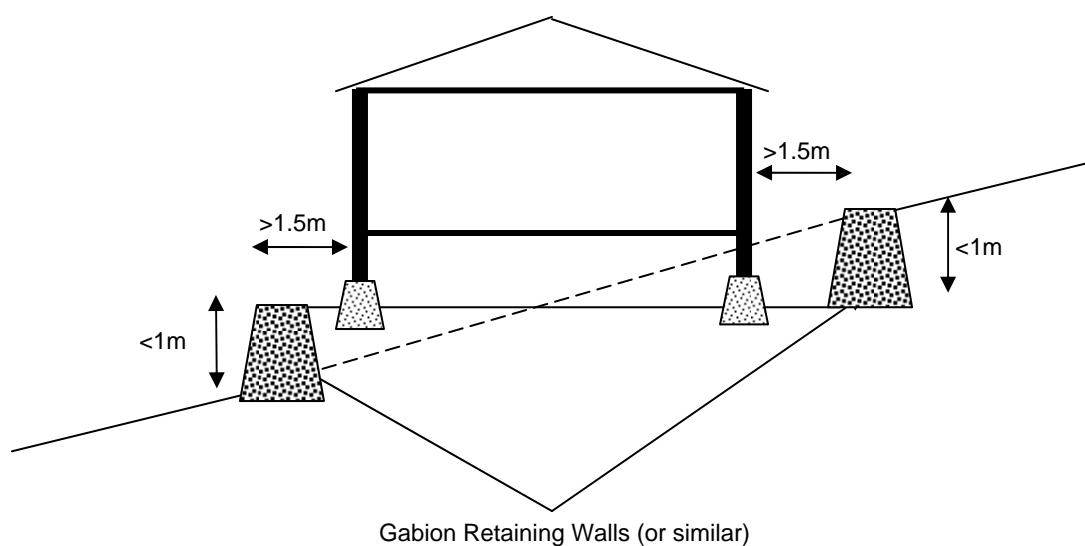
Figure 5.1 **Siting on Sloping Ground**

- Locating housing on flat ground with a gently slope (<5 degrees) to facilitate drainage.
- For sloping sites (5 to 20 degrees), creating small level platforms on which to seat individual houses, as opposed to varying the height of the plinths and/or posts. See representative sketch in Figure 5.1.
- Building houses at least 1.5m away from slope edges or small retaining walls
- Landscaping the whole site with appropriate drainage, retaining walls and earthworks, designed and supervised by geotechnical and civil engineers. This will tend to take some time and be very costly.

(not to scale, walls need to be sized, fill compacted and suitable drainage provided)
