The Apartment Owner's Guide to Earthquake Safety

A Handbook for Owners to Identify
Seismic Hazards in Low Rise Apartment Buildings

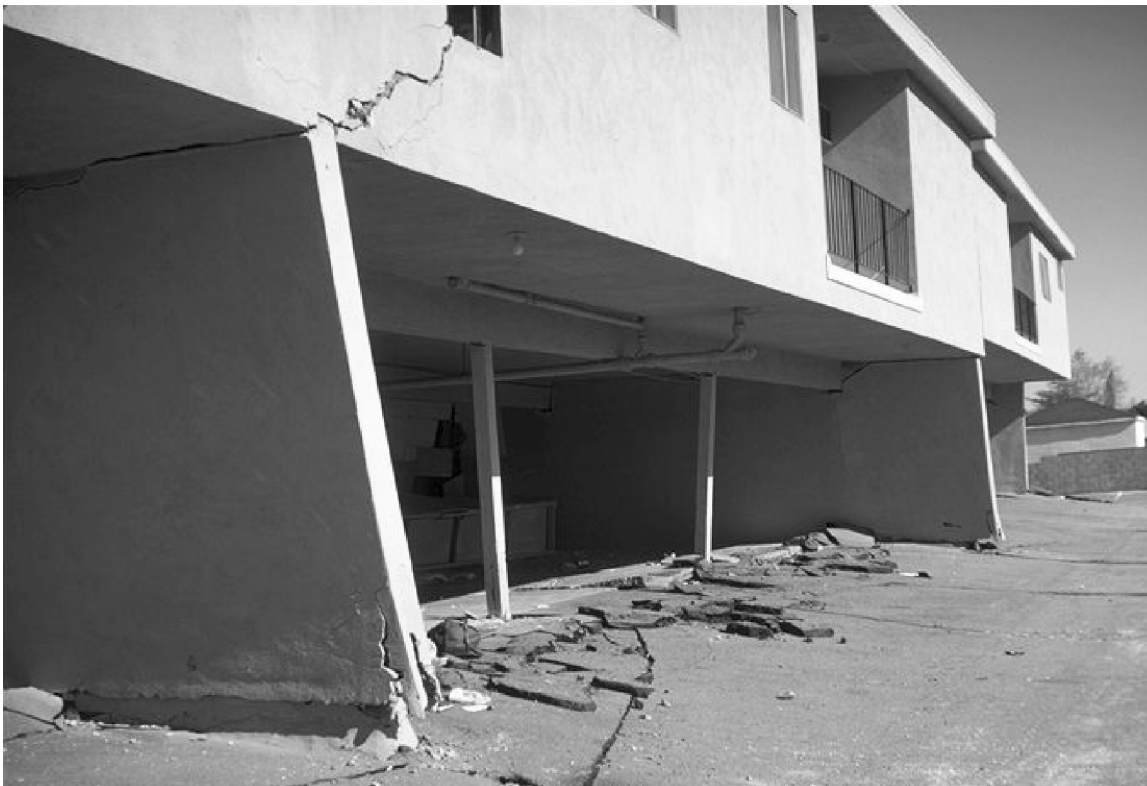
Figure 3. Damage to a tuck-under parking building with stucco shearwalls

Stucco and gypsum board shearwalls coupled with tuck-under parking are present in many wood framed apartment buildings built prior to 1976. The primary reason for this is that the 1976 edition of the UBC contained revisions due to observed performance of buildings in the 1971 San Fernando earthquake. The most significant of these revisions was to decrease the allowable strength of both stucco and gypsum board shearwalls and to increase the seismic load by forty percent. The direct result was the increased use of plywood shearwalls in wood construction and while tuck-under parking was not eliminated it was discouraged. Figure 3 shows damage to stucco shearwalls in a tuck-under parking building following the San Fernando Earthquake. All of the damaged multi-unit buildings inspected after the Northridge earthquake had failed stucco or gypsum board shearwalls. The performance of these weak shearwalls was often made worse by sloppy construction and poor quality control.

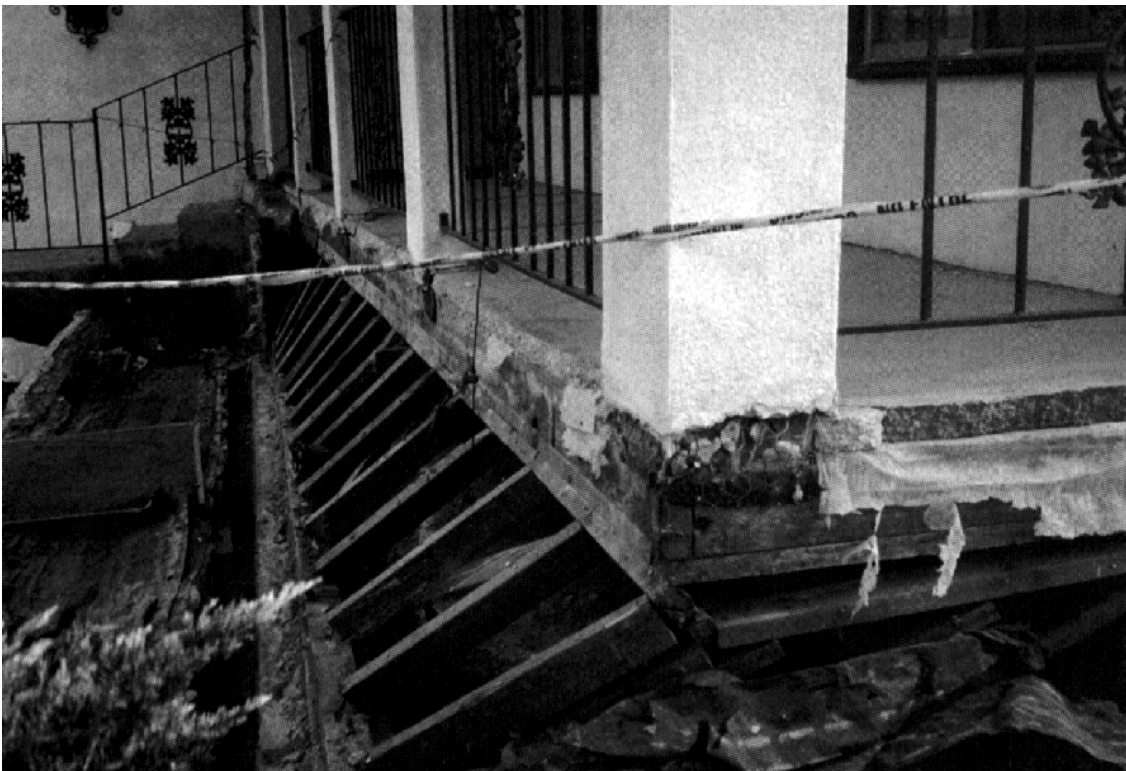
Figure 5. Cripple wall damage in the Northridge earthquake

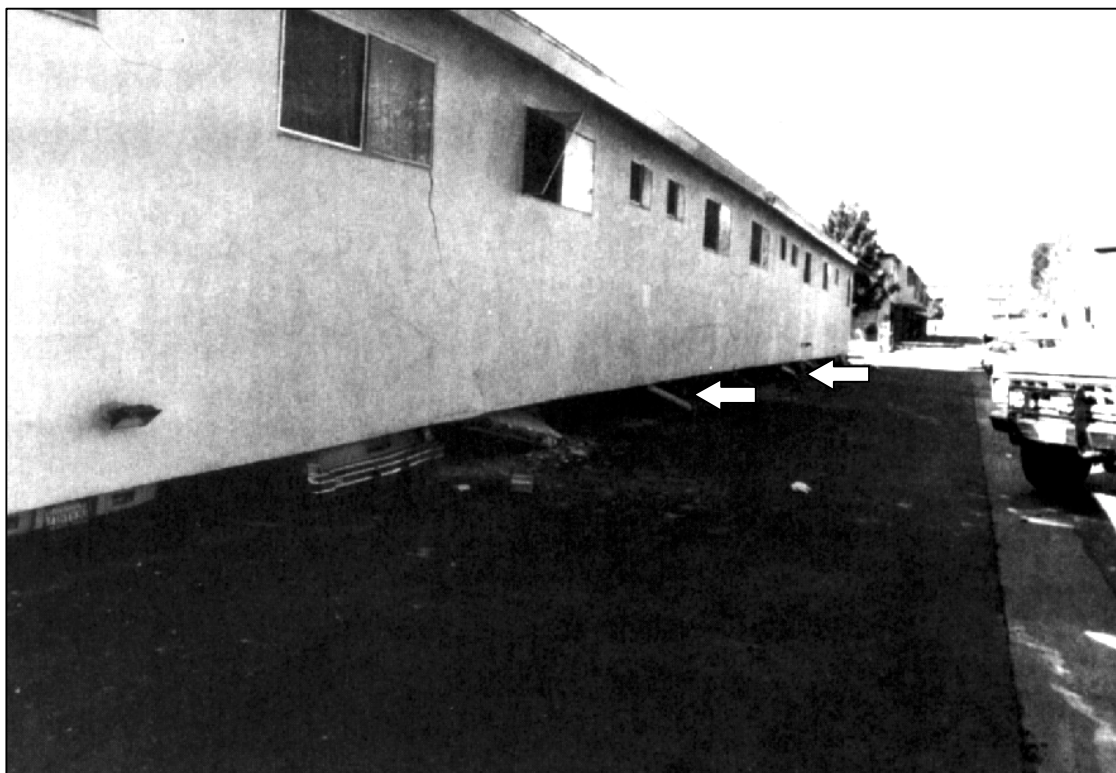
Figure 6. Damage to a tuck-under parking building in the Northridge earthquake.

quate to resist the seismic forces and subsequent large deformation that they are subjected to in a major earthquake. Figure 6 shows a tuck-under parking building that collapsed during the Northridge earthquake. Note the collapsed steel posts indicated by the white arrows and the upper stories remaining almost completely intact. This figure illustrates the inherent weakness of the tuck-under parking configuration and the dangers to human life and property (16 people died in this particular building).

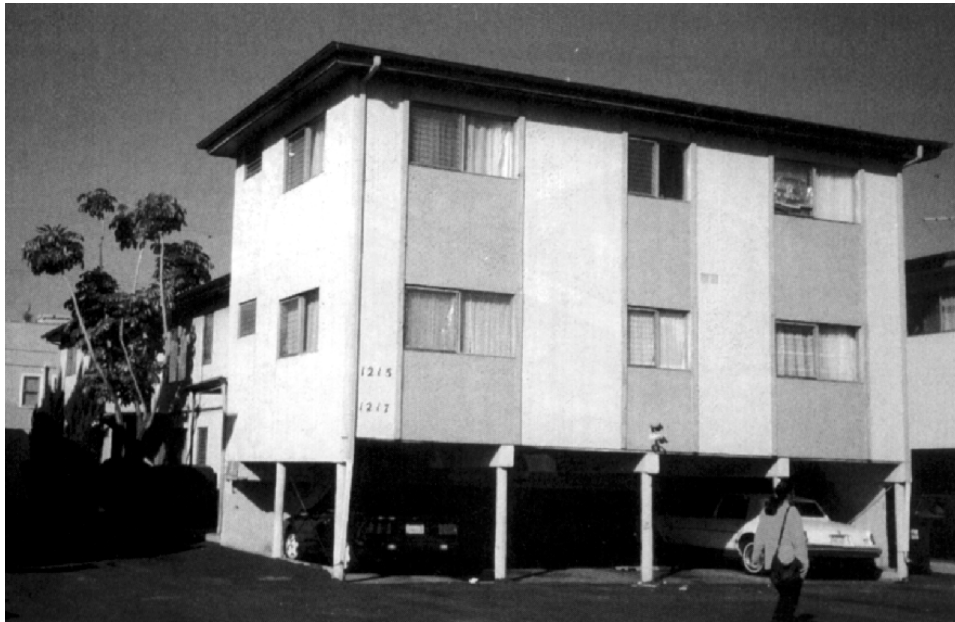
Figure 12. Photo of building for RSP example.

In order to illustrate the RSP and how to fill out the Data Collection Form, the following example is presented. A photo of the example building is shown in Figure 12 and the completed Data Collection Form for this building is shown in Figure 13.

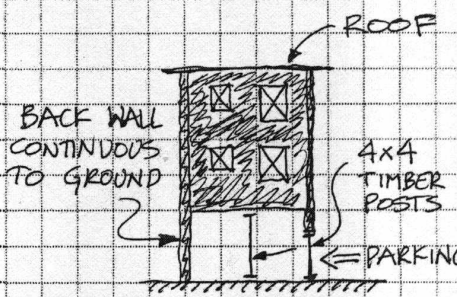
<p style="text-align: center;">SHORT SIDE VIEW</p> </div> </div>	
<p>Comments</p> <p style="font-size: 1.2em; text-align: center;">FINAL SCORE $\Rightarrow 1.7 < 2$</p> <p style="text-align: center;">DETAILED EVALUATION IS RECOMMENDED</p>

Figure 13. Example of completed Data Collection Form.

From the visual survey and data collection, the PMFs that apply to this building are circled on the Data Collection Form. The circled PMFs as indicated on Figure 13 are:

$$6.5 - 2.0 - 2.5 - 0.3 = \underline{1.7}$$

The Final Structural Score of 1.7 is less than 2.0 and it is noted in the comment section that for this building a detailed evaluation by a design professional is recommended.
