GENERAL GUIDELINES  
FOR THE ASSESSMENT AND REPAIR  
OF EARTHQUAKE DAMAGE  
IN RESIDENTIAL WOODFRAME BUILDINGS

Consortium of Universities for Research in Earthquake Engineering

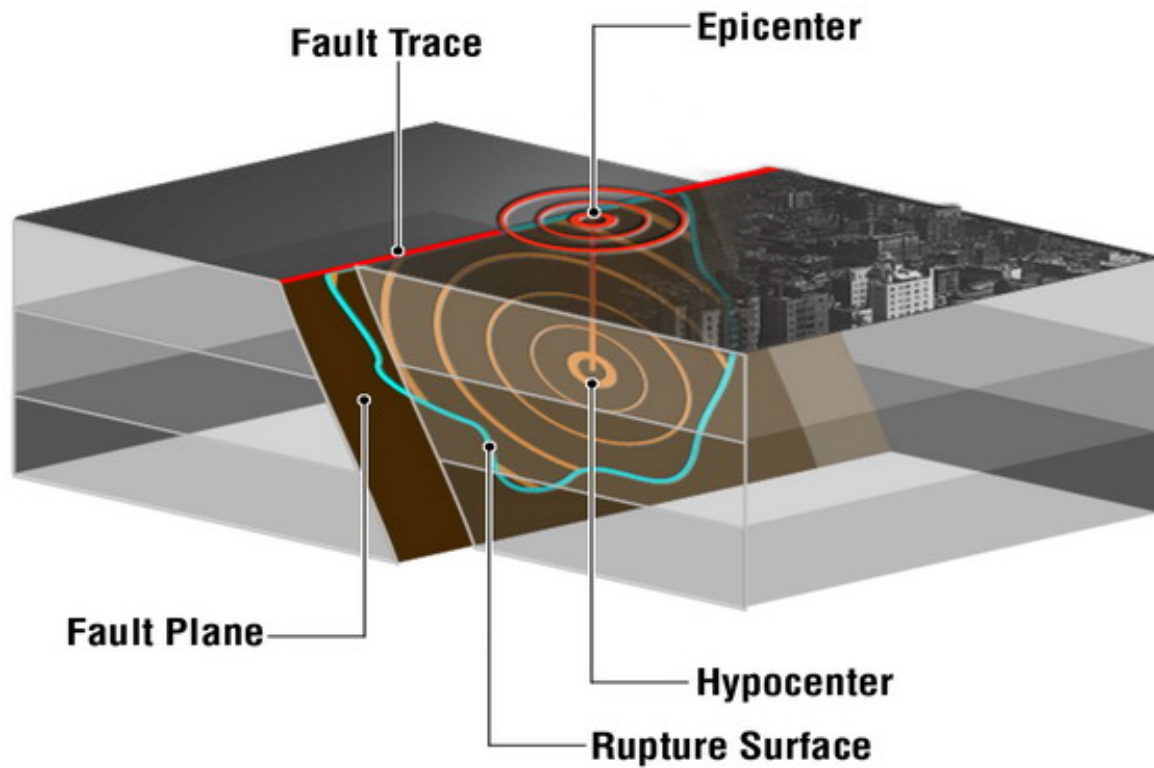
Figure 1.1. Strike-slip fault [Exponent].

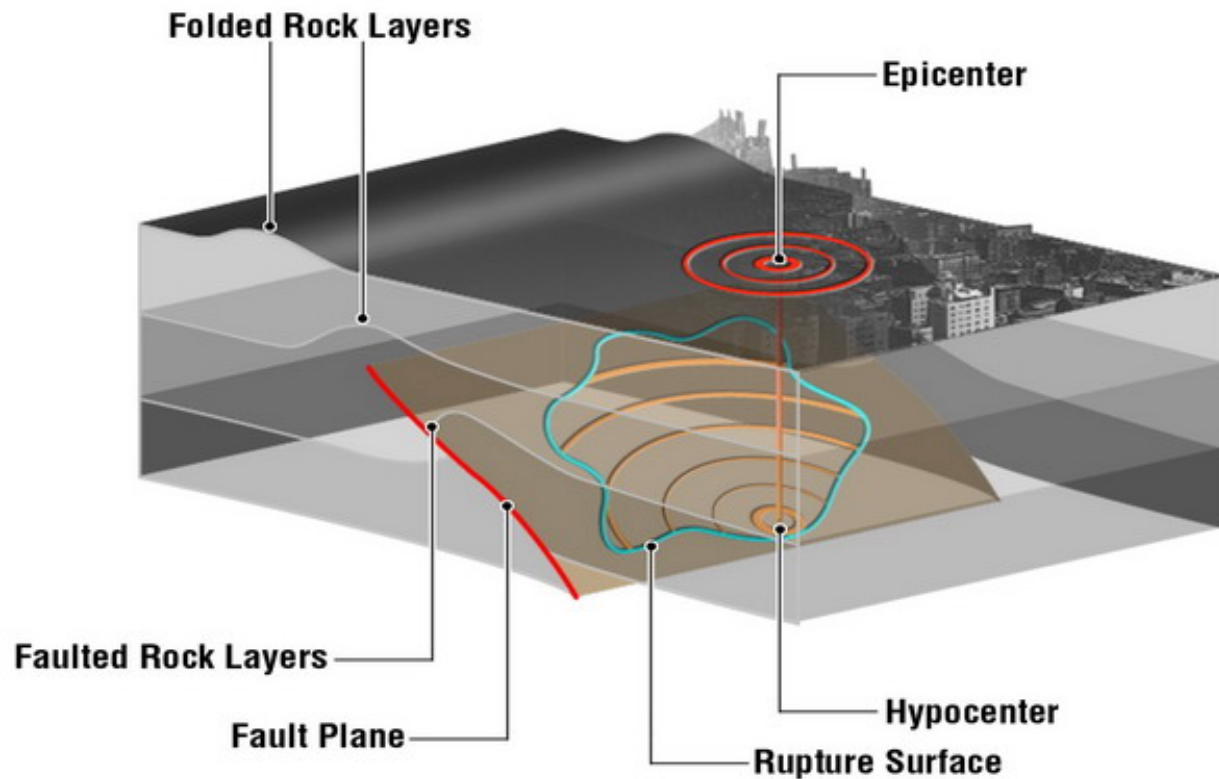
Figure 1.2. Blind thrust fault [Exponent].

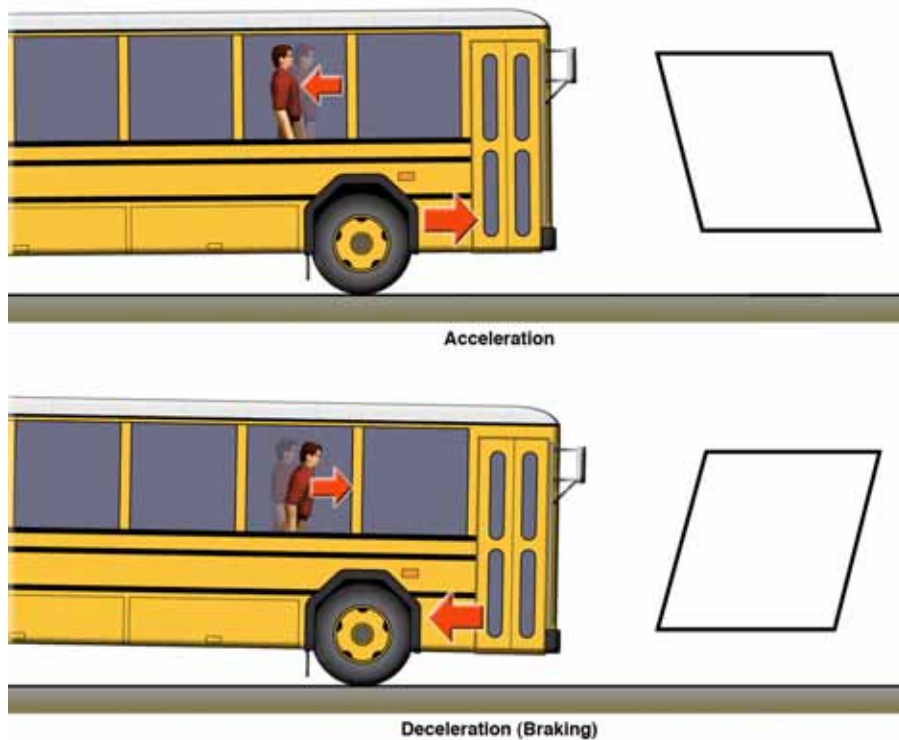
Figure 1.3. Effect of acceleration on vertical objects [Exponent].

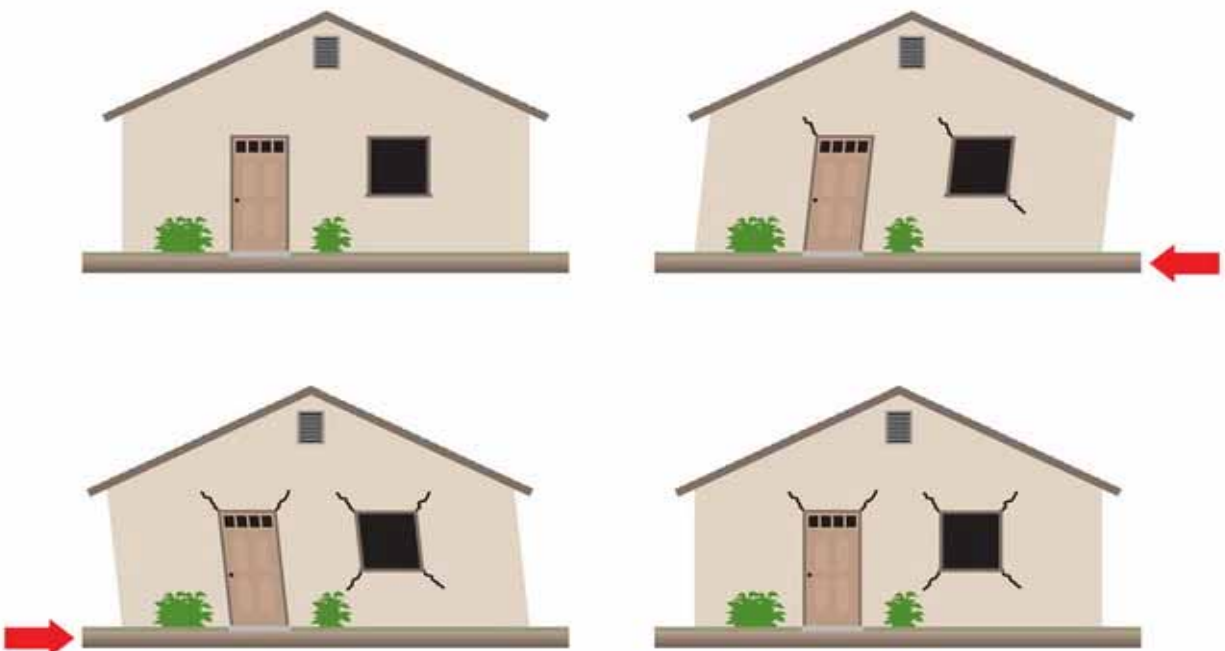
Figure 1.4. Illustration of racking distortion in walls caused by earthquake ground motions; amount of racking shown in this figure is greatly exaggerated for clarity – most buildings deform less than 1-inch laterally per story during a major earthquake [Exponent].

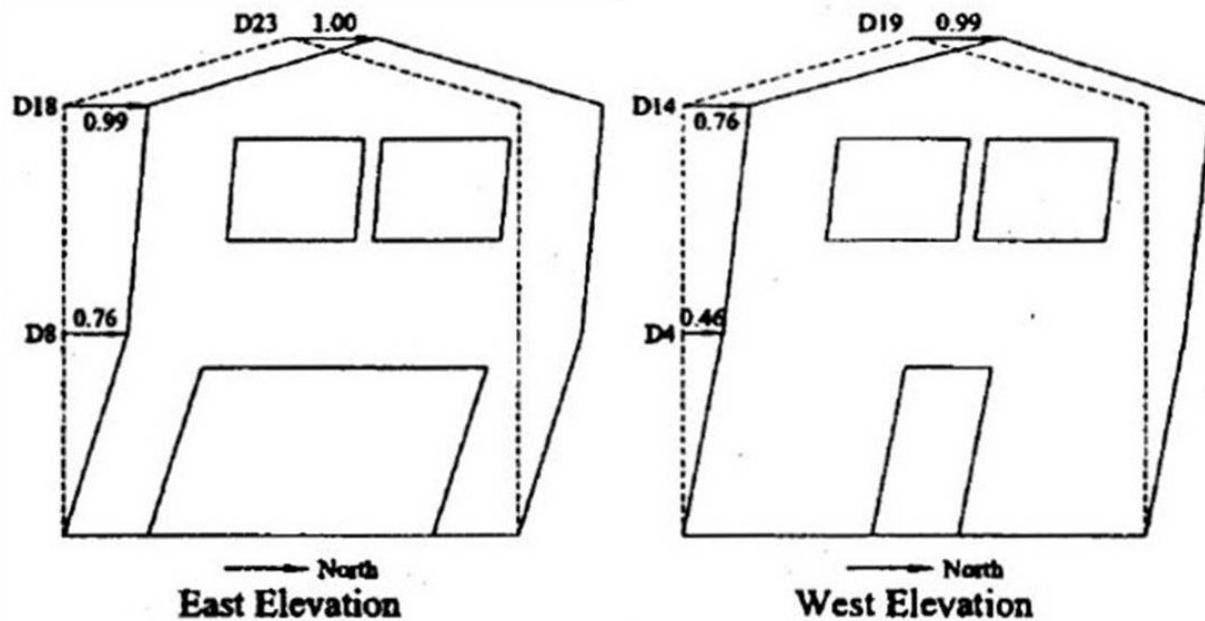
Figure 1.5. Lateral deformation patterns in a full-scale shake-table test of a two-story woodframe building. Horizontal deflections indicated are in inches [CUREE].

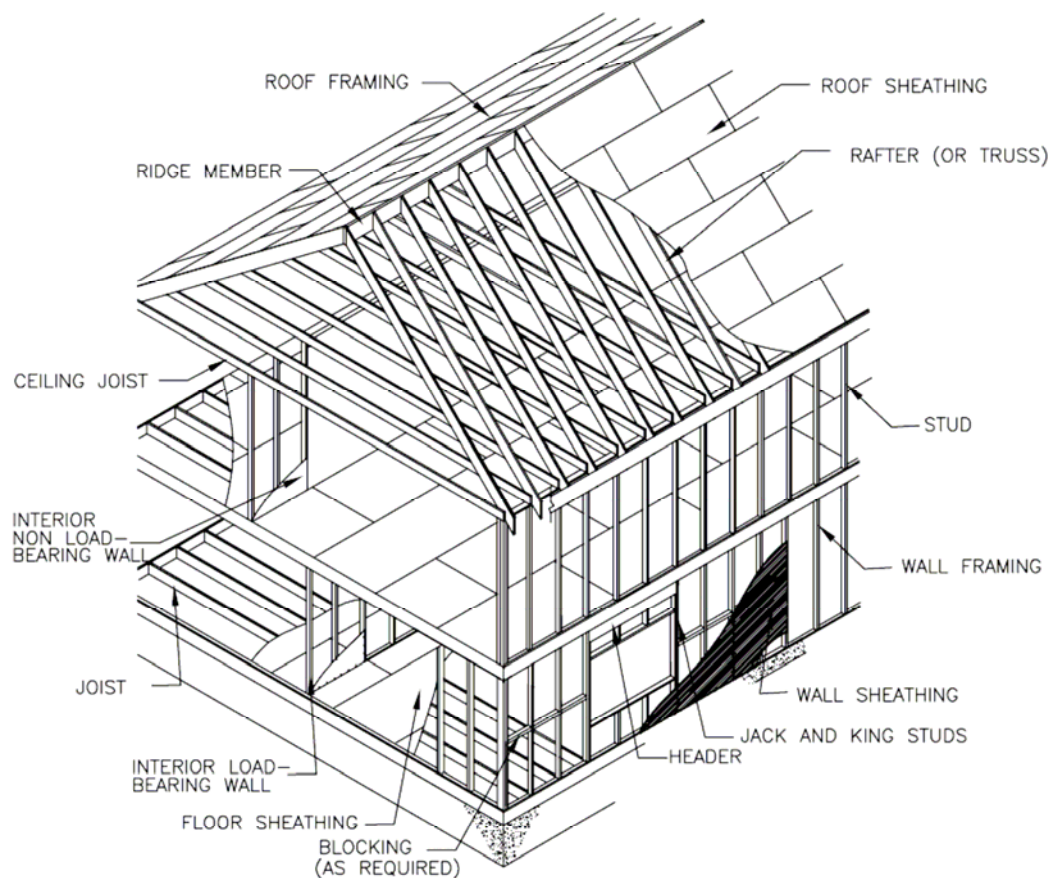
Figure 1.6. Elements of a typical woodframe house [HUD].

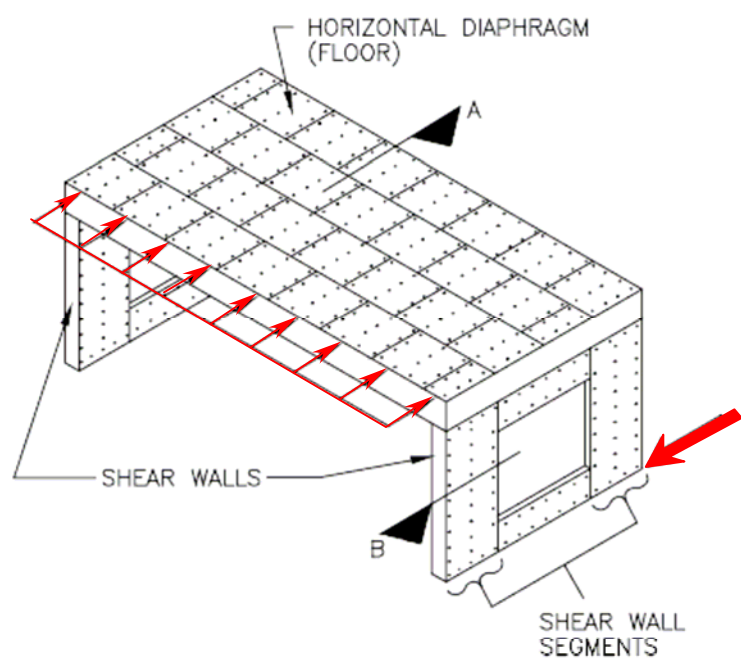
Figure 1.7. Schematic of the role of horizontal diaphragms (floors or roofs) and shearwalls in resisting earthquake loads [HUD].

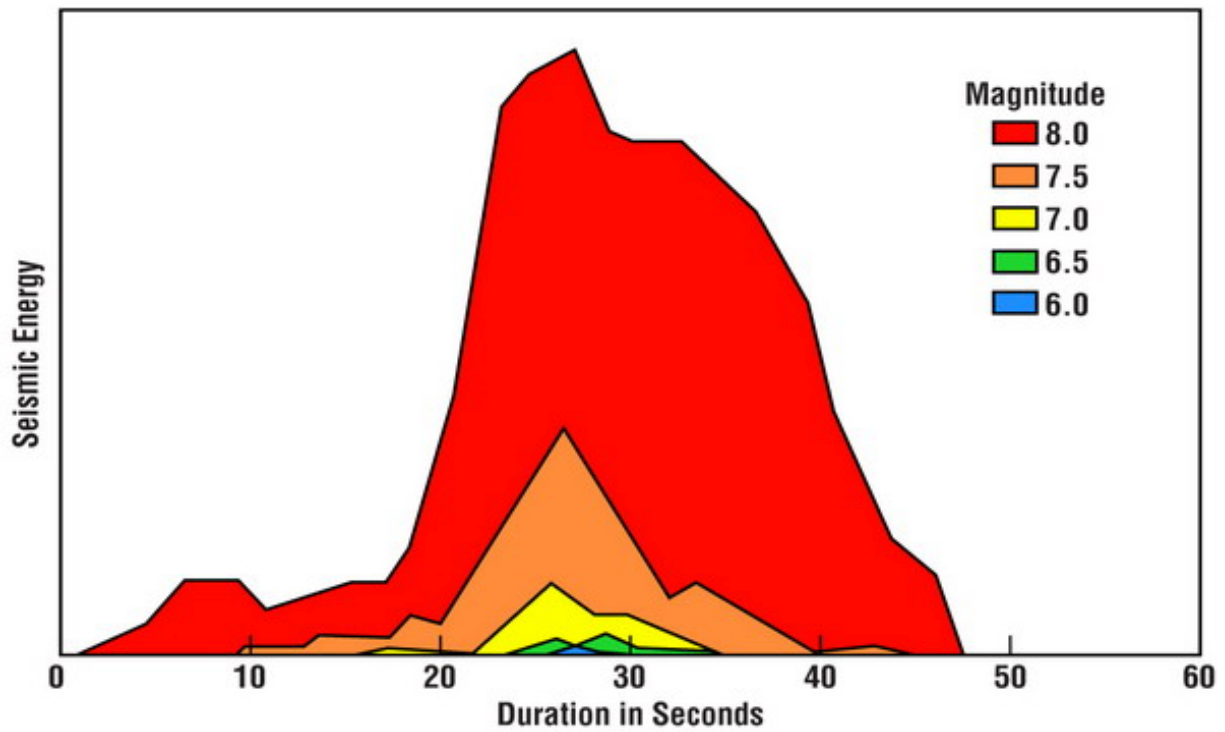
Figure 2.1. Illustration of comparative “size” of earthquakes [USGS].

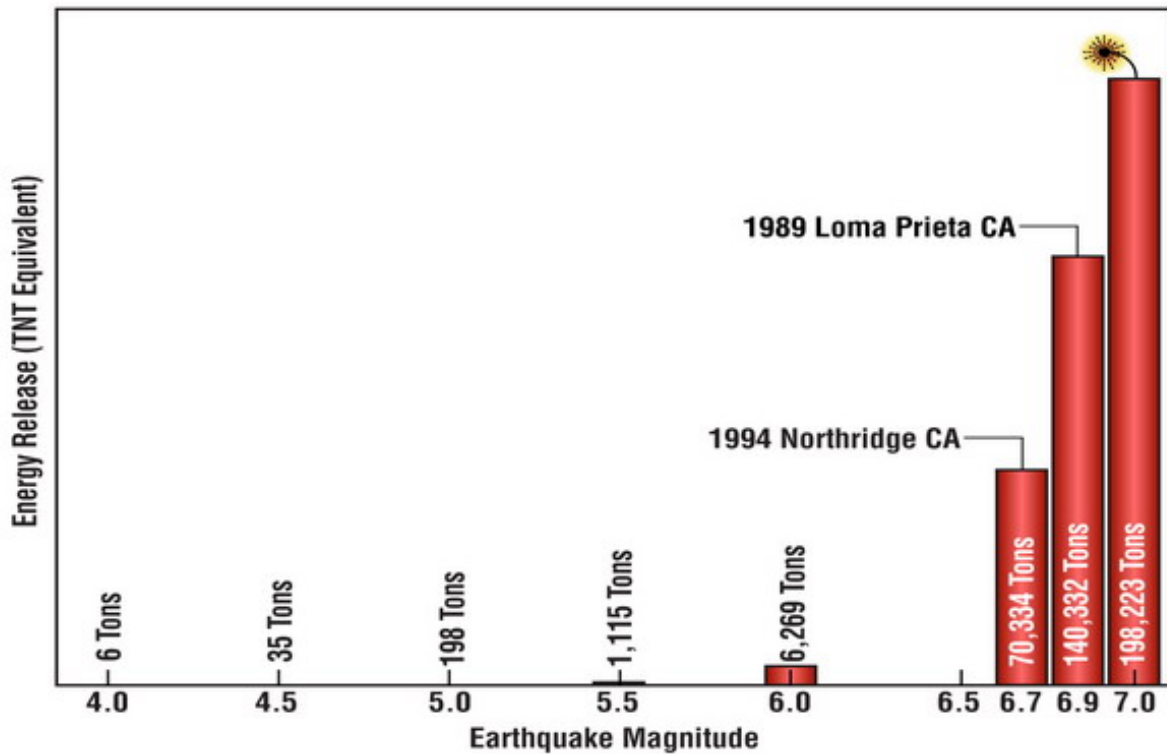
Figure 2.2. Illustration of total energy release as a function of earthquake magnitude [Exponent].

The magnitude<sup>15</sup> of an earthquake is essentially a measure of the size of the earthquake in terms of the total amount of energy released at the rupture surface, reported as a single decimal number, such as 6.7. The size of an earthquake, in general, is related to the surface area of the fault rupture and the amount of displacement over that rupture surface. In terms of the analogy previously given of two books laid back to back on a table and shoved sideways to suddenly lurch, the rupture area is the contact area between the spines of the books, and the displacement would be the distance one book slides vis-avis the other. Ruptures with small displacements over small areas result in imperceptible ground shaking lasting mere seconds, while ruptures with larger displacements over hundreds of square miles of a fault can cause ground shaking that is felt over thousands of square miles and lasting upwards of a minute, as illustrated in Figure 2.1.<sup>16</sup> So, one logical measure of earthquakes is the size of and displacement across the rupture surface – the fundamental basis of the magnitude scale commonly used nowadays. Since fault displacement is strongly correlated with the area of the rupture surface, the total energy released by an earthquake is roughly proportional to the surface area of the fault rupture.

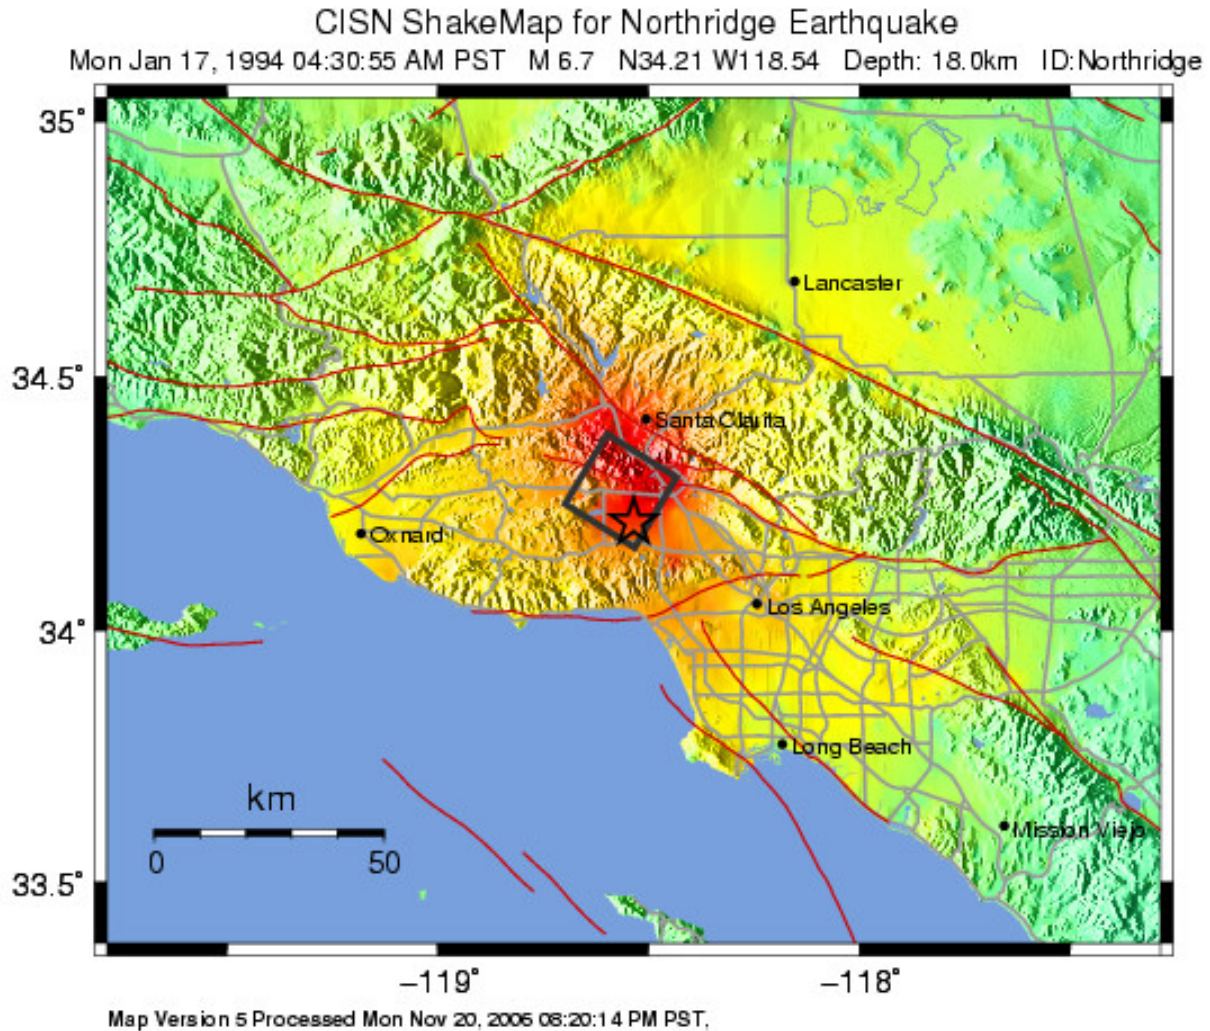
PERCEIVED SHAKING	Not felt	Weak	Light	Moderate	Strong	Very strong	Severe	Violent	Extreme
POTENTIAL DAMAGE	none	none	none	Very light	Light	Moderate	Moderate/Heavy	Heavy	Very Heavy
PEAK ACC.(%g)	<.17	.17-1.4	1.4-3.9	3.9-9.2	9.2-18	18-34	34-65	65-124	>124
PEAK VEL.(cm/s)	<0.1	0.1-1.1	1.1-3.4	3.4-8.1	8.1-16	16-31	31-60	60-116	>116
INSTRUMENTAL INTENSITY	I	II-III	IV	V	VI	VII	VIII	IX	X+

Figure 2.5. ShakeMap showing the instrumental intensities for the 1994 Northridge Earthquake [USGS].

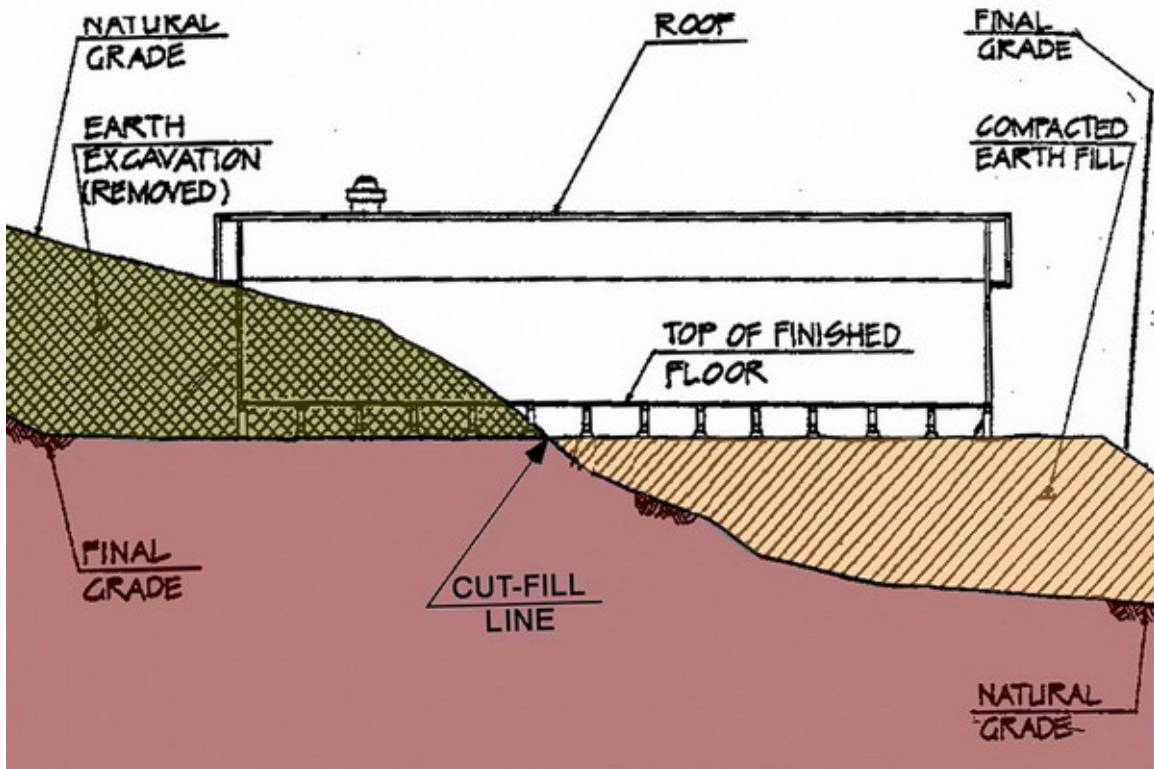
Figure 3.5. Schematic cross-section of a cut-fill building pad [Exponent].

A common condition in hilly or mountainous areas is the terraced building pad constructed with “cut-fill” grading, where earth excavated from the higher part of the lot (the “cut”) is placed as fill on the lower part of the lot as illustrated in Figure 3.5. The location on the ground surface where the undisturbed native soil transitions to the fill material is referred to the “cut-fill line” or “cut-fill boundary.” Such sites may experience problems with long-term differential settlement as well as increased levels of damage during earthquakes because the fill soils at the site may be less dense than the native soil or rock in the cut areas. Furthermore, to create level building pads, such sites often employ earth retaining structures as discussed three paragraphs hence.

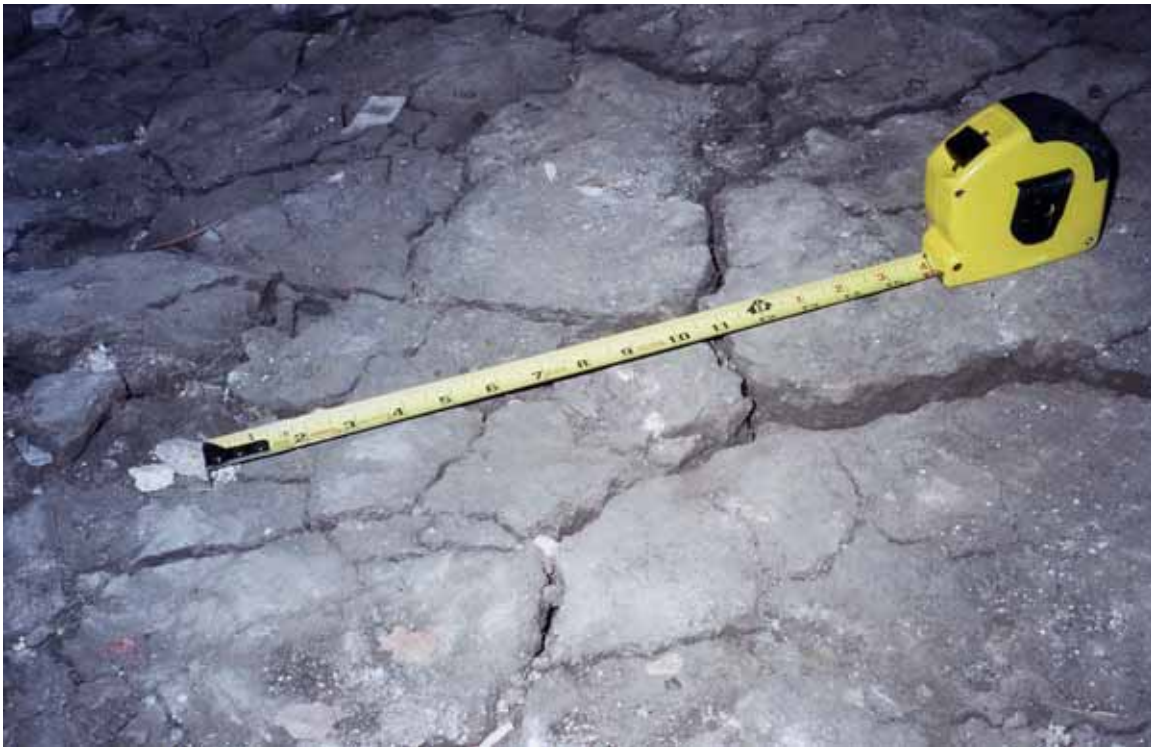
Figure 3.6. Desiccation cracking of expansive soil within a crawlspace, a long-term, non-earthquake condition [Exponent].

Shrinking or swelling of expansive soil occurs when the water content of the soil is reduced (drying) or increased (wetting). Certain clays are particularly sensitive to water content changes. Cycles of shrinking and swelling may occur in soil layers near the ground surface that are subjected to evaporation, transpiration, rainfall, or rising or falling groundwater table (Figure 3.1 to Figure 3.4). The water content variation can be seasonal (e.g., summer to winter) or can follow a long-term trend (e.g., from changes in landscaping and vegetation or installation of pavements that change surface drainage patterns) or can be more transient, such as from irrigation or utility line leaks. A good indication that expansive soils are present at a site is desiccation cracking (a web-like network of cracks as shown in Figure 3.6) in the soil surface during dry seasons of the year.

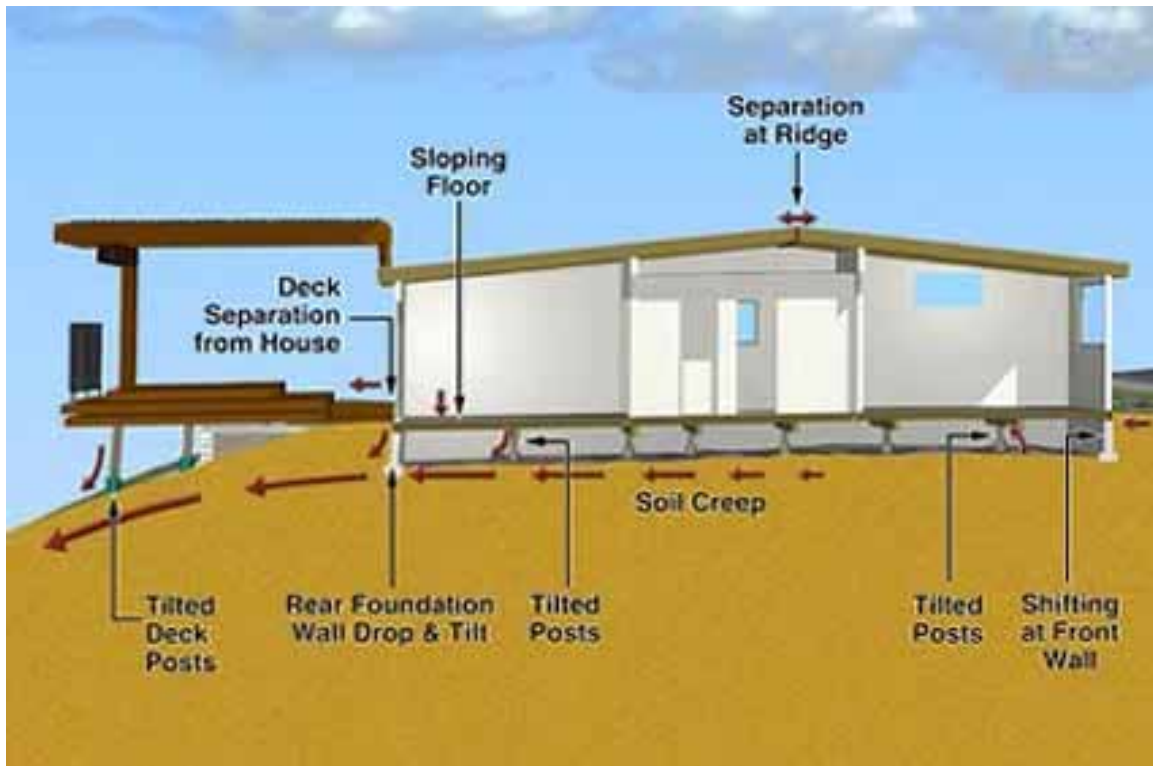
Figure 3.7. Schematic of damage to residence resulting from long-term, non-earthquake soil creep [Exponent].

Slope deformation may sometimes occur due to soil creep – the slow down-slope movement of fill, soil, or rock, usually confined to areas along a slope face or near the top of slope (Figure 3.7). Some creep takes place in almost all steep earth and rock slopes. The rate of creep is dependent of factors such as material type, slope inclination, and water content fluctuations within the slope. Slope creep occurs within shallow soil/rock materials, and hence damage is generally confined to areas along a slope face or near the top of the slope.

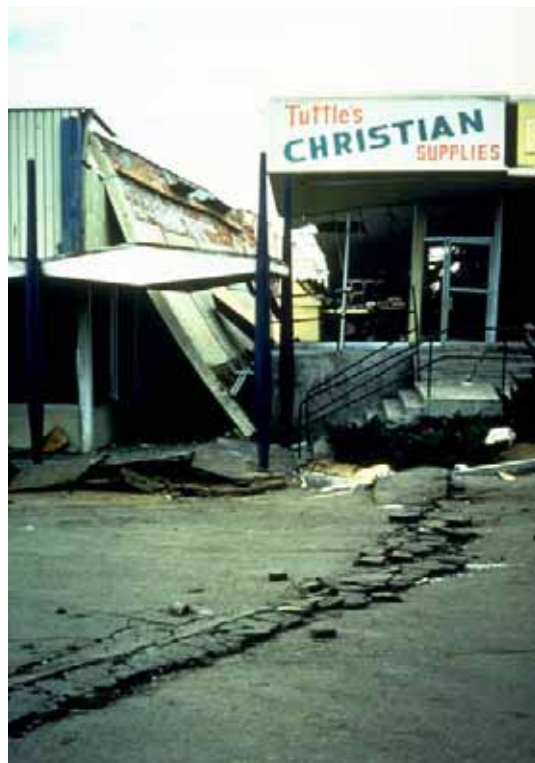
Figure 3.8. Surface fault rupture from the 1971 San Fernando Earthquake and associated damage to pavement and buildings in the Sylmar area [NISEE].

Earthquakes result from relative displacement (i.e., slip) of blocks of rock on opposite sides of the fault surface deep within the earth's crust. Surface fault rupture occurs when these displacements reach the surface of the ground (Figure 3.8 to Figure 3.12).

If ground rupture is confined to a relatively narrow zone, then the total offset will appear as a linear feature that makes the rupture easier to identify. Any buildings, pavements, or utility lines crossing the fault will be destroyed (Figure 3.8 and Figure 3.9). Sometimes fault rupture occurs along multiple branch traces and/or movement is distributed across wider zones, hundreds of feet wide. In this case, the total offset is distributed across a larger area making it difficult to identify the exact location of ground rupture (Figure 3.12).

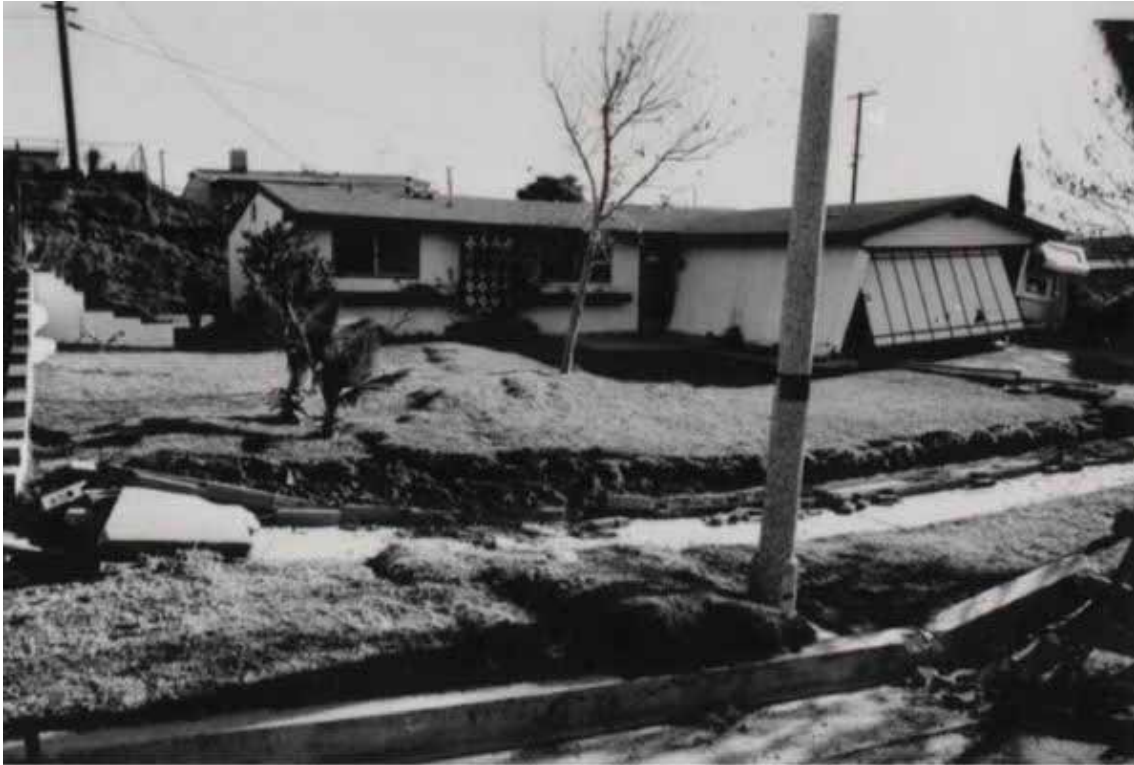
Figure 3.9. House damaged by surface fault rupture from the 1971 San Fernando Earthquake [ATC, Castle].

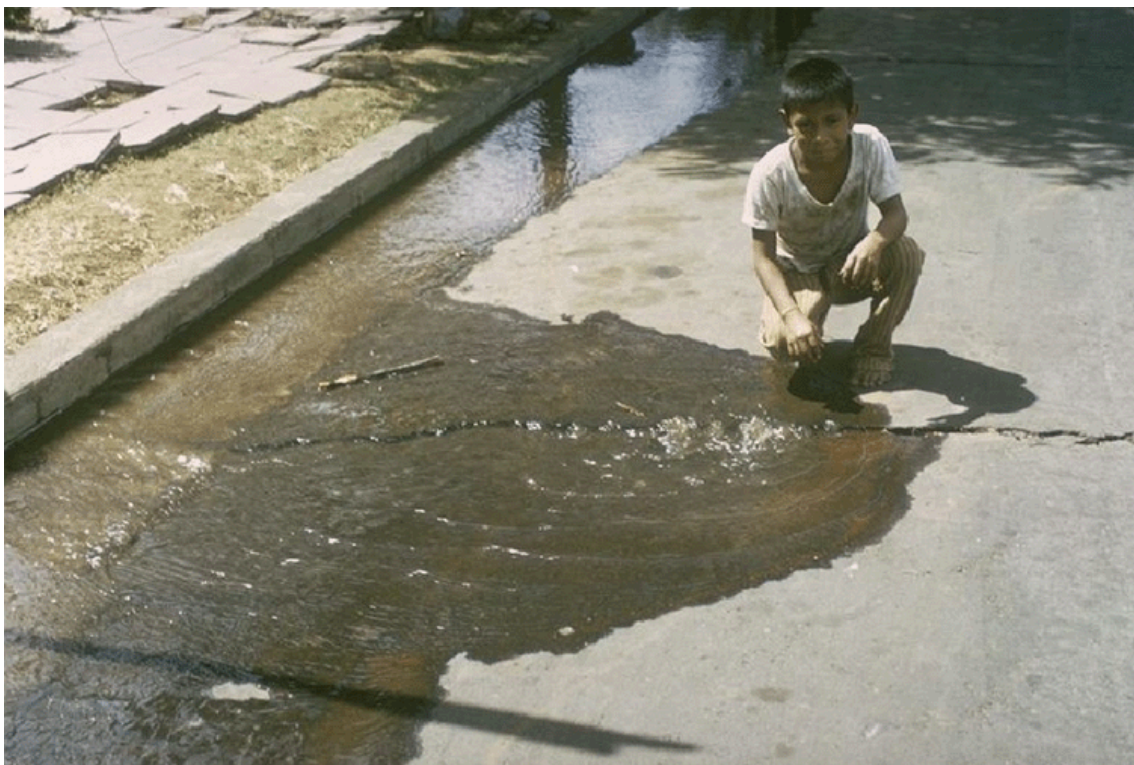
Figure 3.10. Waterline break along fault rupture from the 1972 Managua, Nicaragua Earthquake [NISEE].

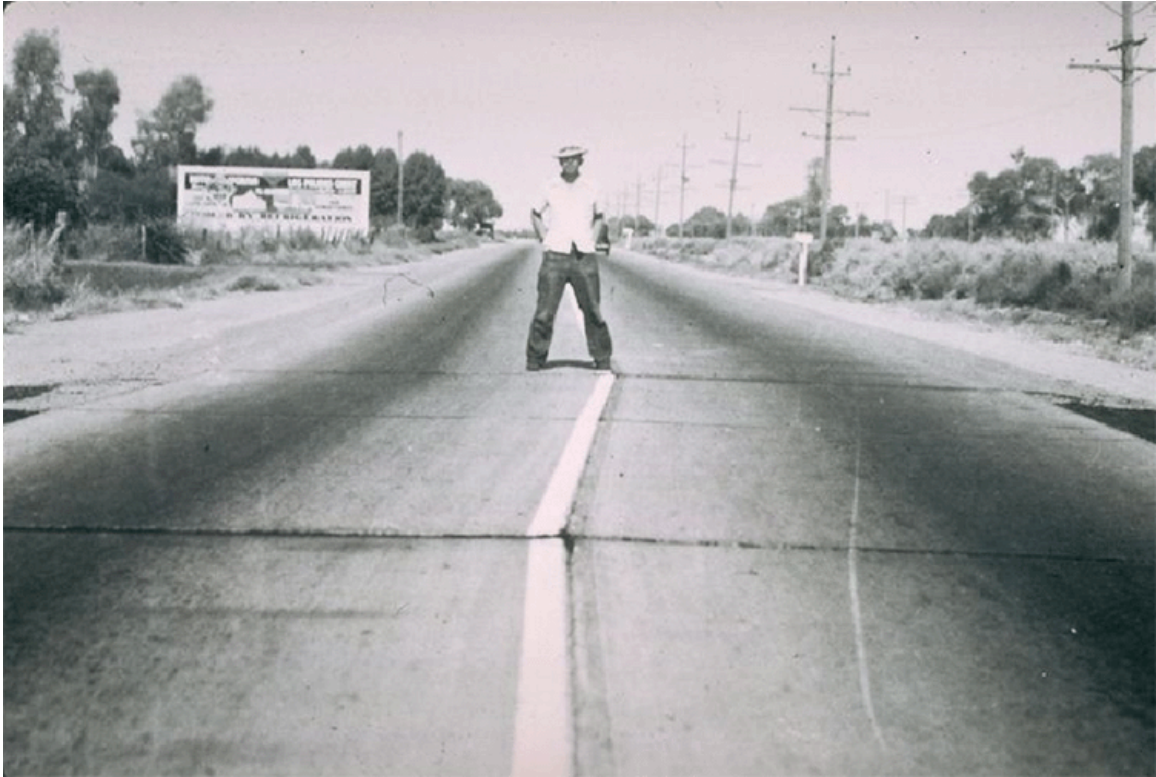
Figure 3.11. Surface faulting midway between El Centro and Holtville from the 1940 El Centro, California Earthquake [NISEE].

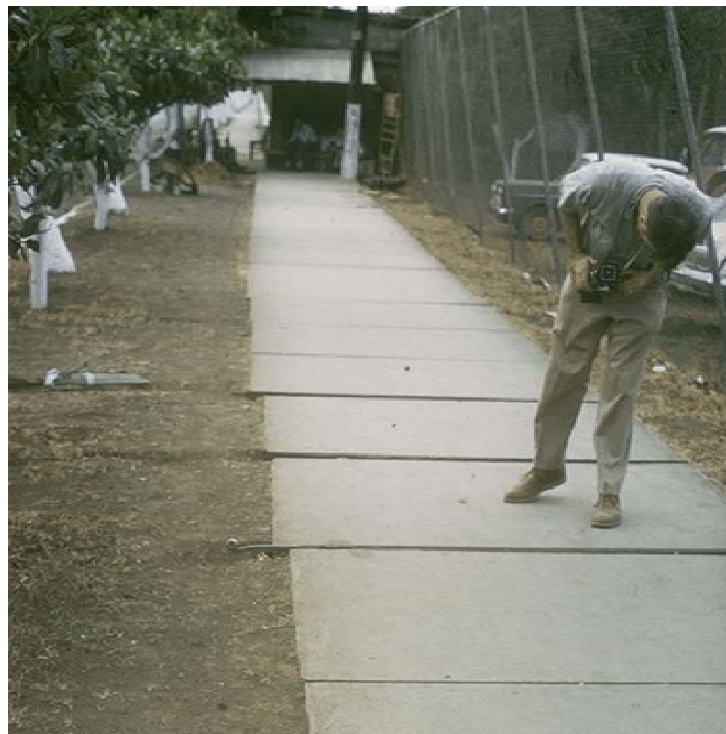
Figure 3.12. Sidewalk displaced by distributed faulting from the 1972 Managua, Nicaragua Earthquake [NISEE].

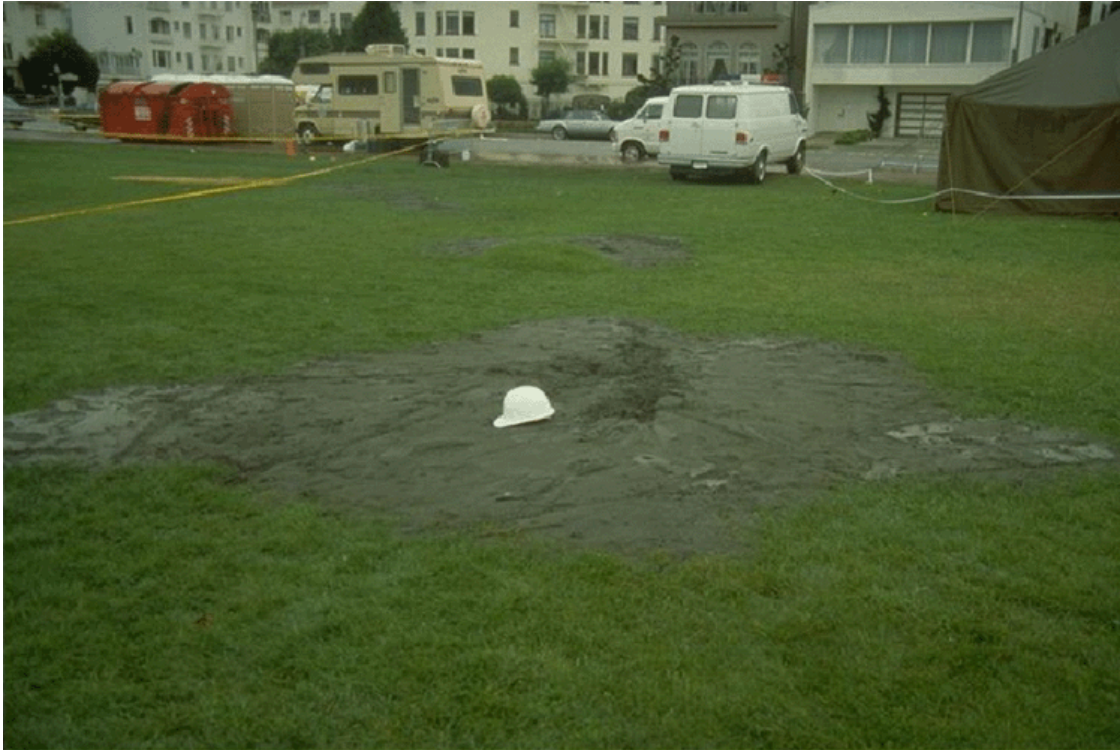
Figure 3.13. Sand boil due to liquefaction of old, poorly compacted, water-saturated fill during the 1989 Loma Prieta Earthquake [NISEE].

Strong shaking in loose, water-saturated sandy soils can cause the soils to liquefy, a phenomenon similar to quicksand, caused by a build up of water pressure as the loose soil begins to densify. When liquefaction occurs, the strength of the soil decreases, and the water-soil mixture temporarily behaves as a liquid rather than a solid and is able to flow. If the pressurized soil-water mixture finds a conduit to the surface, it will vent to the surface and form sand deposits on the ground surface referred to as "sand boils" (Figure 3.13 to Figure 3.15). Other phenomena that are associated with liquefaction include ground settlement and cracking in level ground and lateral movement in sloping ground (flow failure and lateral spreading). The loss of strength associated with liquefaction can result in loss of bearing capacity of the soils underlying a building, which can cause the building to settle and tilt, or an increase in buoyancy of in-ground structures such as buried tanks, which can cause them to float to the surface.

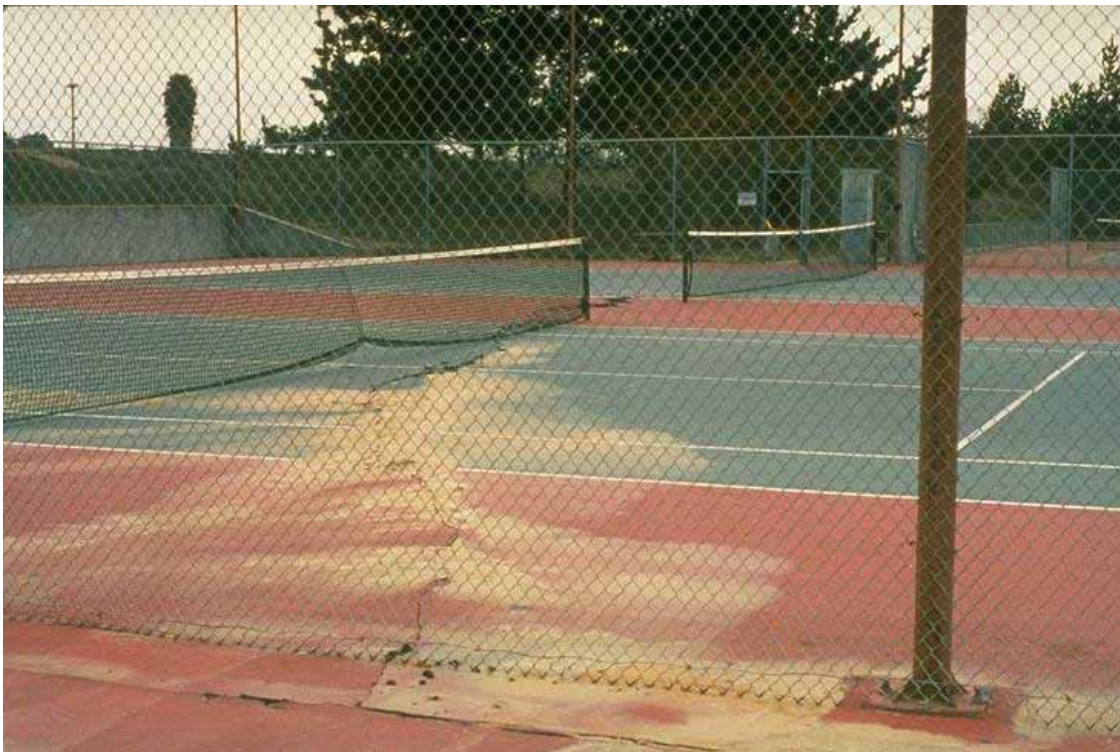
Figure 3.14. Tennis court damage with ejection of wet sand from soil liquefaction (site is adjacent to a river) during the 1989 Loma Prieta Earthquake [NISEE].

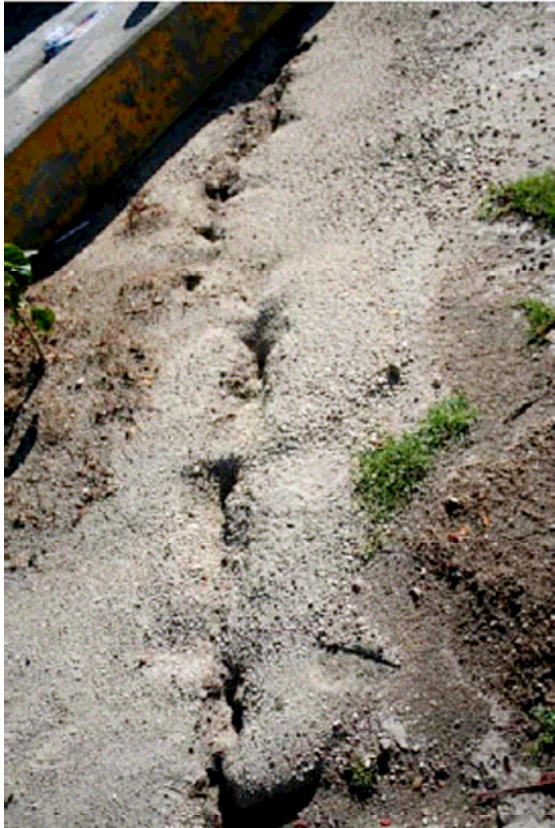
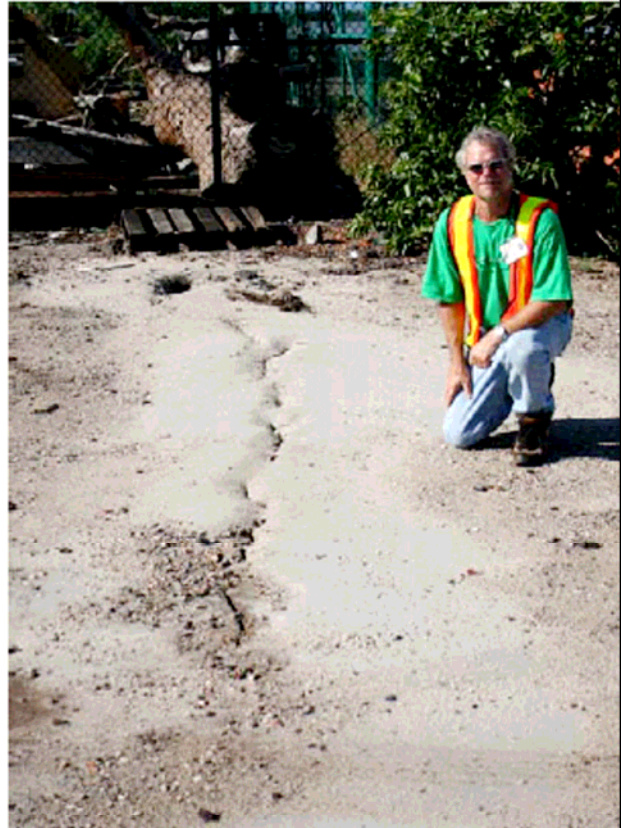
Figure 3.15. Sand boils at Kawaihae Harbor from the 2006 Hawaii Earthquakes [UHM].

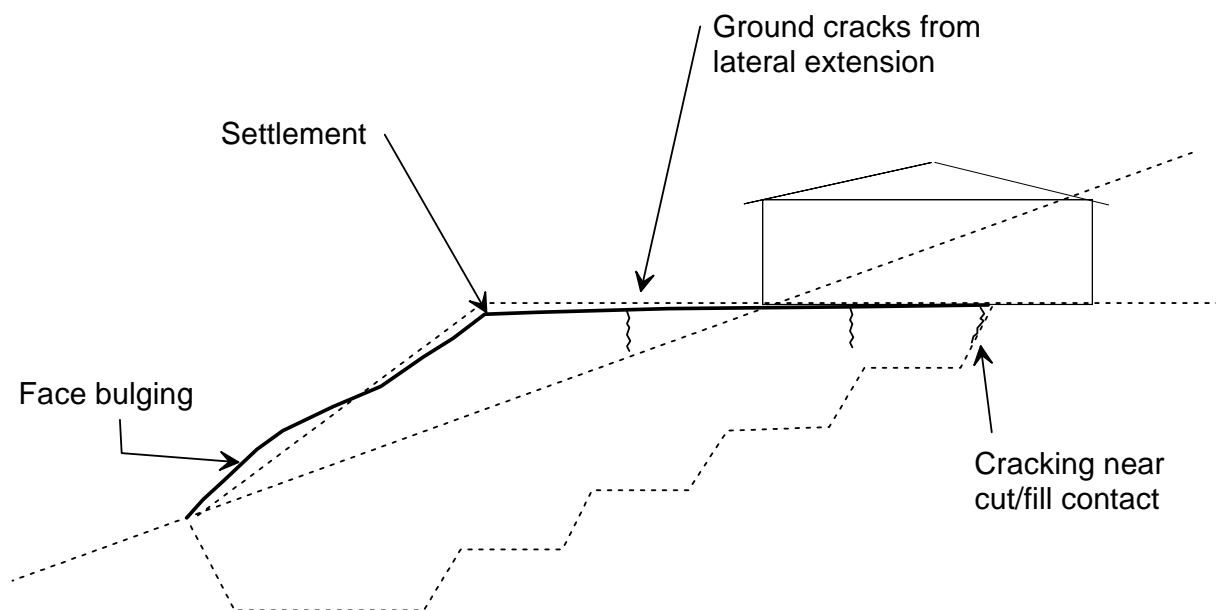
Figure 3.16. Schematic showing possible earthquake damage to a fill slope [Stewart].

While liquefaction occurs only in soil below the water table, soil above the ground water table may also sustain permanent deformation during an earthquake. Some dry soils that experiences strong shaking may decrease in volume, resulting in ground surface settlements and potential lateral movements near slopes (Figure 3.16 to Figure 3.19). This process is termed seismic compression, and is especially prevalent in loose sands but has also been observed in certain types of engineered fills. The process is similar to what happens to the loose contents of a box of cereal during the vibration of shipment, thus the label “contents may have settled during shipment.” The magnitude of seismic compression is directly related to the thickness of the susceptible material; hence, seismic compression may be more apparent in deeper fills.<sup>27</sup>

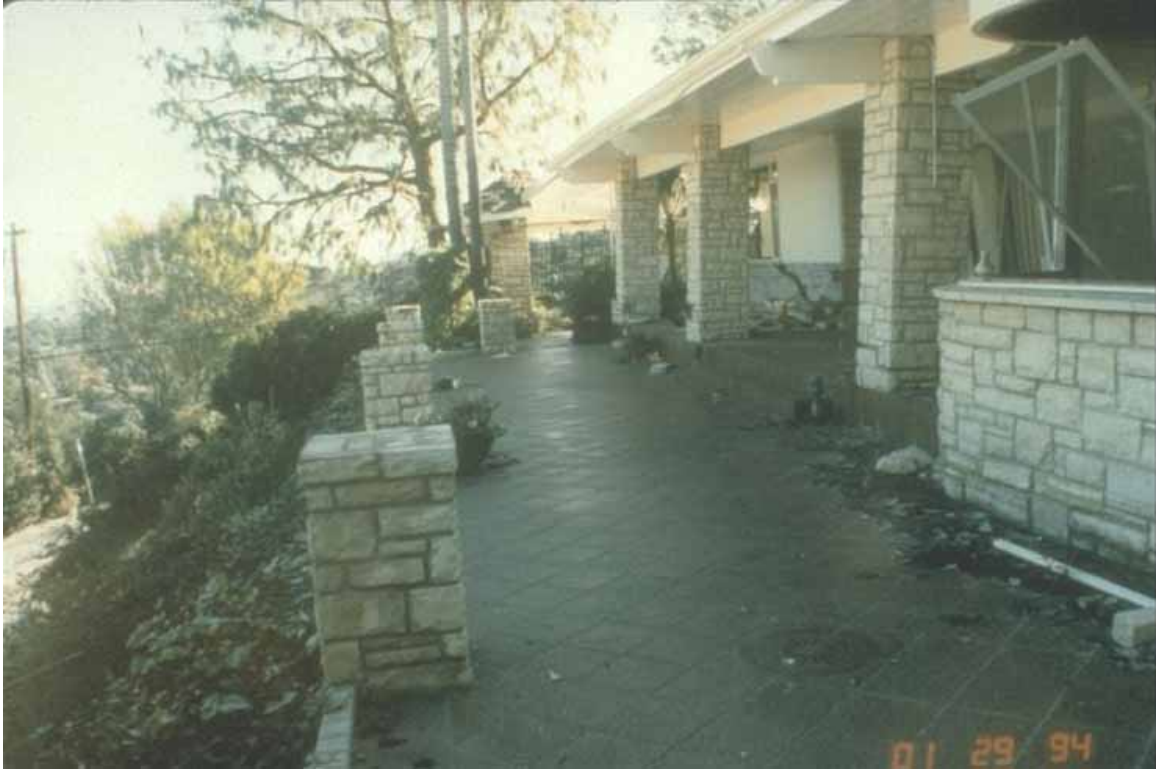
Figure 3.17. Building damaged by movements in hillside fill during the 1994 Northridge Earthquake; damage to the residence is shown in Figure 3.18 [NISEE].

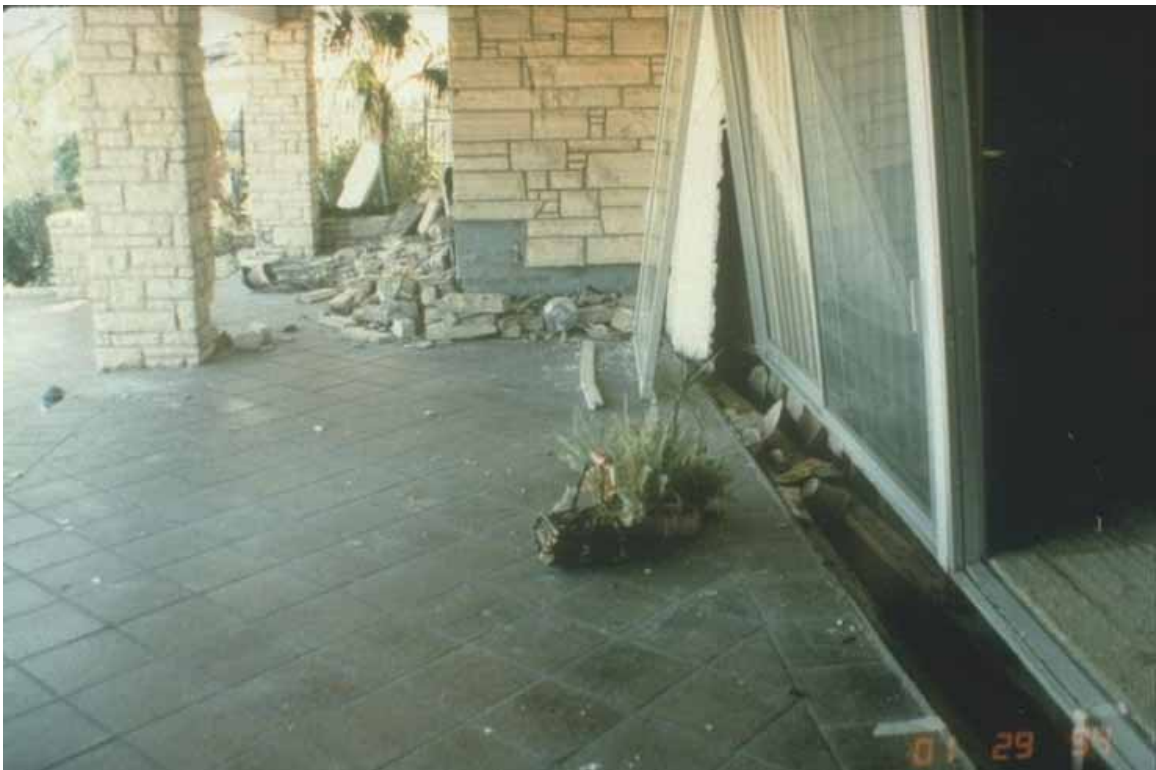
Figure 3.18. Evidence of lateral ground movement, near back of building shown in Figure 3.17 [NISEE].
