GENERAL GUIDELINES  
FOR THE ASSESSMENT AND REPAIR  
OF EARTHQUAKE DAMAGE  
IN RESIDENTIAL WOODFRAME BUILDINGS

Consortium of Universities for Research in Earthquake Engineering

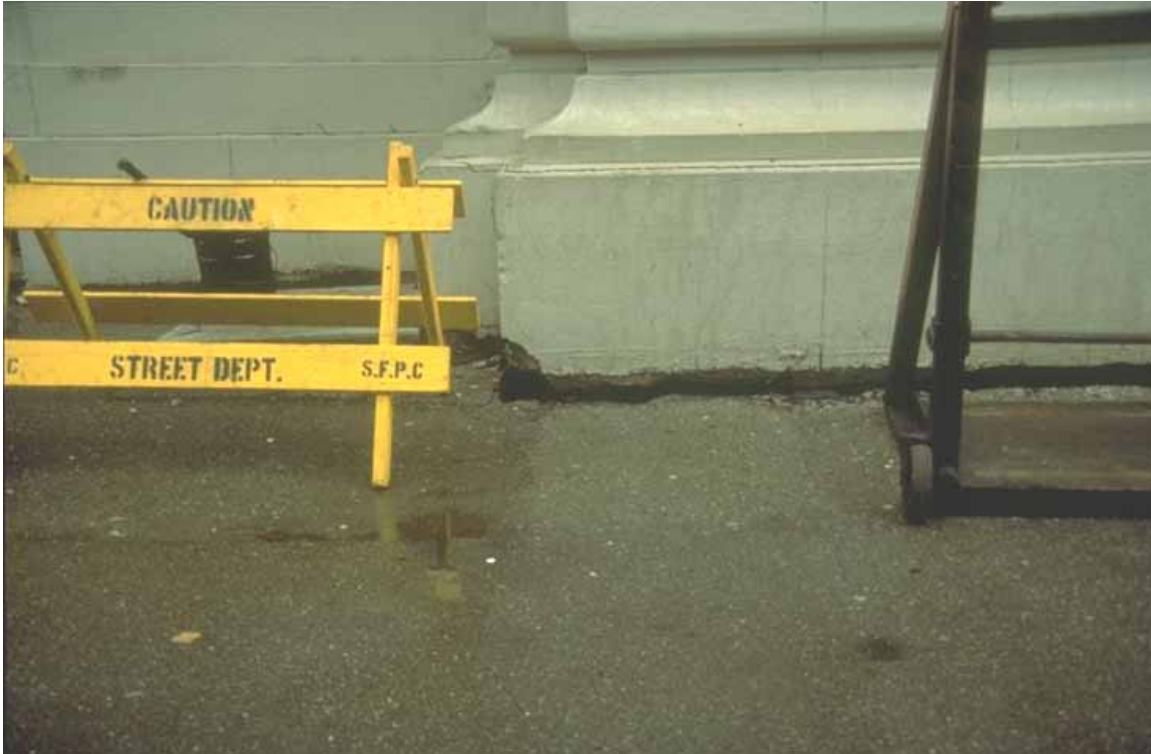
Figure 3.19. Minor settlement caused by densification of loose sandy fill at Embarcadero, Pier 1 in San Francisco during the 1989 Loma Prieta Earthquake; the building is pile-supported [NISEE].

While liquefaction occurs only in soil below the water table, soil above the ground water table may also sustain permanent deformation during an earthquake. Some dry soils that experiences strong shaking may decrease in volume, resulting in ground surface settlements and potential lateral movements near slopes (Figure 3.16 to Figure 3.19). This process is termed seismic compression, and is especially prevalent in loose sands but has also been observed in certain types of engineered fills. The process is similar to what happens to the loose contents of a box of cereal during the vibration of shipment, thus the label “contents may have settled during shipment.” The magnitude of seismic compression is directly related to the thickness of the susceptible material; hence, seismic compression may be more apparent in deeper fills.<sup>27</sup>

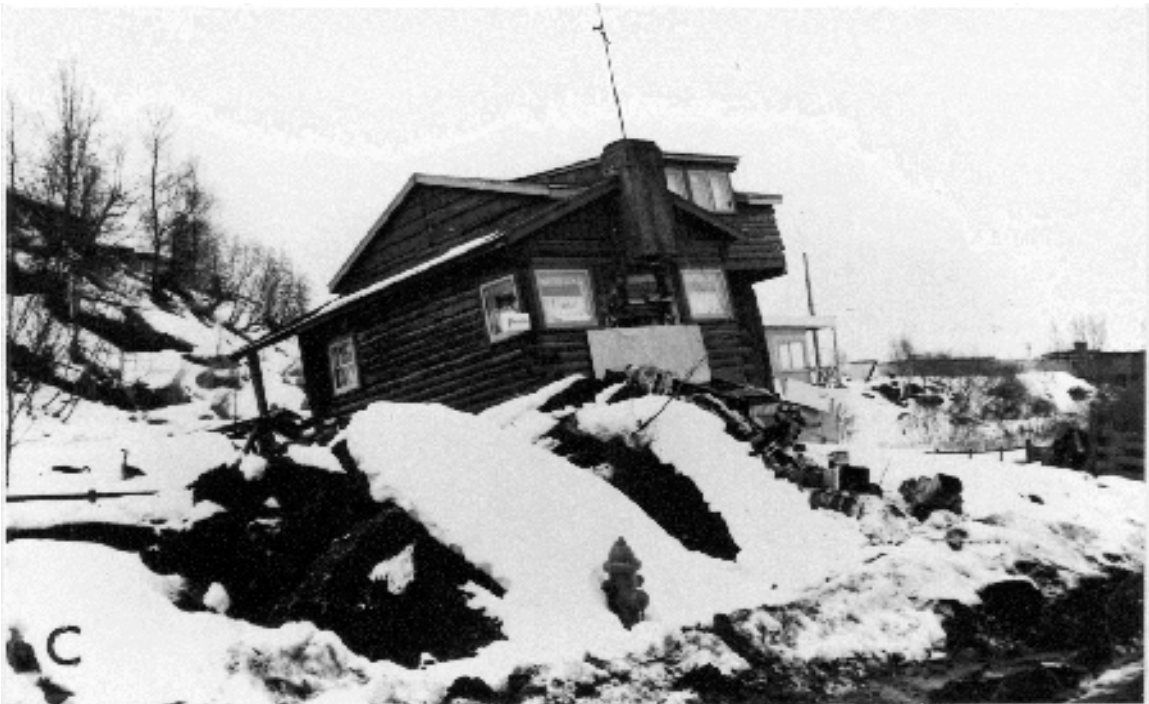
Figure 3.20. House displaced by large blocks of soil uplifted at toe of L Street landslide, Anchorage district, during the 1964 Anchorage, Alaska Earthquake [USGS].

Inertial forces introduced during strong earthquake shaking can cause slopes to experience downslope movement (Figure 3.20 to Figure 3.23). This movement can occur in slopes consisting of fill, soil, or rock and may range in size from a few feet across to spanning hundreds of acres. Buildings located near the moving part of the slope can be taken down with it, and those beneath the slope can be pushed aside or covered with the debris. Less dramatic movement is also possible. Depending on the level of shaking, geometry and soil conditions, the slope response can include toe bulging at the bottom of the slope, cracking near the crest and some downhill movement of mass near the crest. Homes located very close to the toe of an unstable slope can be damaged by the lateral forces imposed by the bulging mass near the toe. Near the crest, the foundation of a home can be pulled apart or distorted by cracks near the crest of the slope. Depending on many factors such as geometry, soil and rock conditions, drainage conditions, groundwater regime, if left unrepaired, it is possible that, minor earthquake-induced ground cracking on or behind a slope or minor earthquake-induced slope movement could lead to the slope being more susceptible to rain-induced landsliding.

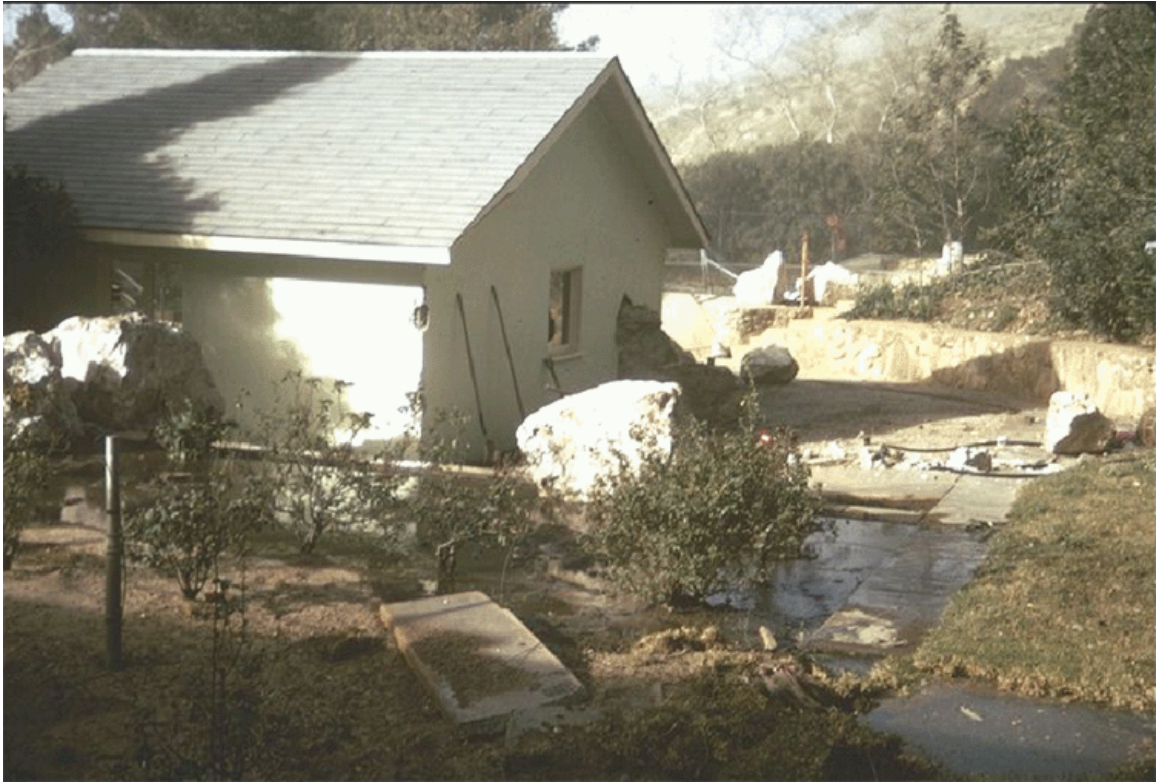
Figure 3.21. Rockfalls from the 1971 San Fernando Earthquake [NISEE].

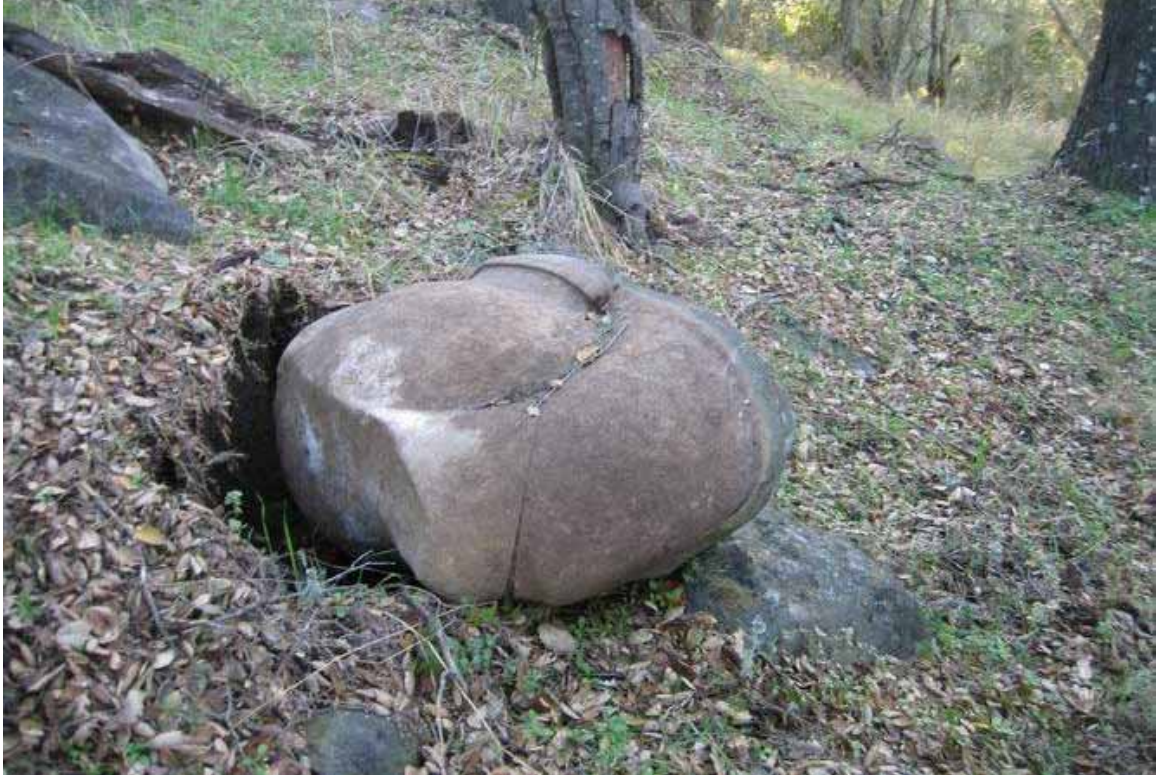
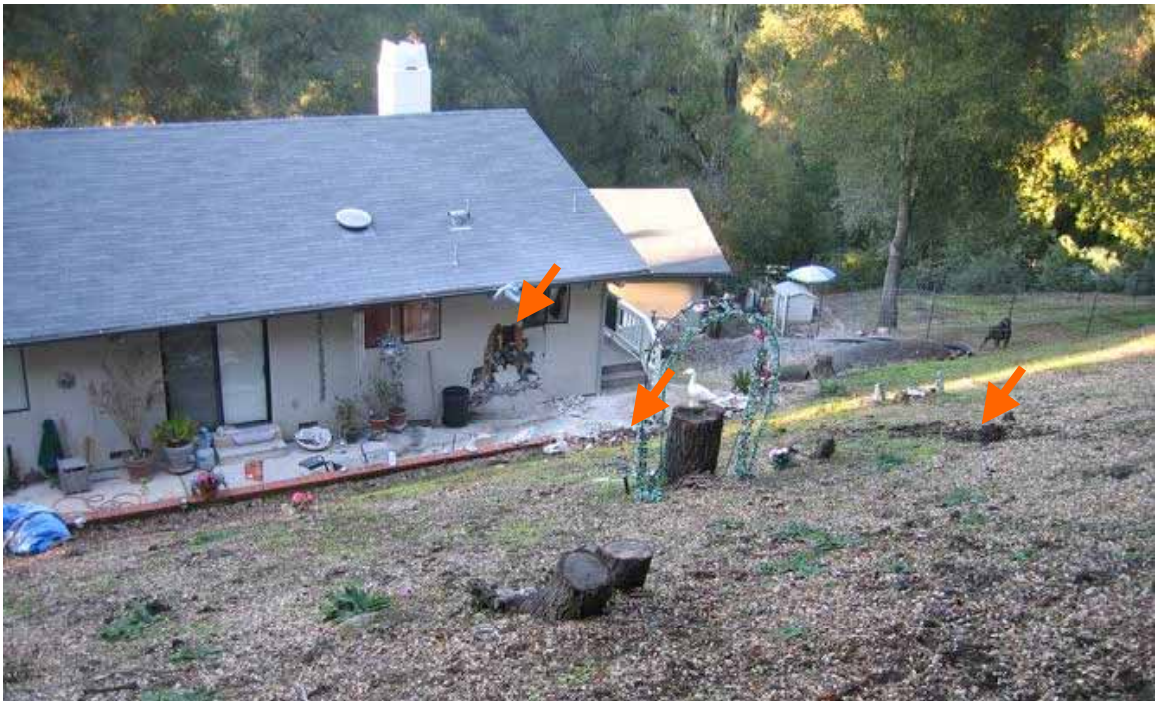
Figure 3.22. Rockfall from 2003 San Simeon Earthquake (top); similar rockfall occurred downslope and impacted house; impact marks on slope and house indicated by arrows (bottom) [Exponent].

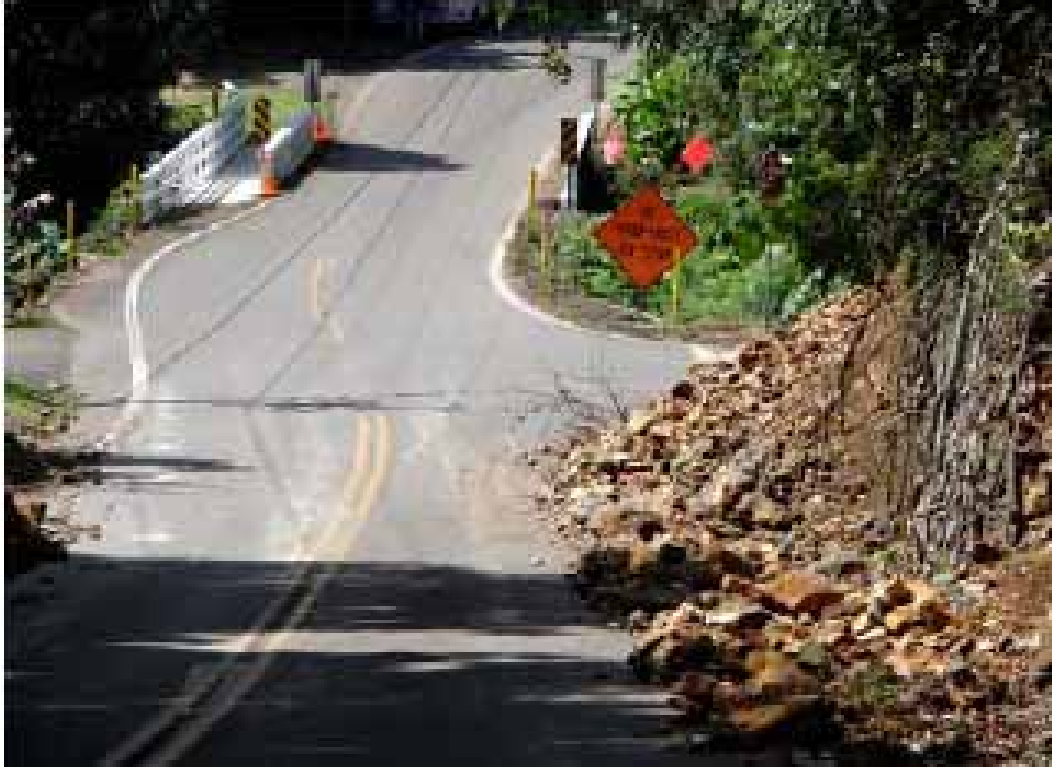
Figure 3.23. Rockfall on a road cut at northern end of North Kohala from 2006 Hawaii Earthquakes [UHM].

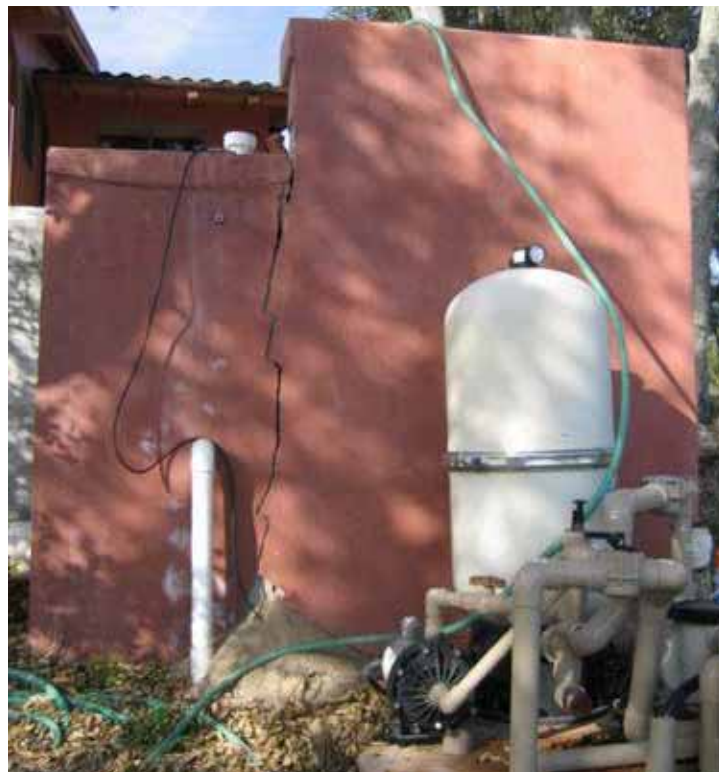
Figure 3.24. Retaining wall damage during the 2003 San Simeon Earthquake; granular backfill spilling from new crack in retaining wall [Exponent].

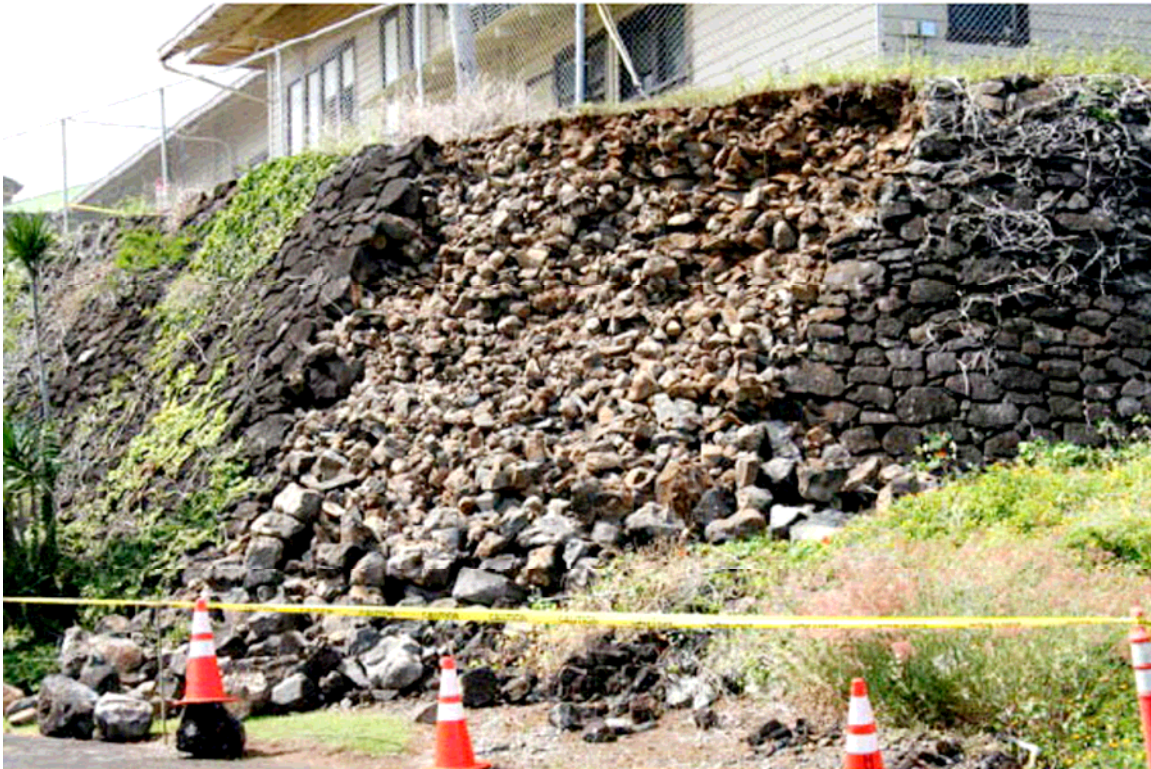
Figure 3.25. Collapse of un-mortared and unreinforced stone retaining wall in Honokaa, Hawaii during the 2006 Hawaii Earthquakes [UHM].

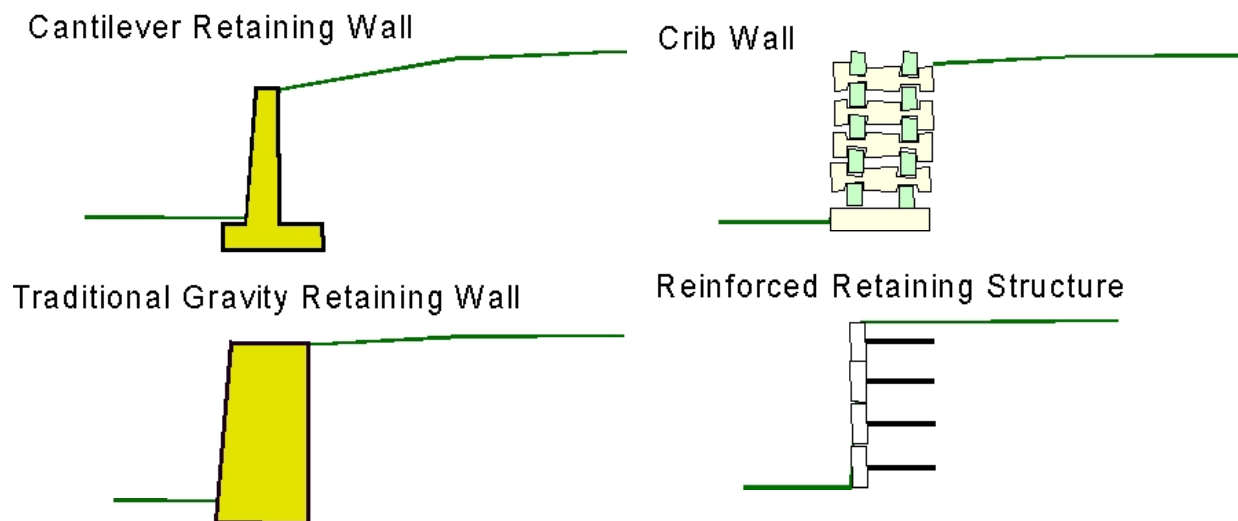
Figure 3.26. Examples of different types of retaining walls utilized in residential construction [Exponent].

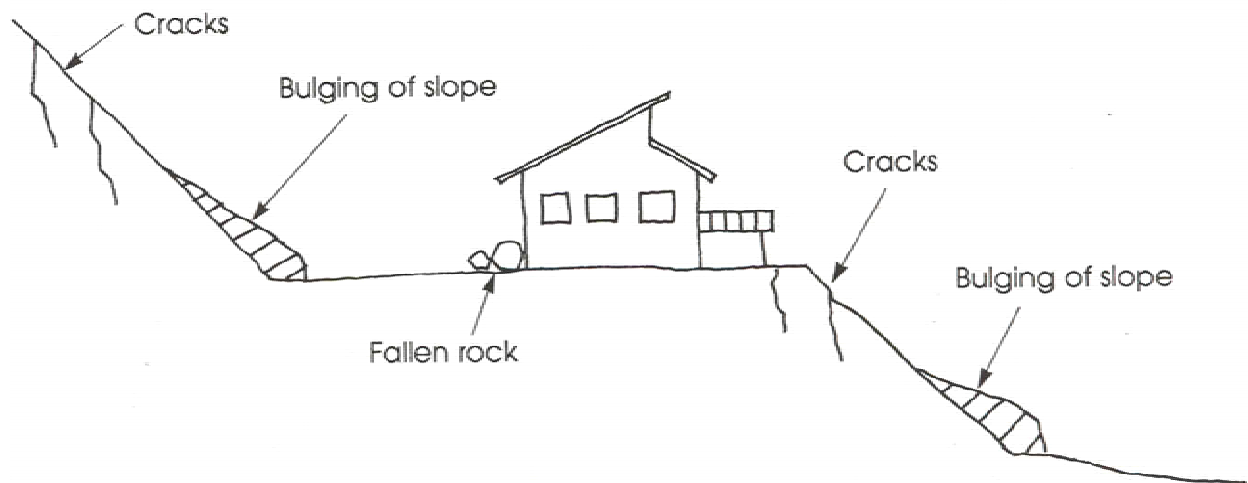
Figure 3.27. Schematic illustration of evidence of possible seismically-induced ground failure [ATC].

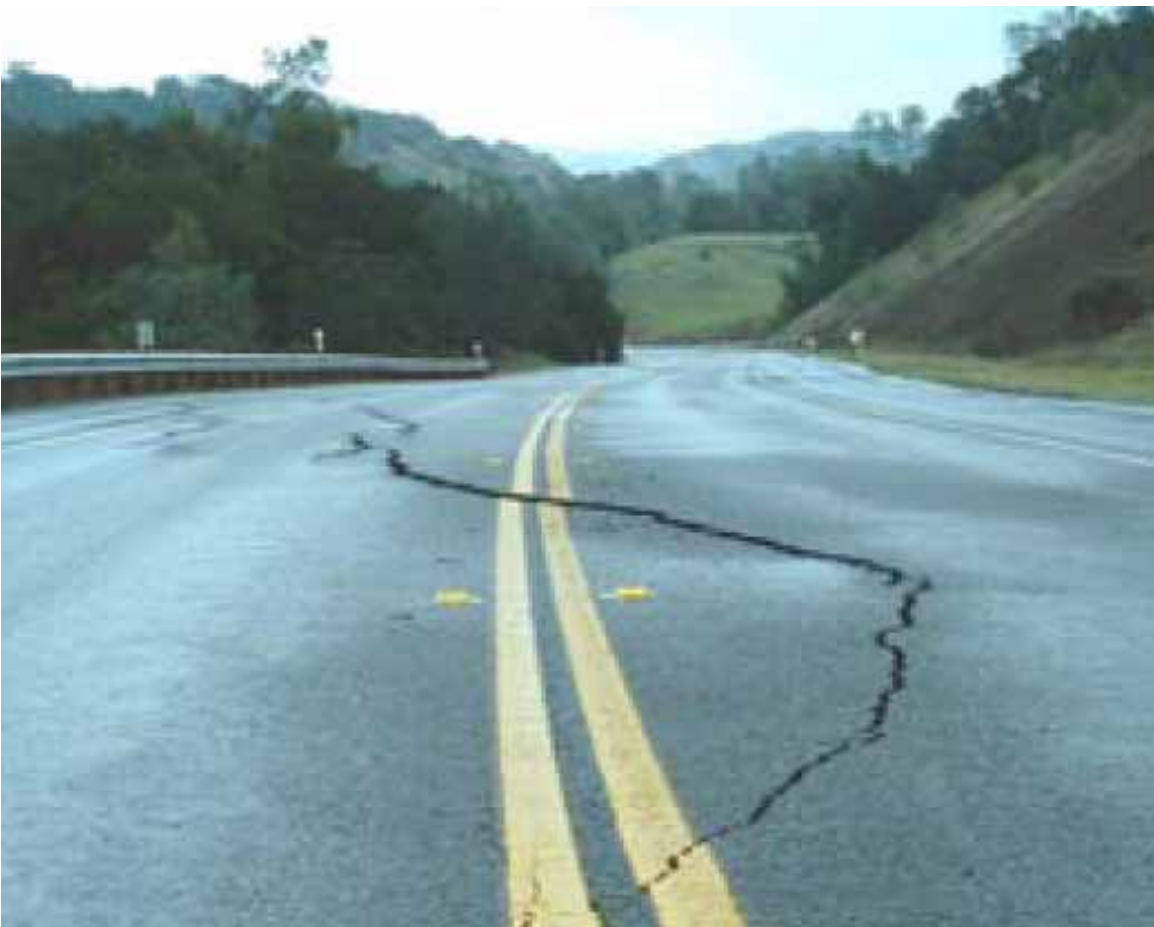
Figure 3.28. Asphalt pavement cracking along SR 46 as a result of a deep rotational slope failure in fill during the 2003 San Simeon Earthquake [EERI].

1. **Hardscape (Driveway, Patios, Sidewalks, etc.):** Fresh cracks in hardscape or the significant widening of pre-existing cracks or construction joints are good indicators of earthquake-induced permanent ground deformation (Figure 3.28 to Figure 3.35). Also, fresh out-of-levelness in driveways, patios, decks, and other hardscape not consistent with the normal construction practices (e.g., patios adjacent to buildings are usually sloped away from the building for drainage) (Figure 3.36) or evidence of movement of exterior improvements relative to the building (Figure 3.37 through Figure 3.39) are indicators of possible earthquake-induced permanent ground deformation. Features such as paint or debris within cracks, previous patching of cracks, and previous releveling of wood decks are indicators of a pre-existing condition, possibly associated with non-earthquake geotechnical processes (e.g., consolidation or slope creep, Figure 3.40 and Figure 3.41). See Section 4.7.2 for guidance on determining whether a fracture is recent.

- Offsets or patterns of cracking in sidewalks, curbs, street pavements, and other similar features (Figure 3.28 through Figure 3.30 and Figure 3.31 through Figure 3.33).
- Surface fault rupture (Figure 3.8 to Figure 3.12).
- Sand boils from liquefaction (Figure 3.13 to Figure 3.15).
- Slope deformation or instability (Figure 3.20, Figure 3.21, and Figure 3.23).
- Seismic compression of deep fills – distress should follow the cut/fill line and occur predominantly in fill.
- Ridge-top shattering.
- Indications of damage to underground utility lines (Figure 3.10, Figure 3.42, and Figure 3.43).

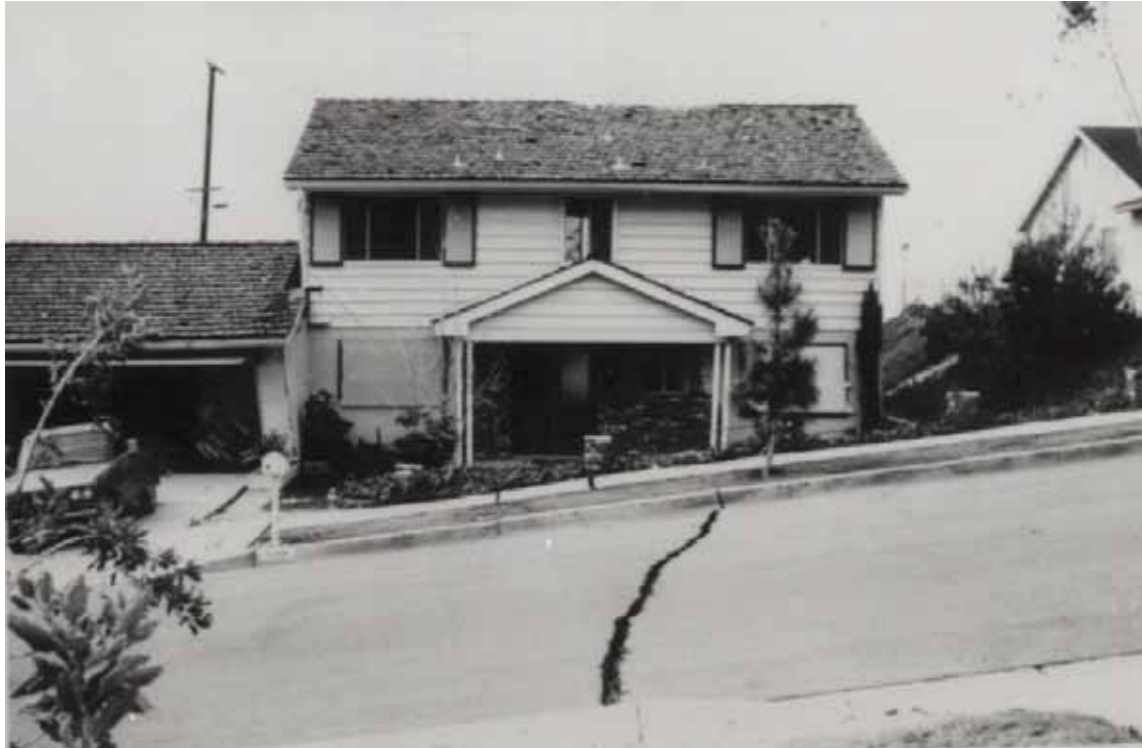
Figure 3.29. Street and house damaged by several inches of landslide displacement during the 1971 San Fernando Earthquake; displacement is readily visible as street crack in photograph [ATC, Youd].

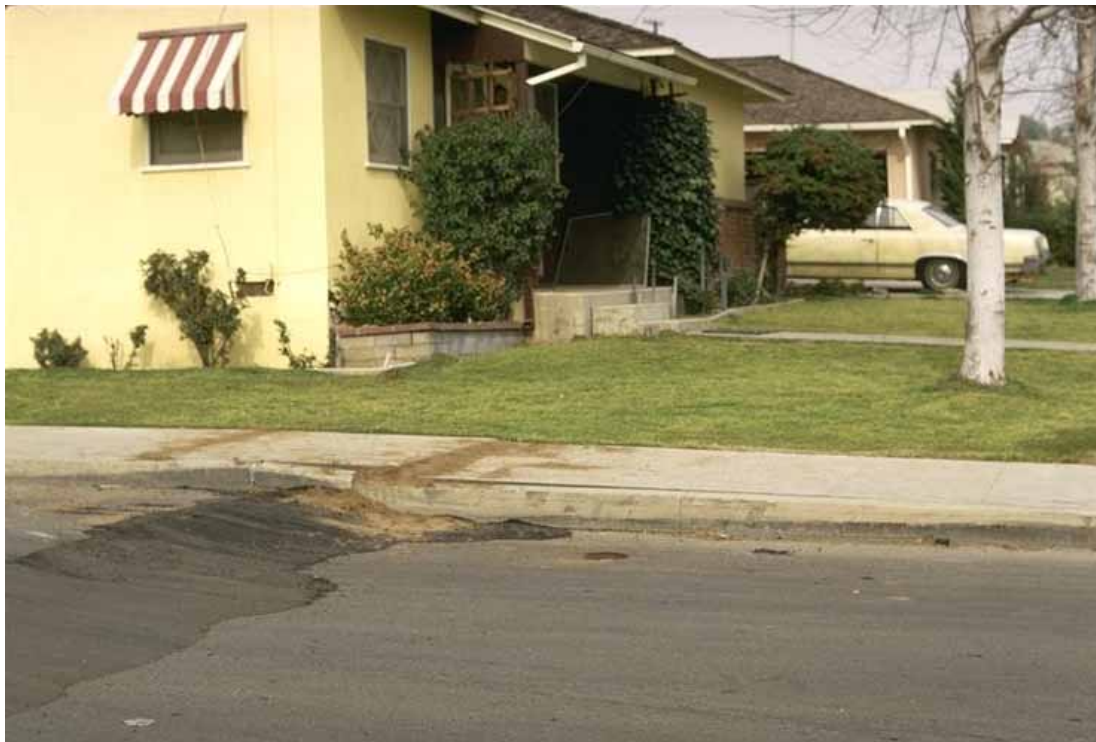
Figure 3.30. Pavement patching and damage to adjacent sidewalk in City of San Fernando following the 1971 San Fernando Earthquake [NISEE].

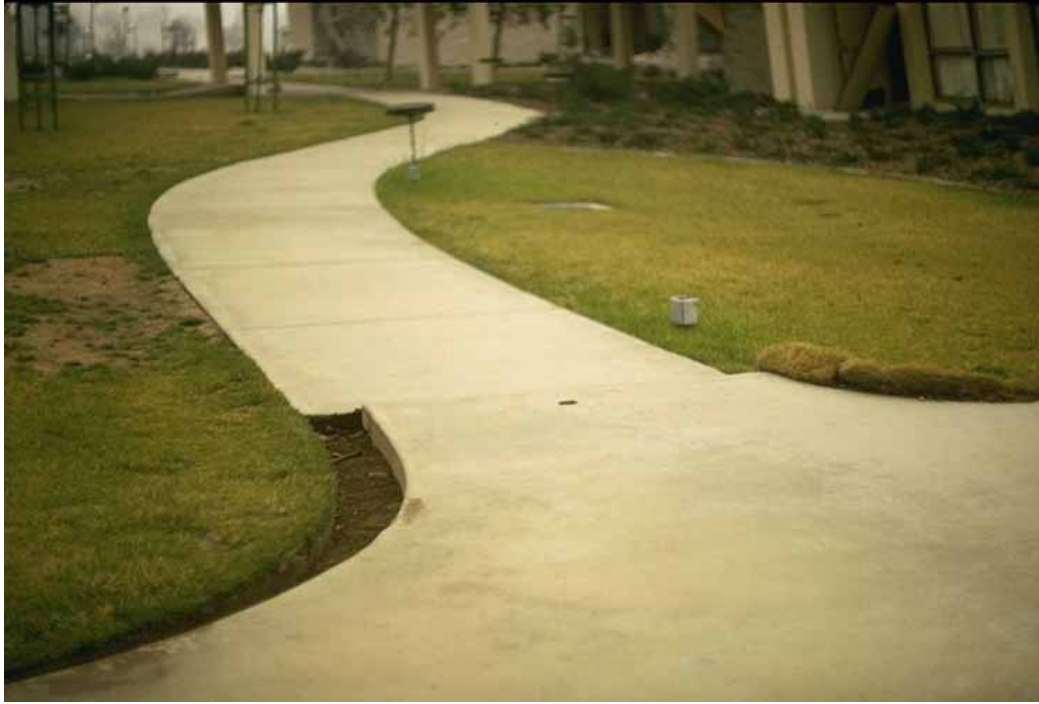
Figure 3.31. Offset sidewalk from the 1971 San Fernando Earthquake [NISEE].

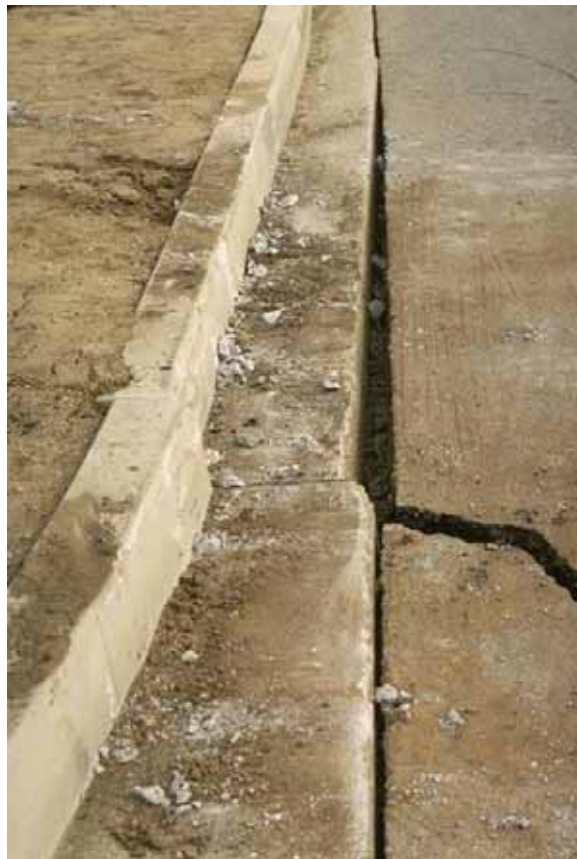
Figure 3.32. Damaged street, gutter, and curb from the 1971 San Fernando Earthquake [NISEE].

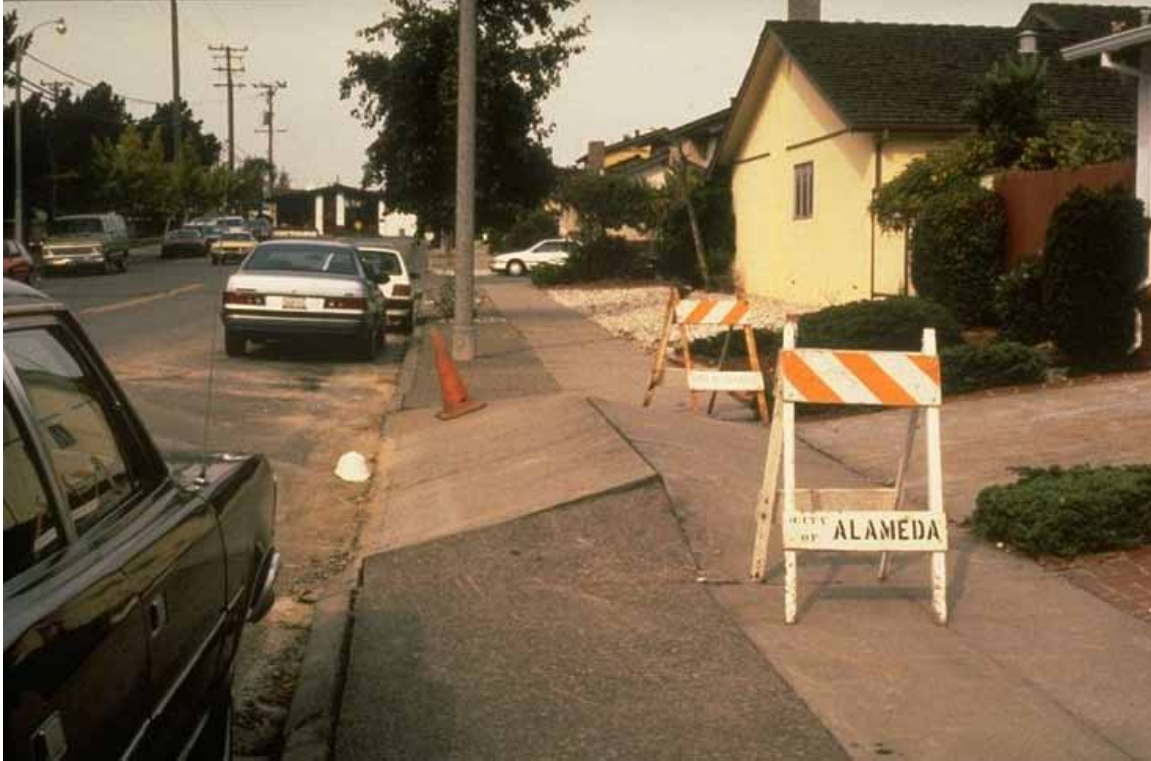
Figure 3.33. Buckling of driveway reportedly due to liquefaction during the 1989 Loma Prieta Earthquake [NISEE].

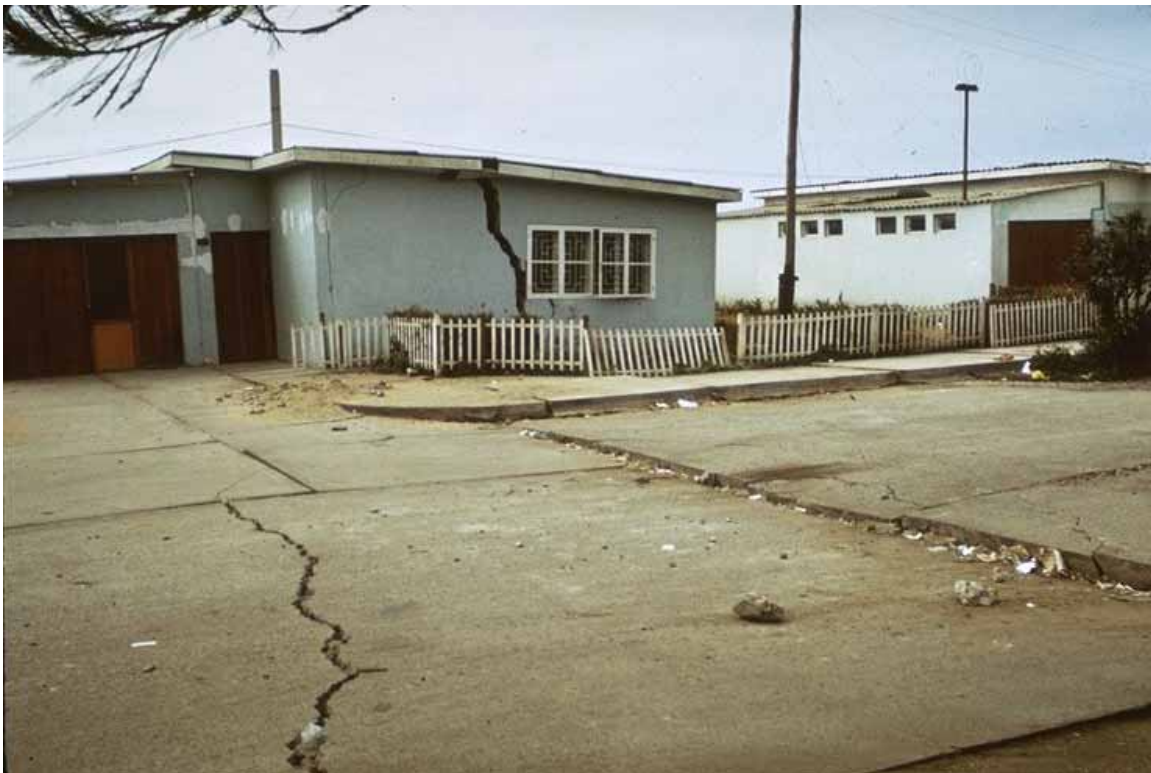
Figure 3.34. Projection of liquefaction-induced ground cracking through a building in the city of Chimbote during the 1970 Peru Earthquake [NISEE].

- c. out-of-levelness consistent with conspicuous earthquake damage to adjacent wall finishes (Figure 3.34, Figure 3.49 to Figure 3.52). The presence of patched cracks, debris within cracks, and evidence of previous releveling (Figure 3.53) are indicators of long-term, re-occurring ground movement unrelated to earthquake shaking. Careful attention to detail is necessary to distinguish the effects of long-term foundation movement from movement associated with earthquake-induced permanent ground deformation.

of earthquake-induced permanent ground deformation. To assess the possible contribution of earthquake-induced permanent ground deformation to damage in these elements, a pattern of cracking such as vertical cracks coincident with ground cracks, or parallel diagonal cracks (often referred to as *en echelon* cracks) consistent with settlement should be present that is consistent with an earthquake-induced ground deformation mode (Figure 3.34, Figure 3.45, Figure 3.46, and Figure 3.49 to Figure 3.51).

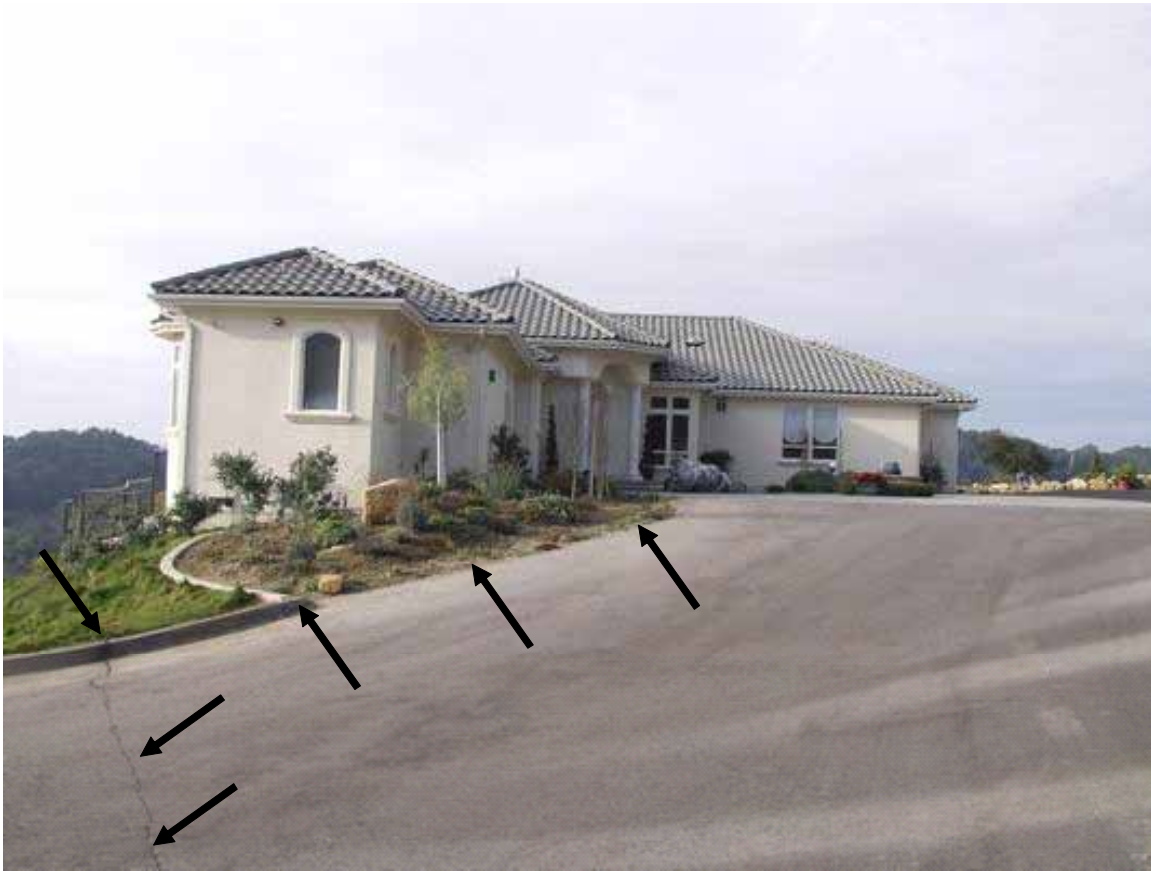
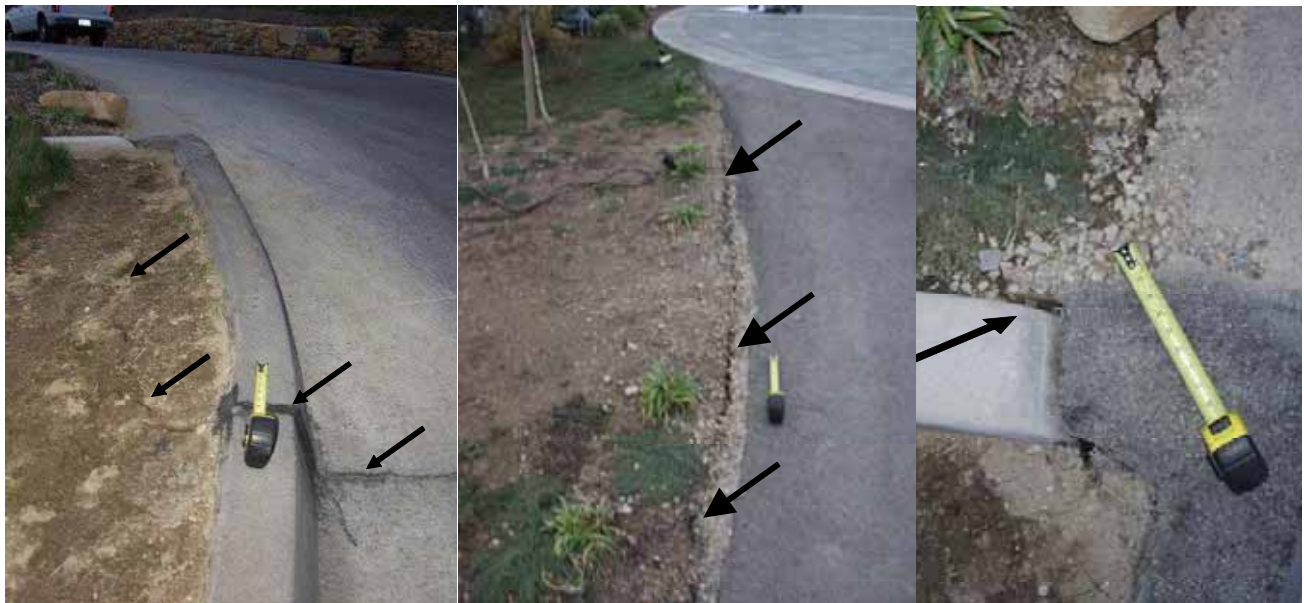
Figure 3.35. Driveway cracking following the 2003 San Simeon Earthquake; arrows indicate pavement cracking (top and bottom left), ground cracking (bottom), and offset in curb (bottom right) [Exponent].

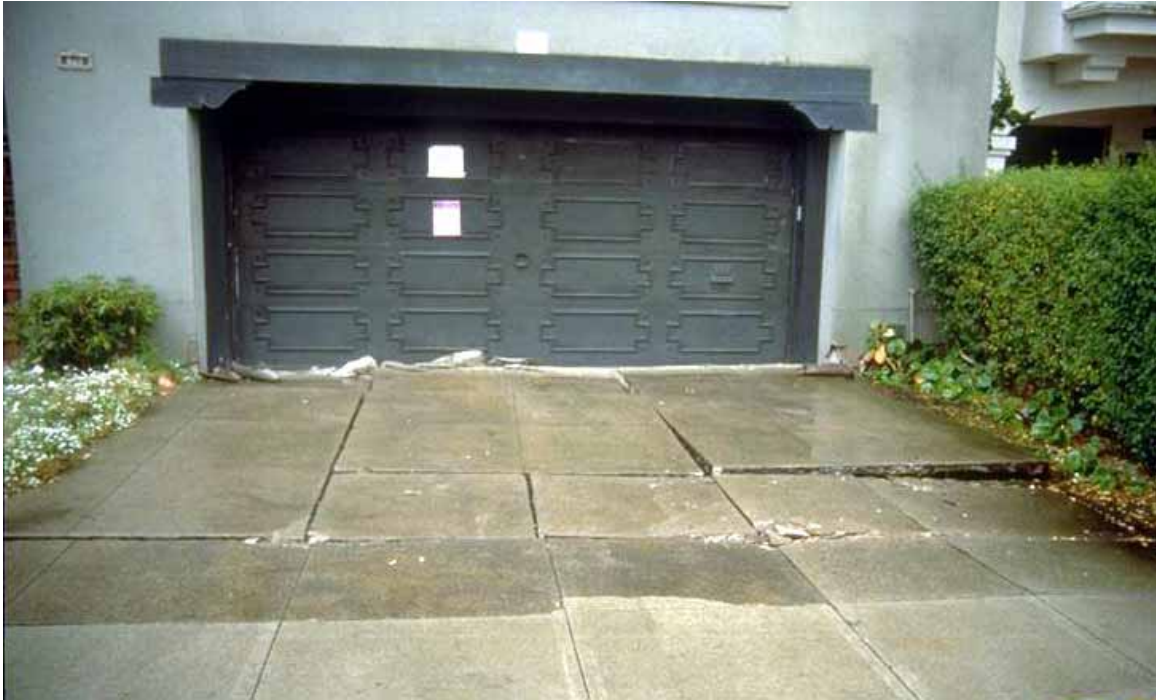
Figure 3.36. Driveway cracking and differential settlement following the 1989 Loma Prieta Earthquake [NISEE].

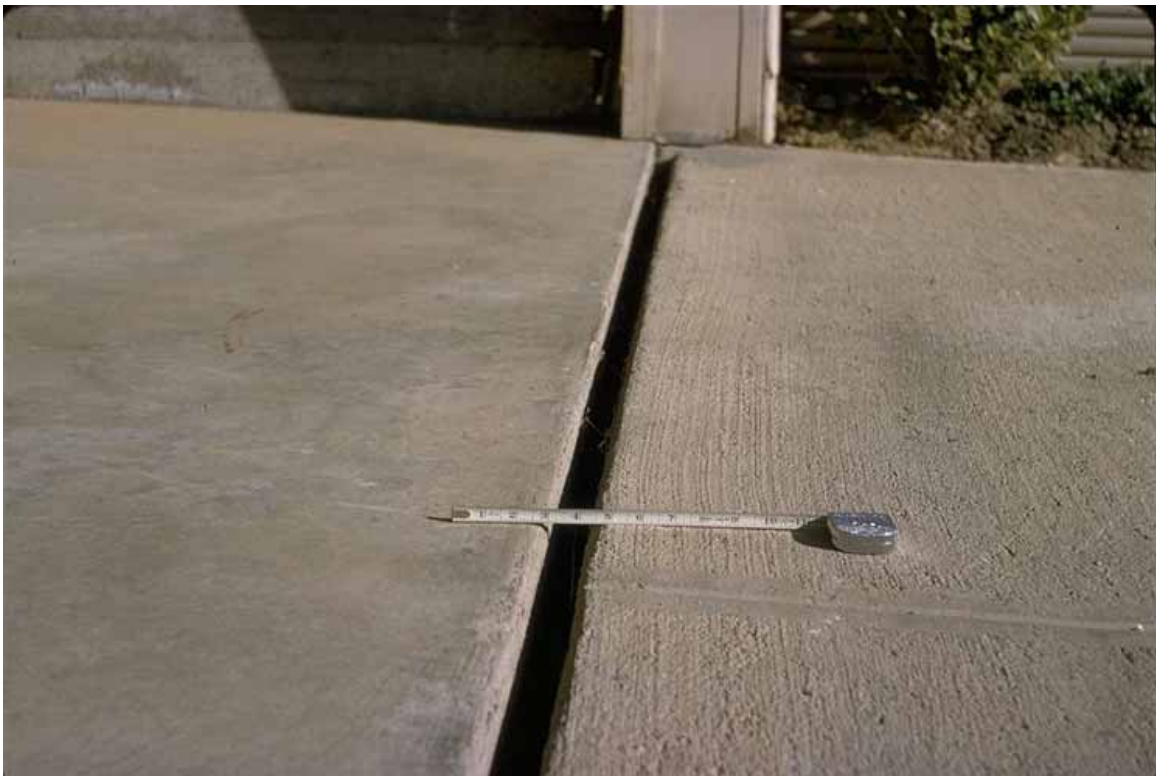
Figure 3.37. A 2-inch separation opened at the construction joint between the garage slab and driveway slab following the 1957 Daly City Earthquake [NISEE].

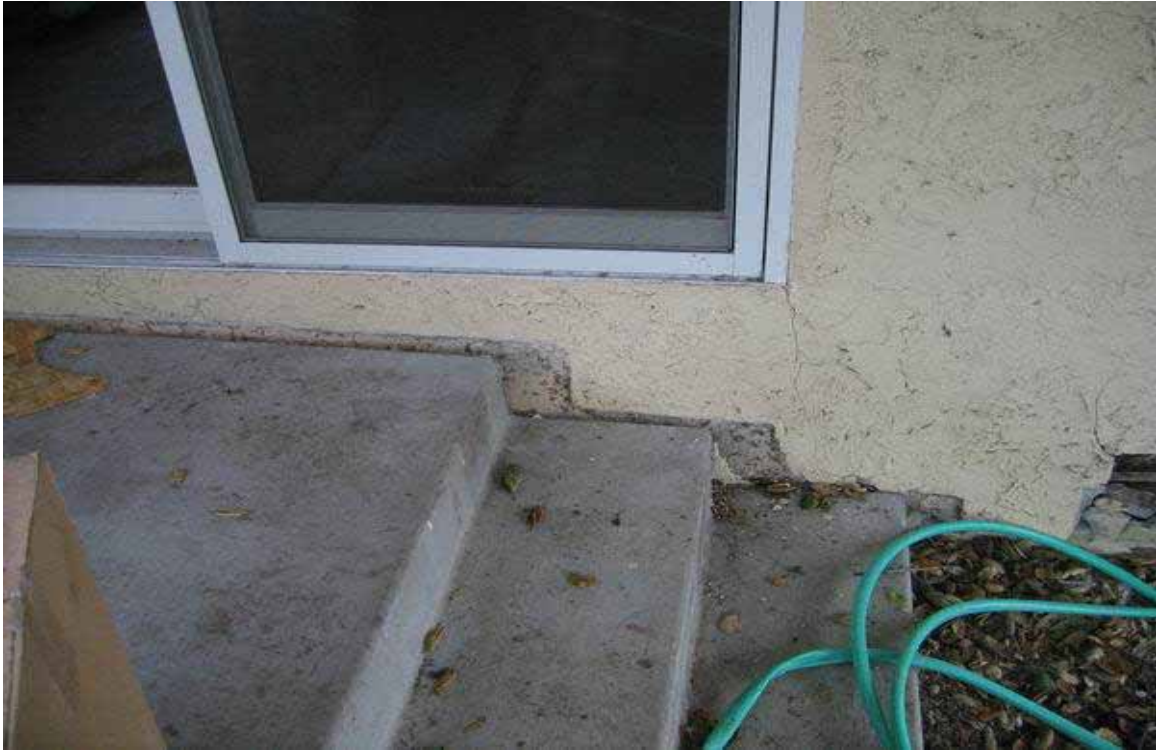
Figure 3.38. Concrete porch and steps offset from original position by earthquake-induced permanent ground deformation as evidenced by exposed foundation concrete [Exponent].

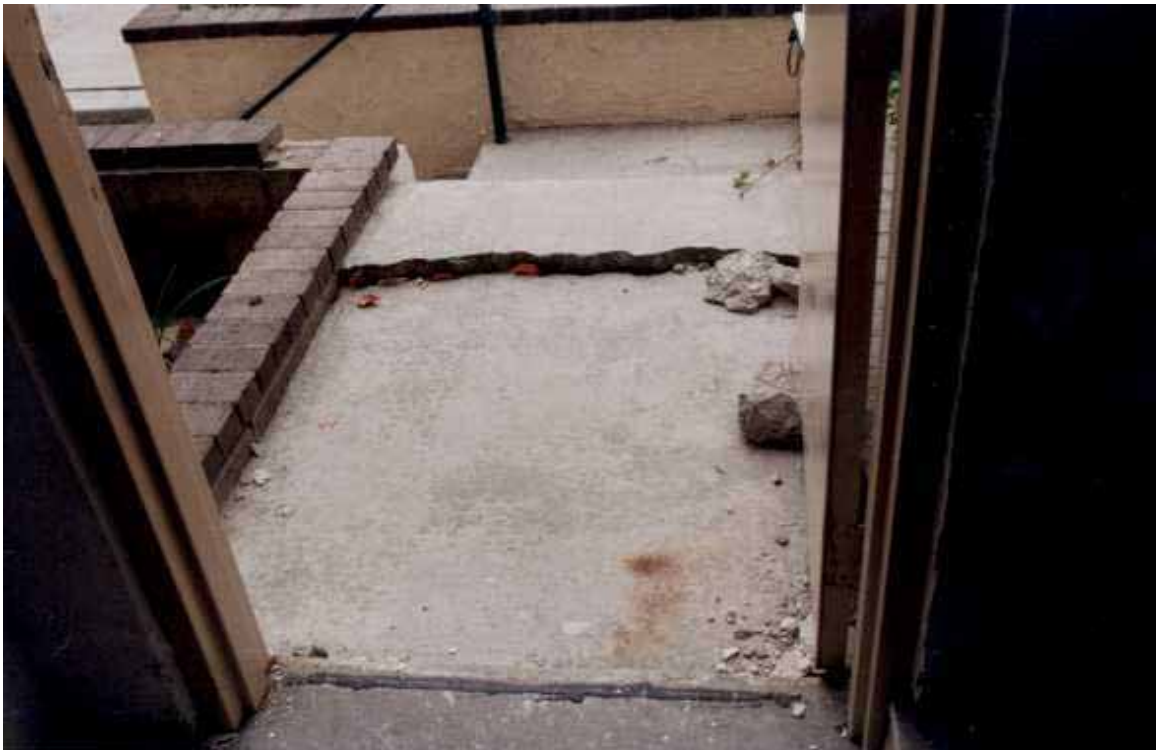
Figure 3.39. Dropping of entry walkway supported on poorly compacted backfill during the Northridge Earthquake [Exponent].

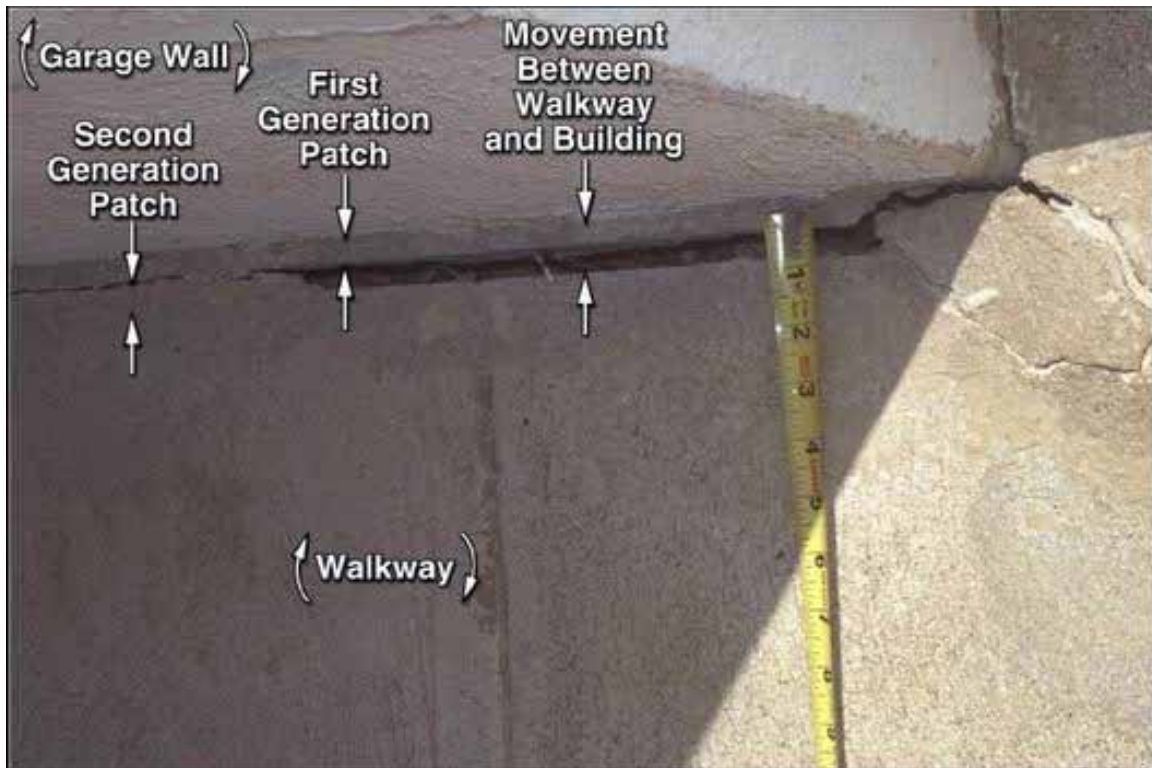
Figure 3.40. Different vintages of grout between a sidewalk and residence near a top of slope indicate a history of lateral movement as a result of slope creep rather than earthquake damage [Exponent].

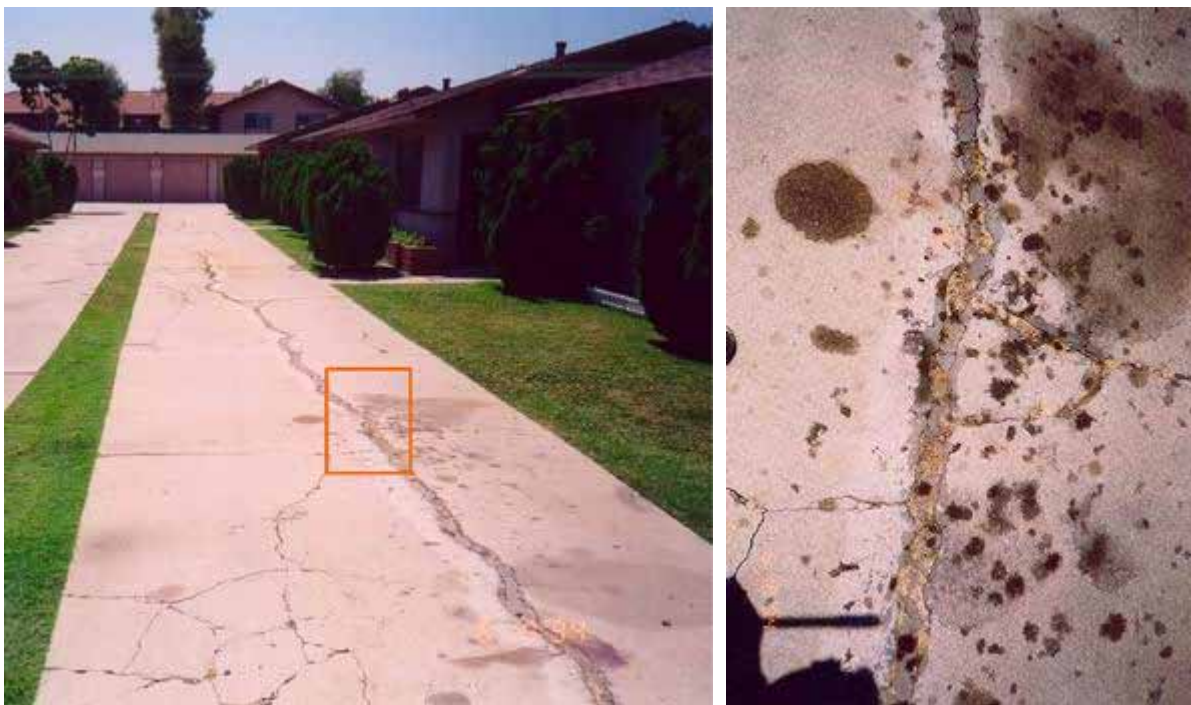
Figure 3.41. Grout within driveway slab-on-grade crack indicates long-term problem with expansive soil beneath driveway rather than earthquake damage [Exponent].
