GENERAL GUIDELINES  
FOR THE ASSESSMENT AND REPAIR  
OF EARTHQUAKE DAMAGE  
IN RESIDENTIAL WOODFRAME BUILDINGS

Consortium of Universities for Research in Earthquake Engineering

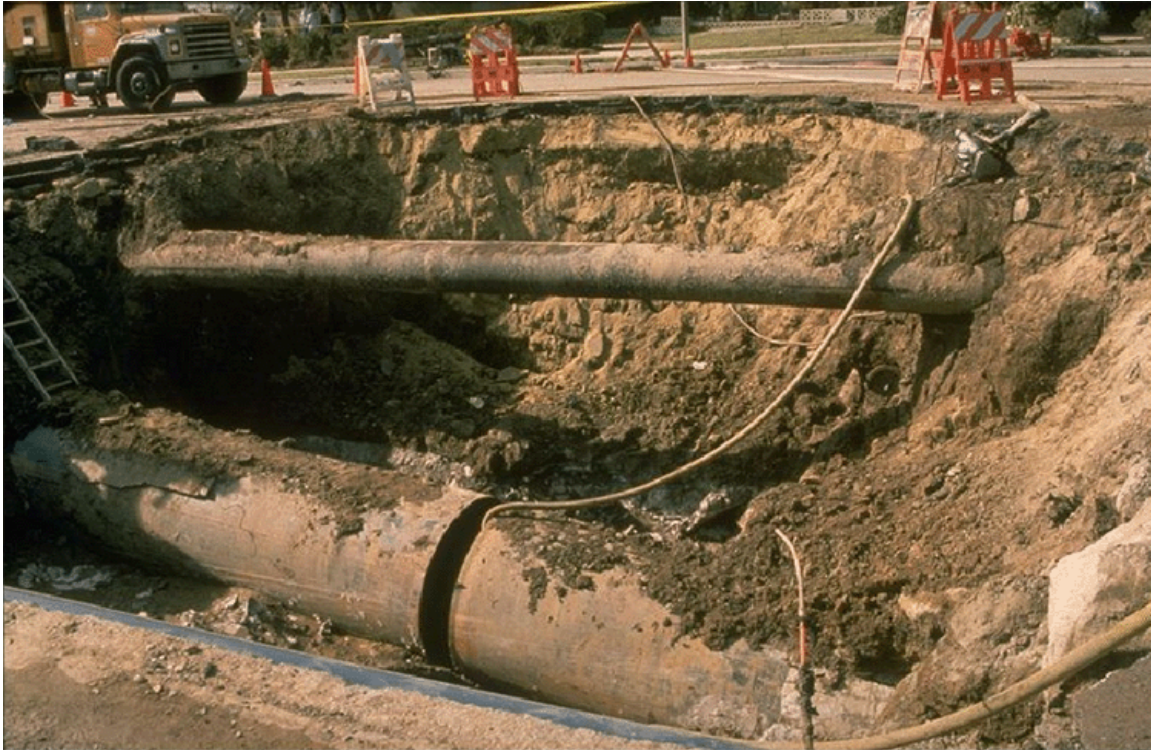
Figure 3.42. Utility pipe ruptured by lateral spreading on Balboa Boulevard from the 1994 Northridge Earthquake [NISEE].

2. **Utility Lines:** Damage to underground utility lines on the property, such as water service lines, sanitary sewer lines, and gas lines, are indicators of possible earthquake-induced permanent ground deformation (Figure 3.10, Figure 3.42, and Figure 3.43).<sup>29</sup> The condition of these lines, and serviceability of the lines (i.e., recent clogging of sewer lines) relative to their

- Offsets or patterns of cracking in sidewalks, curbs, street pavements, and other similar features (Figure 3.28 through Figure 3.30 and Figure 3.31 through Figure 3.33).
- Surface fault rupture (Figure 3.8 to Figure 3.12).
- Sand boils from liquefaction (Figure 3.13 to Figure 3.15).
- Slope deformation or instability (Figure 3.20, Figure 3.21, and Figure 3.23).
- Seismic compression of deep fills – distress should follow the cut/fill line and occur predominantly in fill.
- Ridge-top shattering.
- Indications of damage to underground utility lines (Figure 3.10, Figure 3.42, and Figure 3.43).

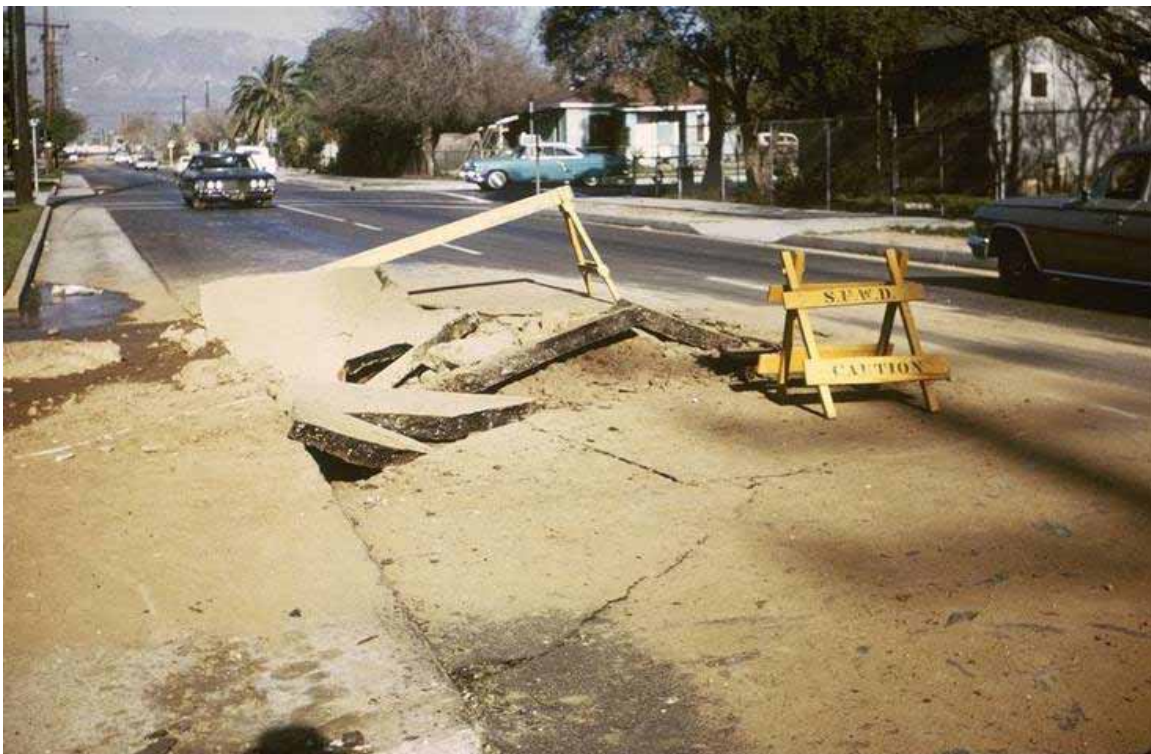
Figure 3.43. Pipe failures and resulting pavement distress and settlement from the 1971 San Fernando Earthquake [NISEE].

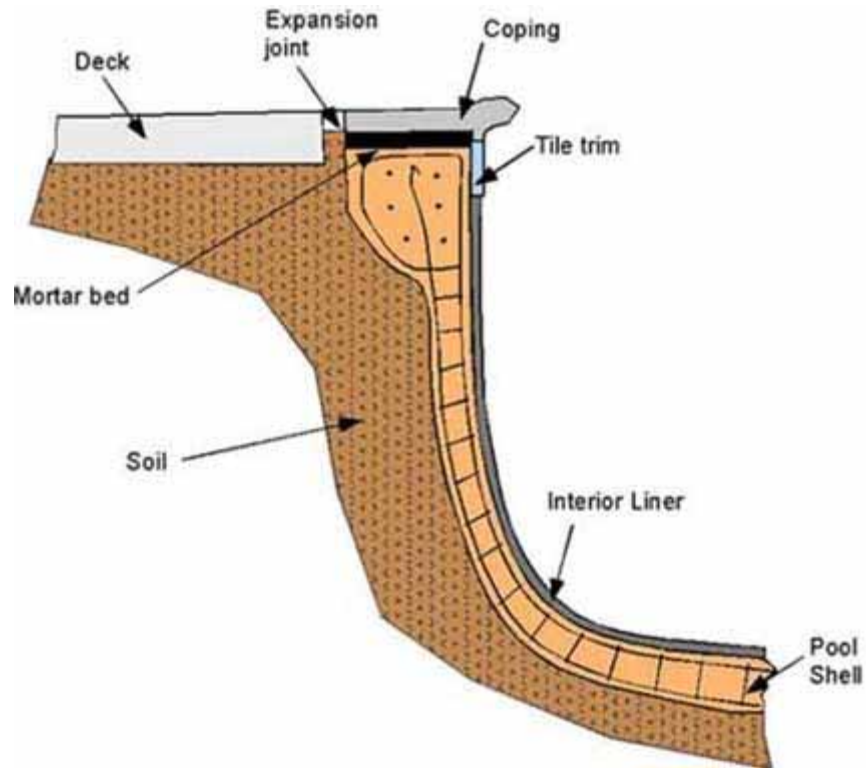
Figure 3.44. Schematic cross-section of typical in-ground swimming pool [Exponent].

3. **Swimming Pool:** Swimming pools can be an effective means by which to assess recent changes in the levelness of at-grade improvements. Typically, swimming pool waterline tile are installed reasonably level (good workmanship is  $\pm 1/4$  inch for waterline tile)<sup>30</sup> and significant deviations from level may be indications of earth movement, earthquake-induced or otherwise (Figure 3.44). Chemical residues, if present on the waterline tile, can indicate the pre-earthquake water surface location. The degree to which these residues form a non-level surface may indicate whether swimming pool movement occurred prior to or as a result of the earthquake. Fresh-appearing out-of-levelness of the pool coping not consistent with construction tolerances and fresh-appearing cracking of the pool shell are indicators of possible earthquake-induced permanent ground deformation.

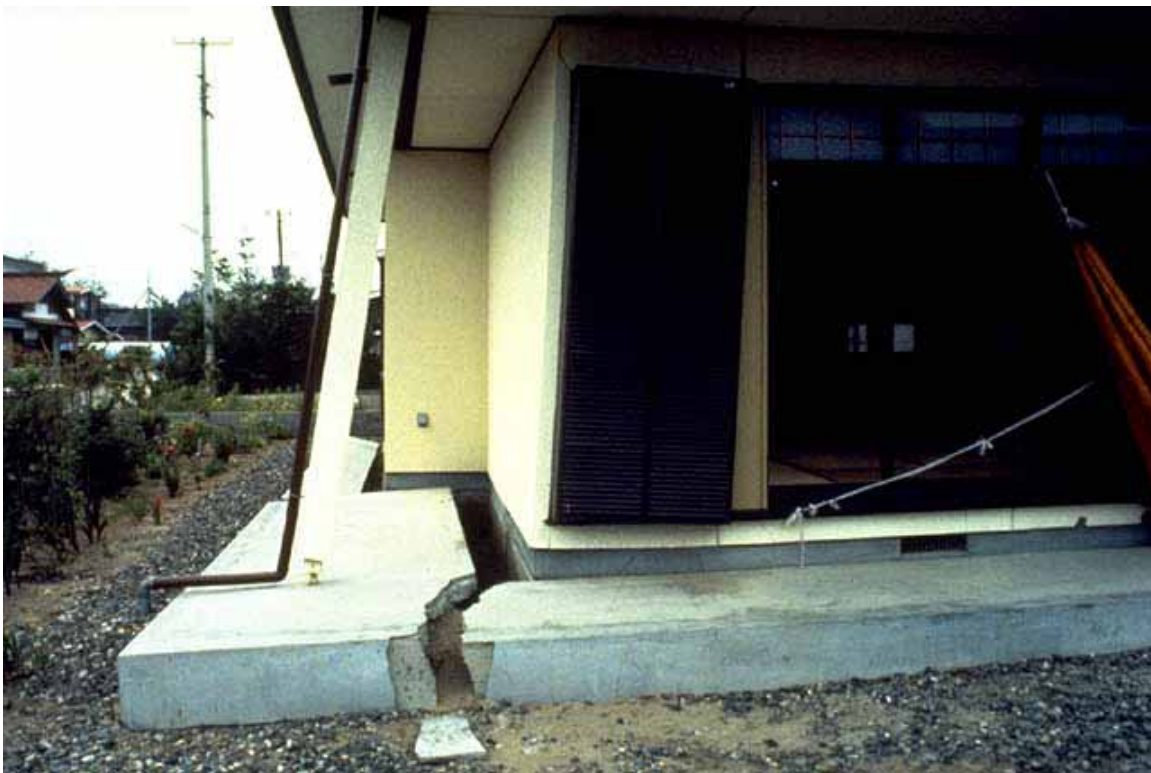
Figure 3.45. Damage from lateral spreading to house foundation in Wakami, Japan during the 1983 Nihonkai-Chubu Earthquake [NISEE].

- a. fresh cracking or the significant widening of pre-existing cracks in concrete stem walls or footings (Figure 3.45 to Figure 3.48),
  - b. soil deformations adjacent to foundations (e.g., bulging or tension cracks), and

of earthquake-induced permanent ground deformation. To assess the possible contribution of earthquake-induced permanent ground deformation to damage in these elements, a pattern of cracking such as vertical cracks coincident with ground cracks, or parallel diagonal cracks (often referred to as *en echelon* cracks) consistent with settlement should be present that is consistent with an earthquake-induced ground deformation mode (Figure 3.34, Figure 3.45, Figure 3.46, and Figure 3.49 to Figure 3.51).

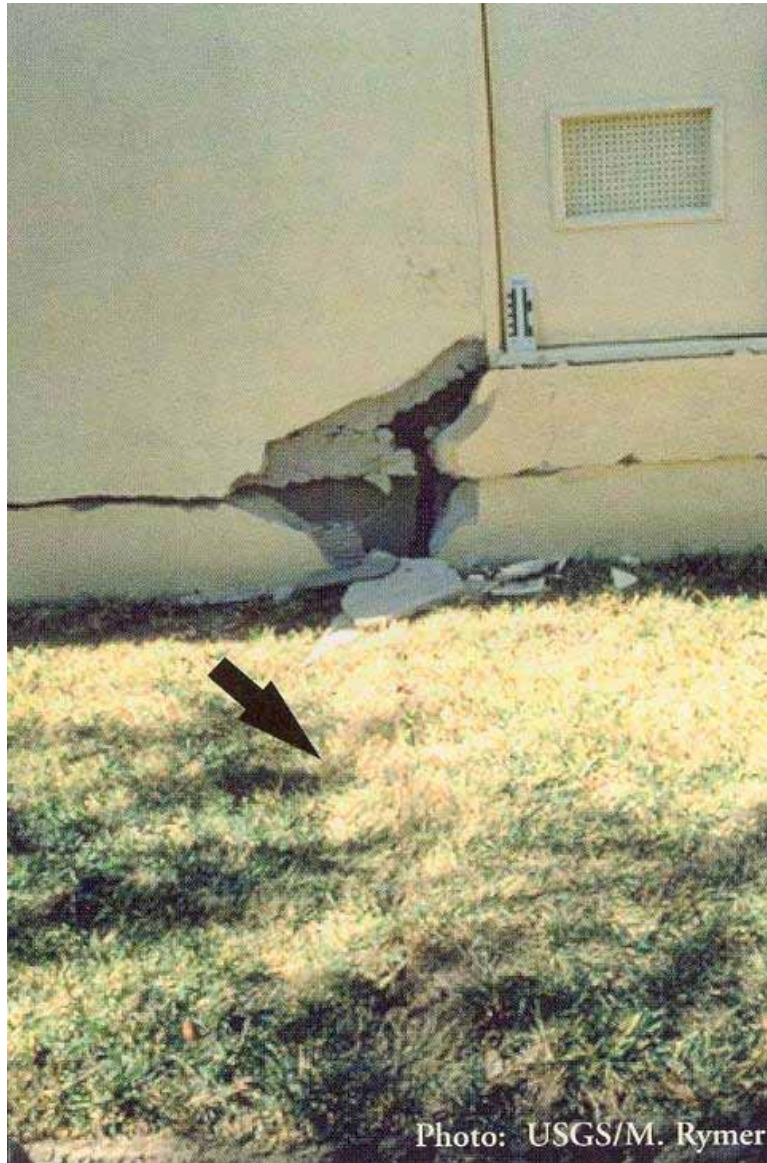
Figure 3.46. Foundation slab and wall of this house in the Balboa Boulevard area was damaged by small settlement and ground cracking that is evident in the lawn (arrow) during the 1994 Northridge Earthquake [USGS].

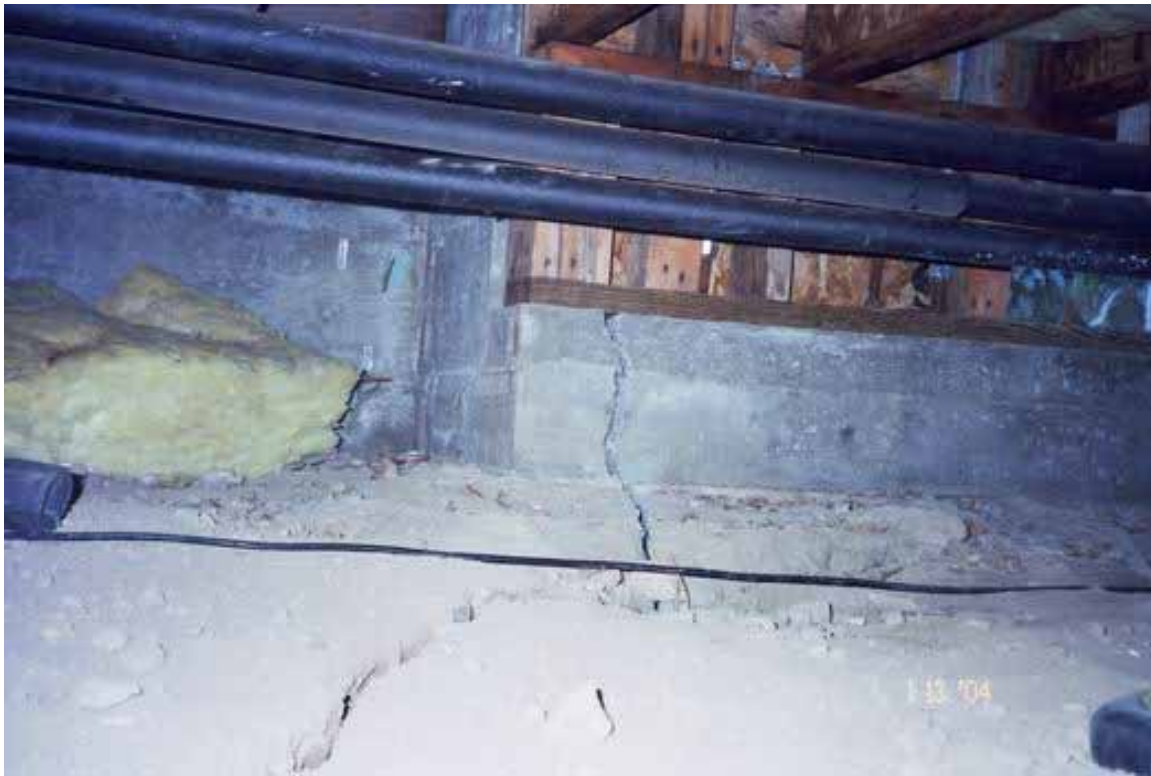
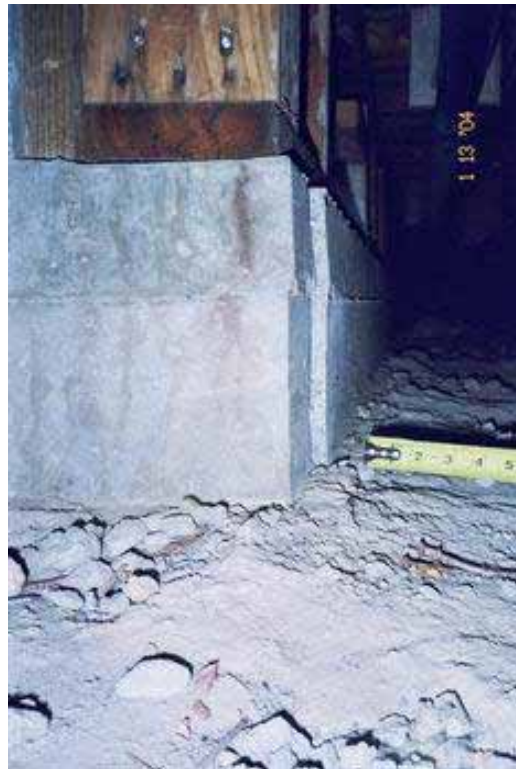
Figure 3.47. Foundation and ground cracking following the 2003 San Simeon Earthquake; bottom shows the out-of-plane offset present across foundation crack shown in top photograph [Exponent].

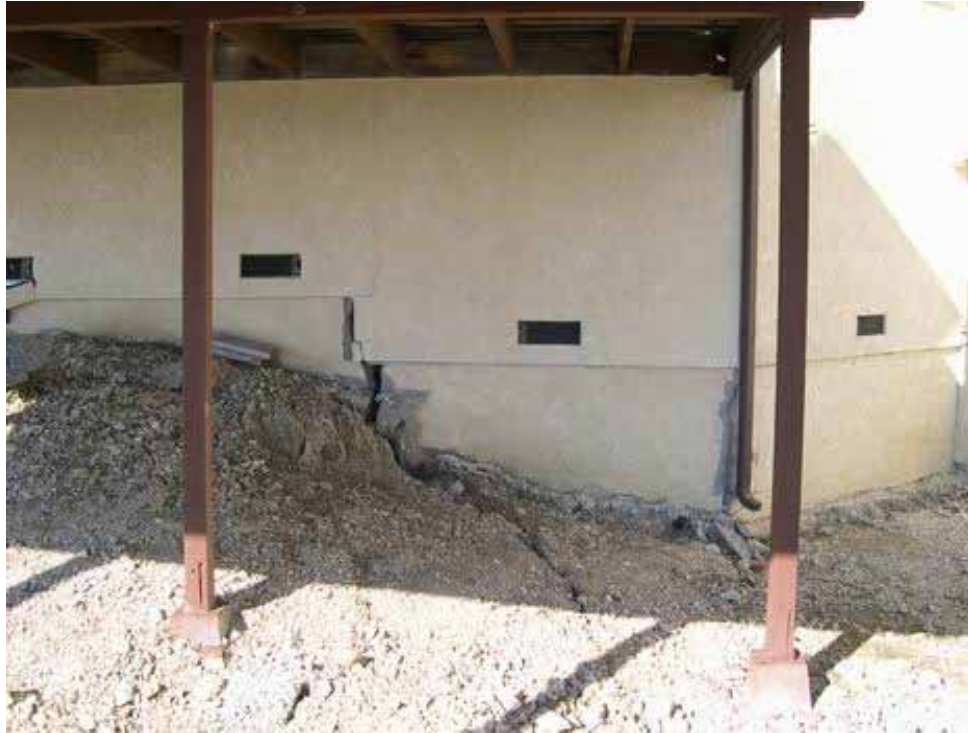
Figure 3.48. Foundation and ground cracking following the 2003 San Simeon Earthquake [Exponent].

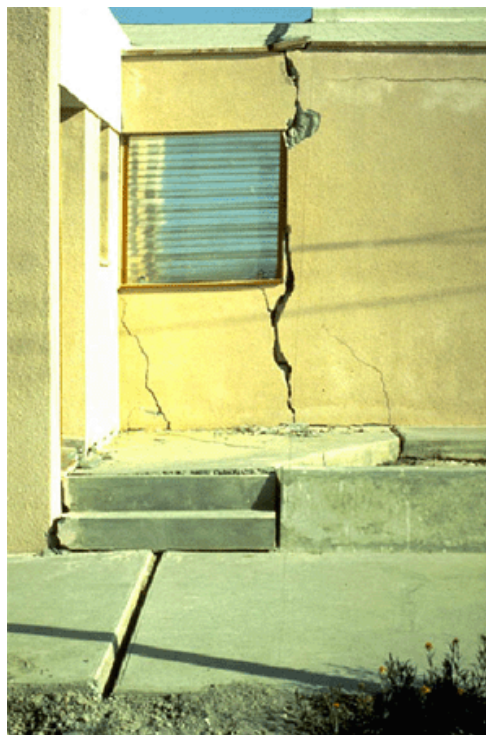
Figure 3.49. One-story masonry house in a main housing development in the town of Caucete, damaged due to differential settlement caused by liquefaction during the 1977 Caucete, San Juan, Argentina Earthquake; damage to the interior slab is shown in Figure 3.50 [NISEE].

- c. out-of-levelness consistent with conspicuous earthquake damage to adjacent wall finishes (Figure 3.34, Figure 3.49 to Figure 3.52). The presence of patched cracks, debris within cracks, and evidence of previous releveling (Figure 3.53) are indicators of long-term, re-occurring ground movement unrelated to earthquake shaking. Careful attention to detail is necessary to distinguish the effects of long-term foundation movement from movement associated with earthquake-induced permanent ground deformation.

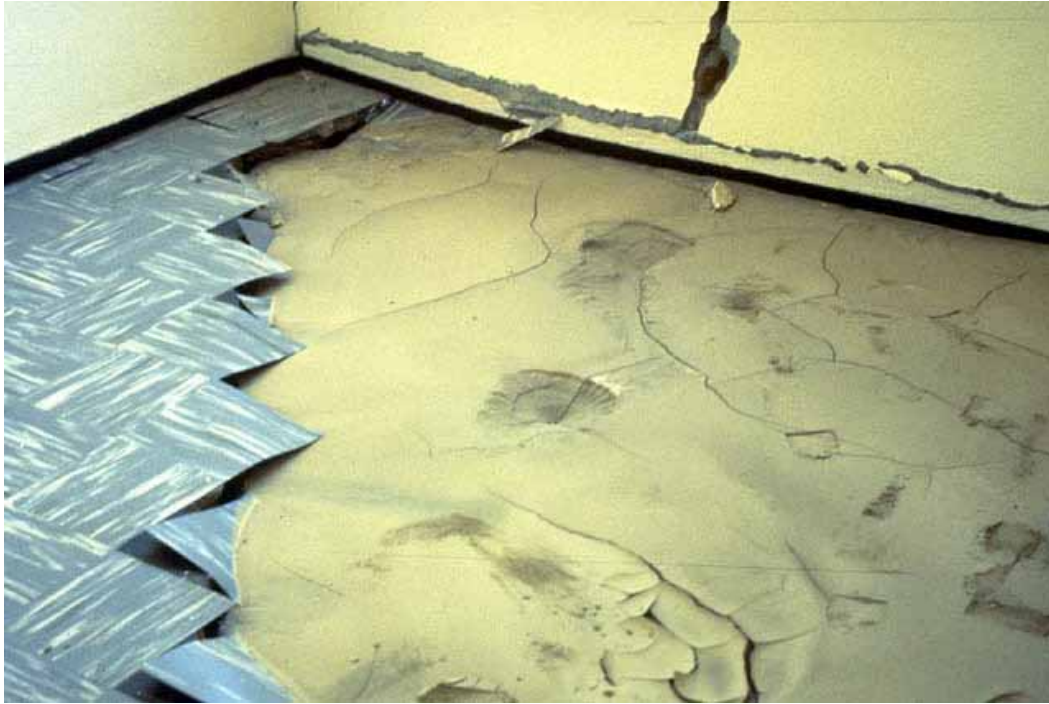
Figure 3.50. Damaged concrete slab-on-grade floor of the house shown in Figure 3.49; sandy mud ejected by liquefaction covers part of the floor [NISEE].

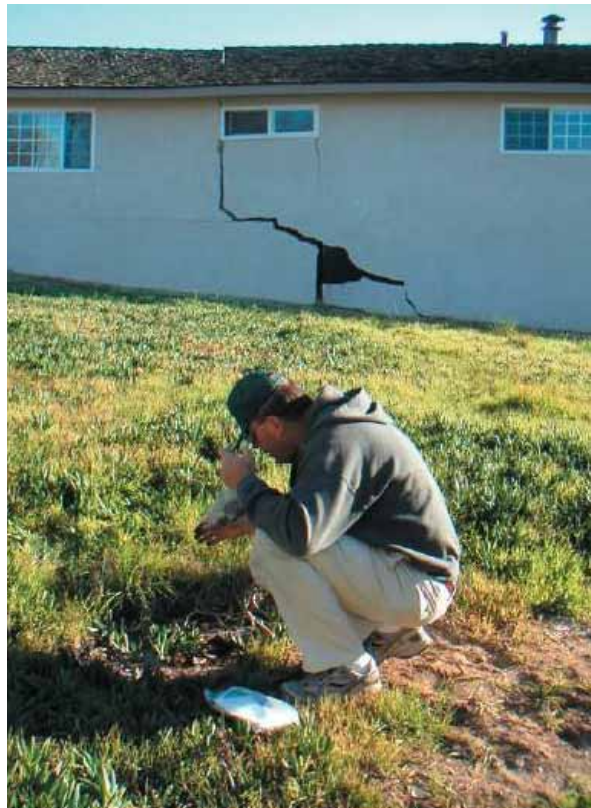
Figure 3.51. Damage to a residence in Oceano, California from lateral spreading following the 2003 San Simeon Earthquake [USGS].

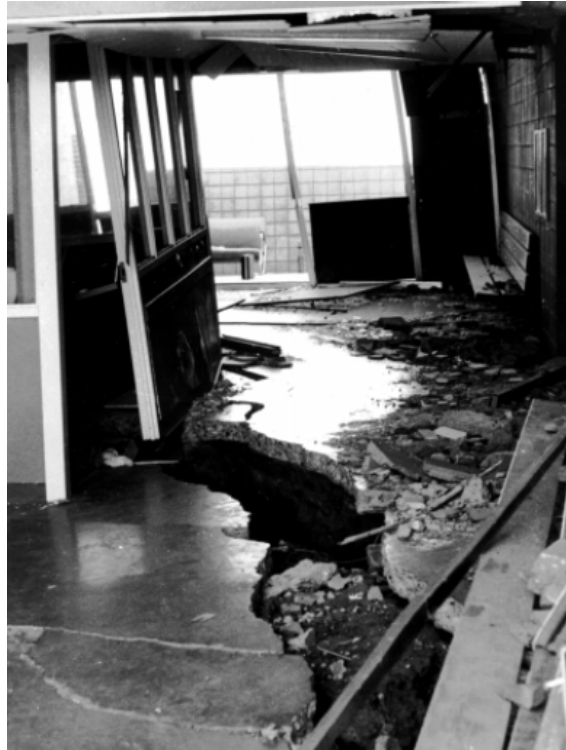
Figure 3.52. Damage to a slab-on-grade from liquefaction at Los Angeles County Juvenile Hall, Sylmar, California during the 1971 San Fernando Earthquake [Meehan].

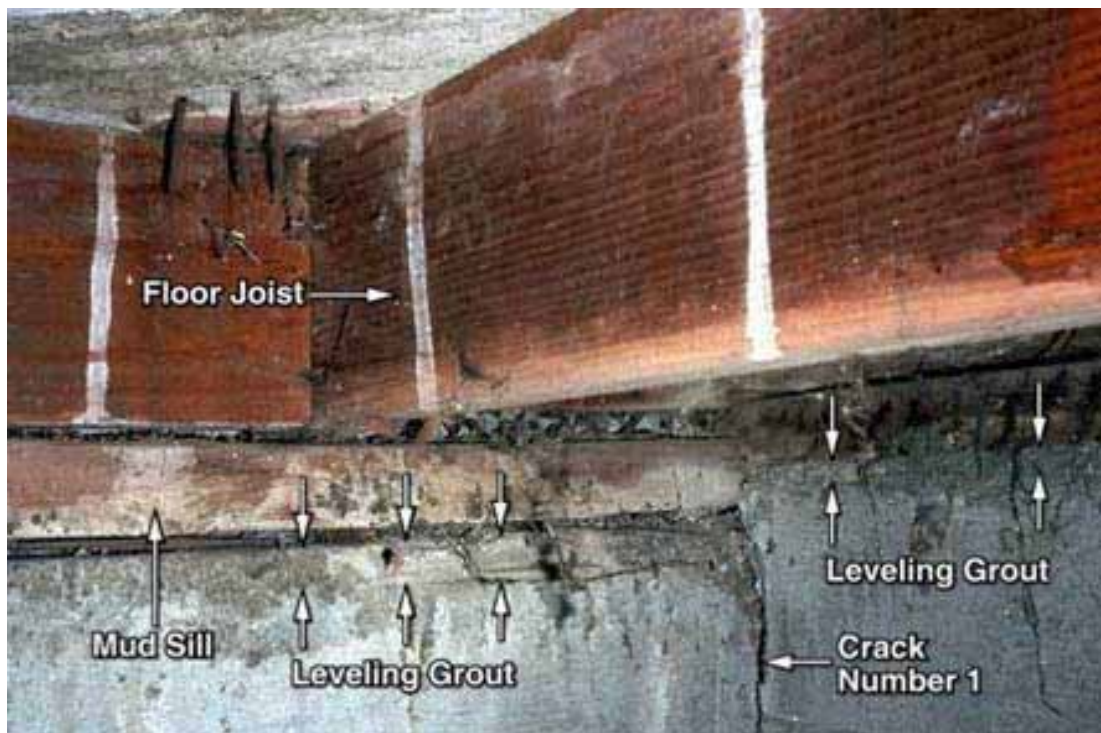
Figure 3.53. Releveling of foundation indicates prior settlement and possibly on-going deformation mode rather than earthquake damage [Exponent].

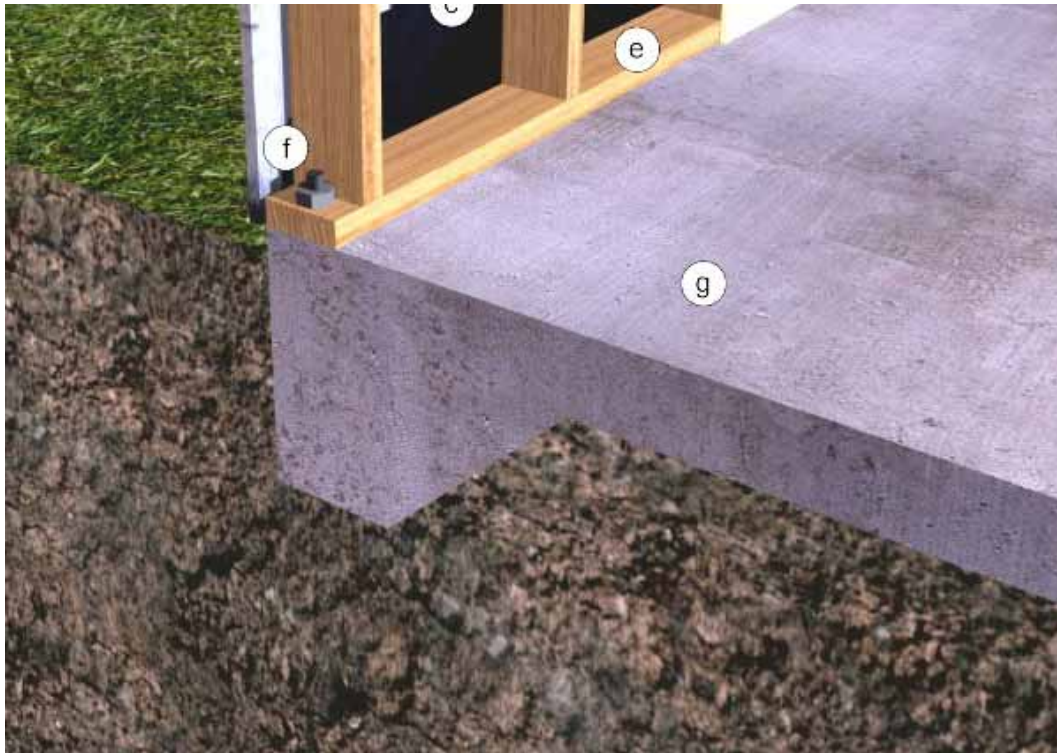
Figure 4.1. Continuous footing at perimeter of a slab-on-grade – single-pour system [Exponent].

- Thickened slab edges around the perimeter of concrete slab-on-grade floors (Figure 4.1).
- Continuous strip footings around the perimeter of a slab-on-grade (Figure 4.2 and Figure 4.8).

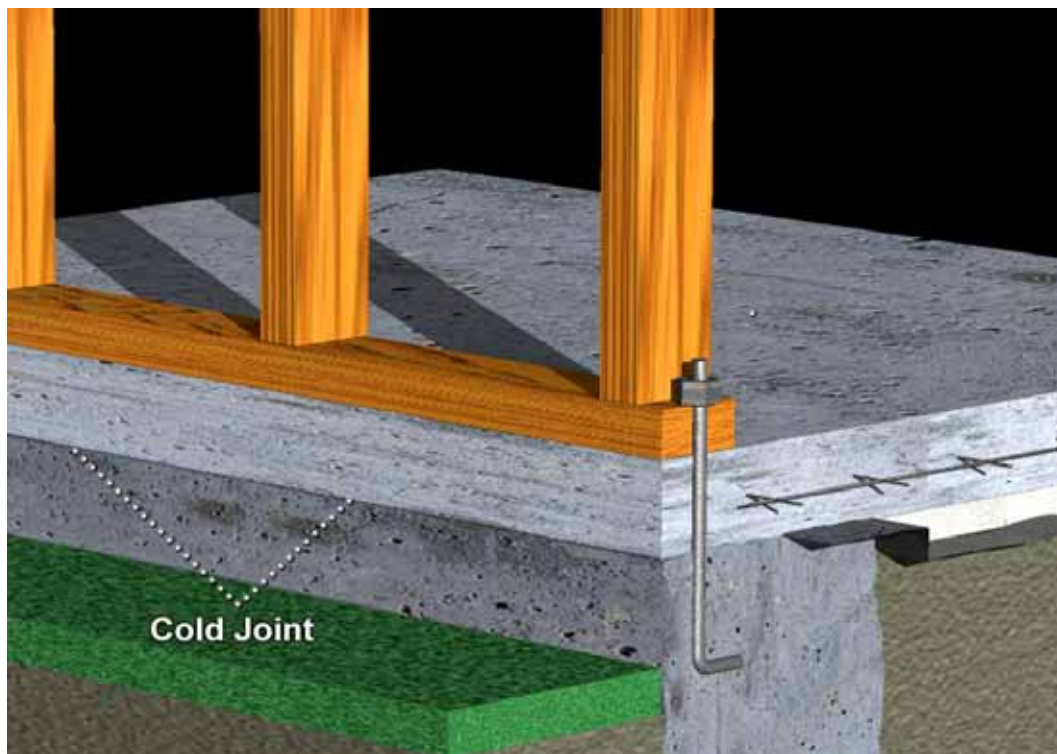
Figure 4.2. Continuous footing at perimeter of a slab-on-grade – two-pour system with cold joint between slab and footing [Exponent].

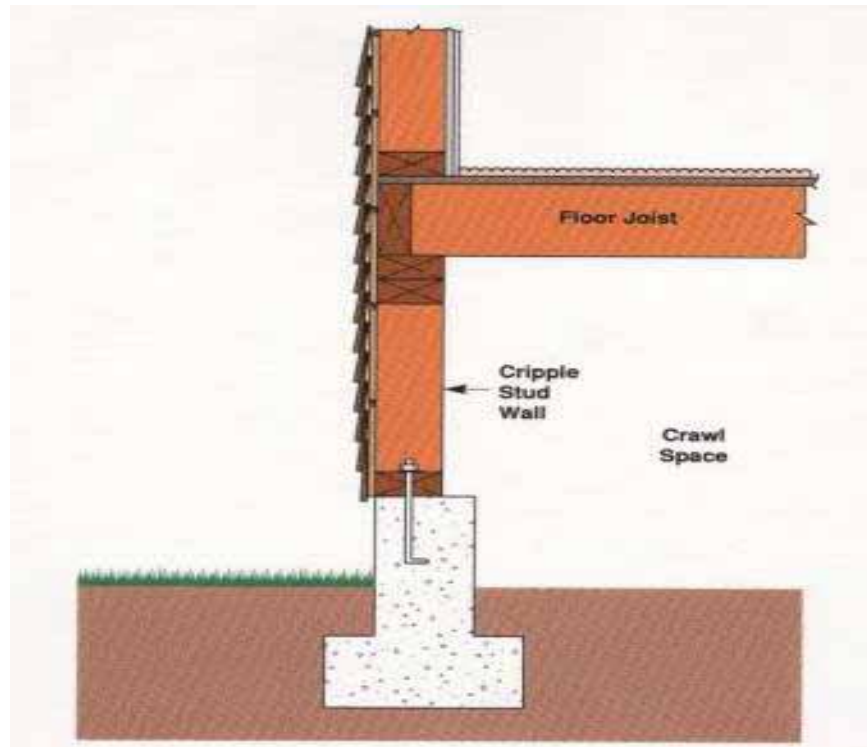
Figure 4.3. Continuous footing supporting woodframed cripple wall [Exponent].

- Continuous strip footings under woodframe stud walls (cripple walls) that support the first floor framing over a crawlspace (Figure 4.3).
- Continuous stem walls from the soil to the underside of the first floor framing over a crawlspace (Figure 4.4).

It is also necessary to identify relevant details of the foundation construction. If the house has a raised foundation, are there wood cripple walls over concrete footings (Figure 4.3), or is the crawlspace enclosed by full-height concrete stem walls (Figure 4.4)? Is the interior of the house supported in the same way as the perimeter, or are there individual wood posts on concrete (or masonry) piers (Figure 4.5)? In addition to the raised portion, does the house also have a more recent slab-on-grade addition?

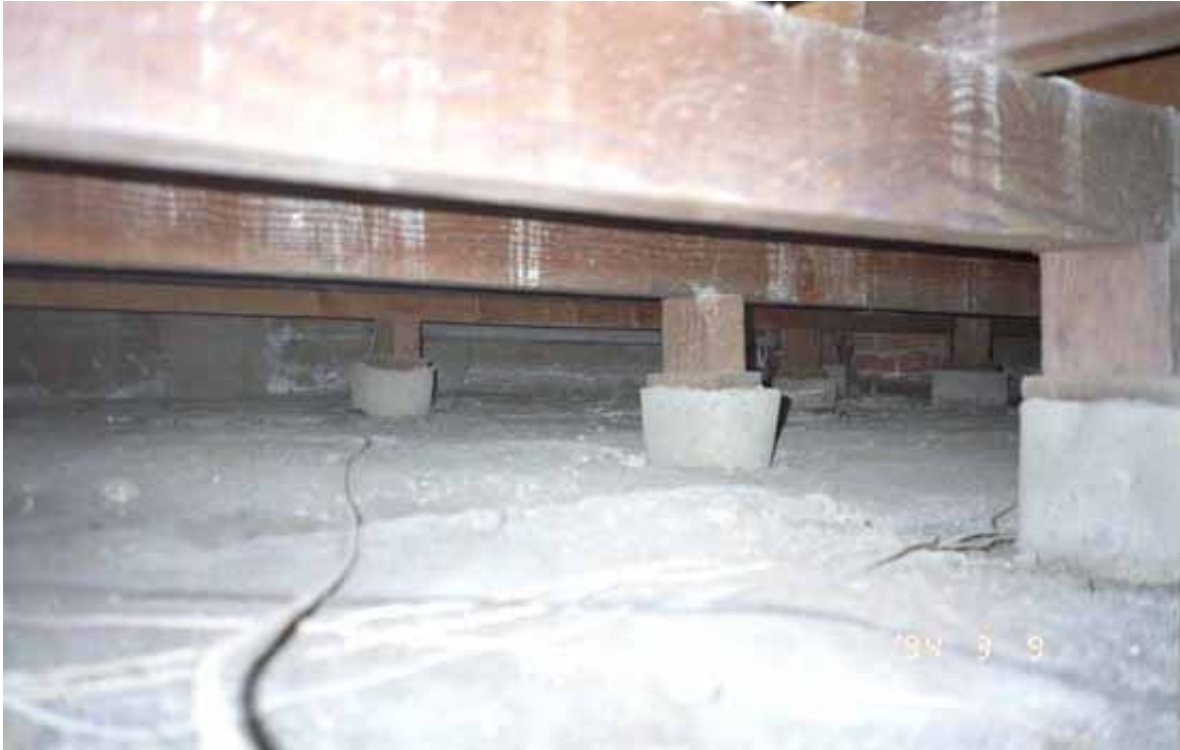
Figure 4.5. Undamaged isolated footings supporting wood posts of first floor woodframing [Exponent].

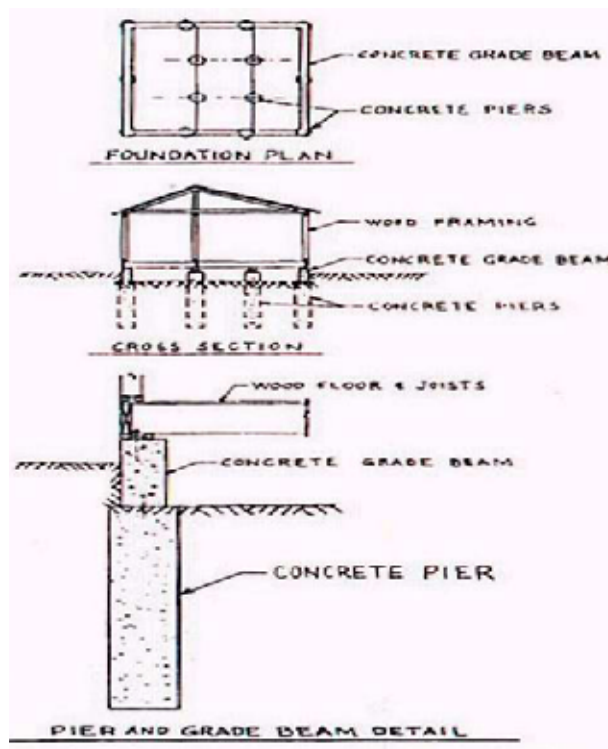
Figure 4.6. Drilled pier-and-grade-beam foundation supporting first floor woodframing.

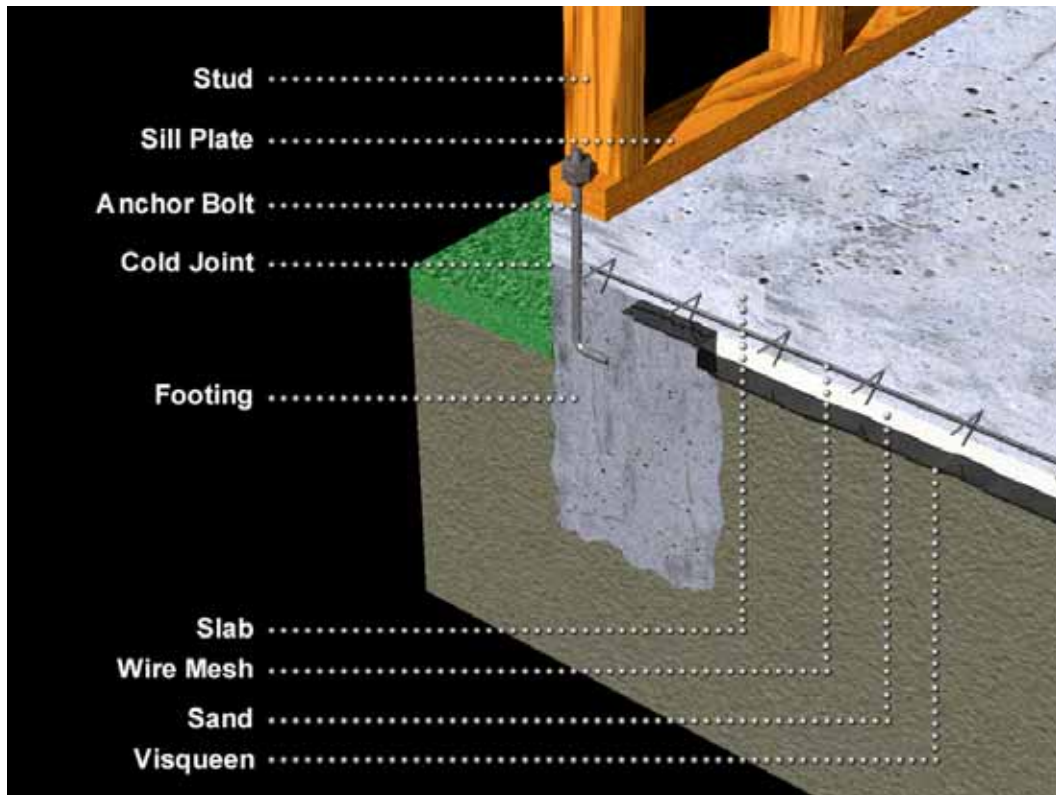
Figure 4.7. Slab-on-grade with independent perimeter footing and horizontal construction joint [Exponent].

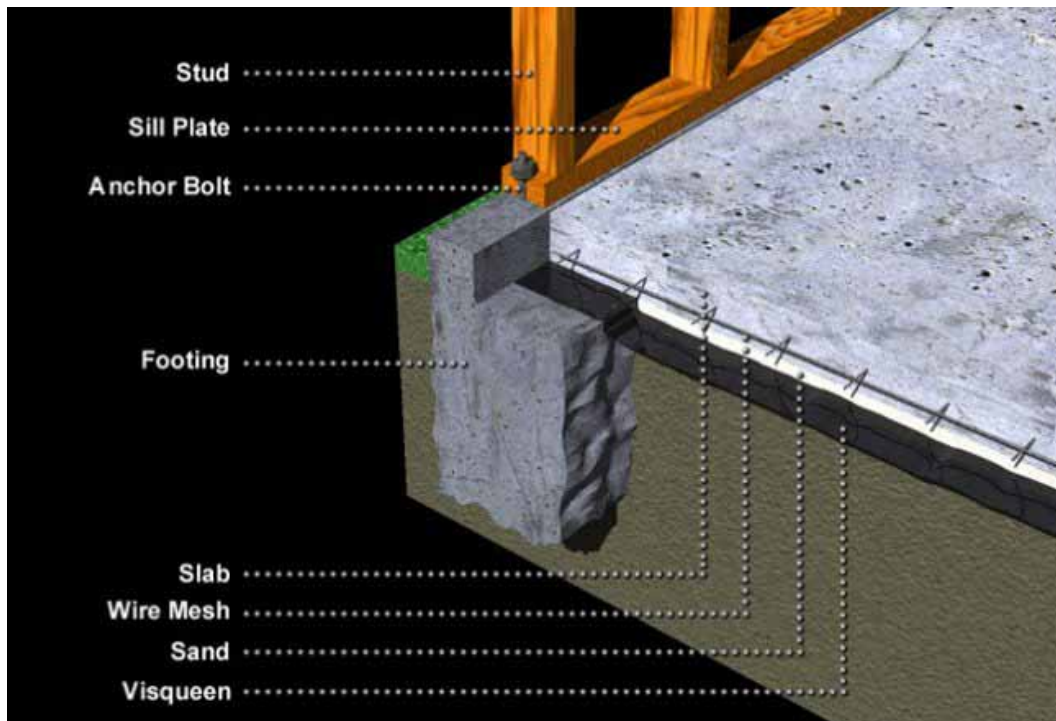
Figure 4.8. Slab-on-grade with independent perimeter footing and vertical construction joint [Exponent].

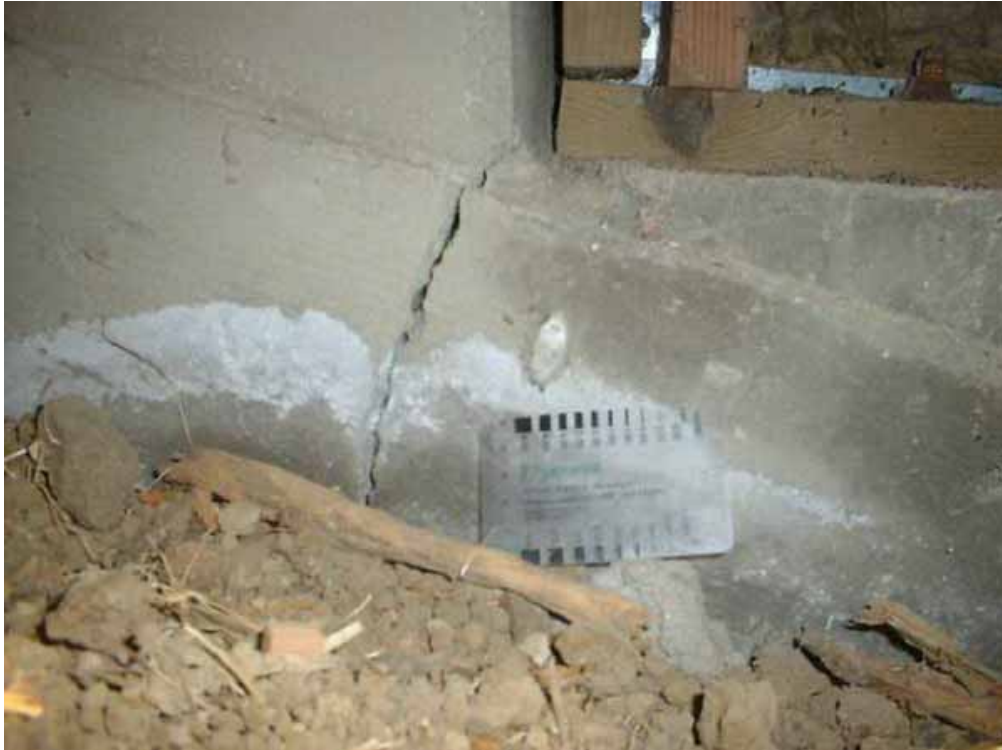
Figure 4.9. Concrete shrinkage crack emanating from reentrant corner at a step in a perimeter stem wall [Exponent].

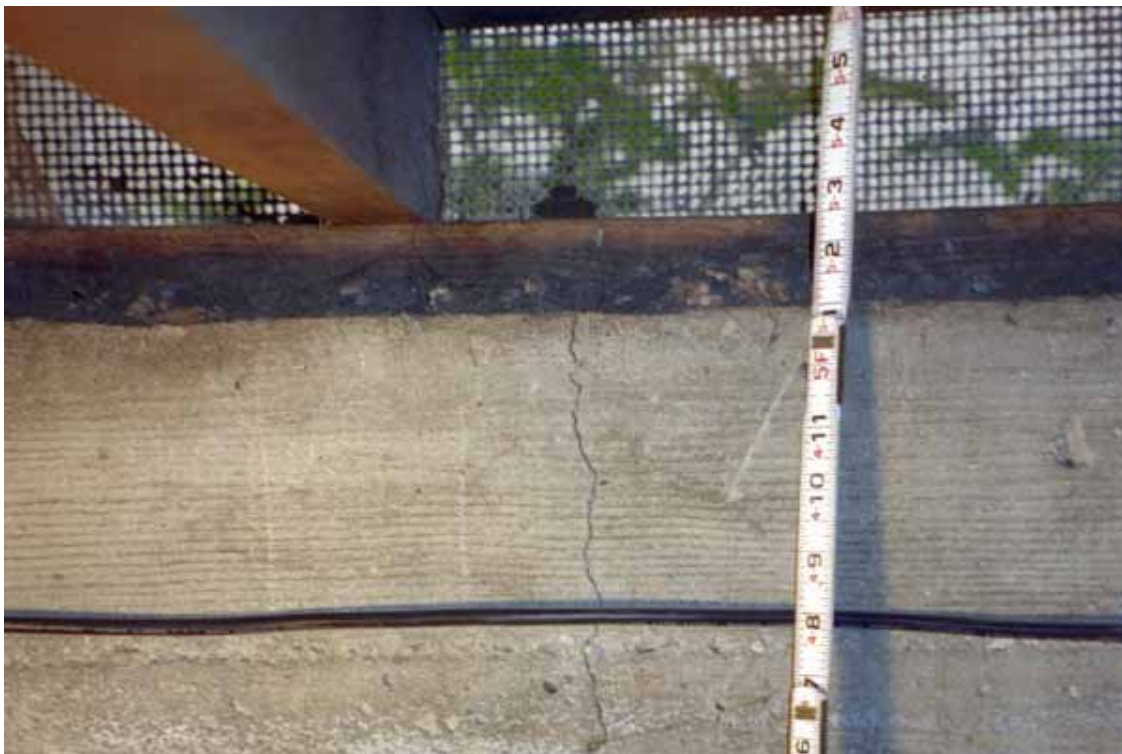
Figure 4.10. Shrinkage crack in a concrete stem wall emanating from an anchor bolt [Exponent].

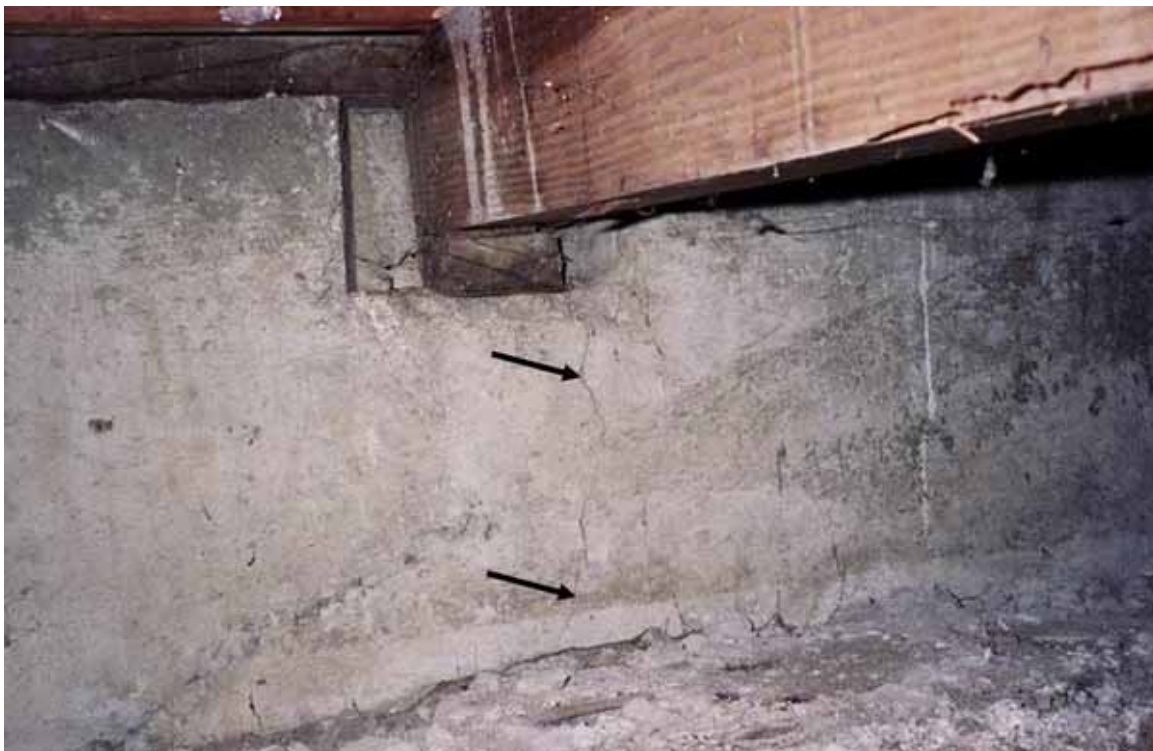
Figure 4.11. Shrinkage crack in a concrete stem wall emanating from a beam pocket [Exponent].

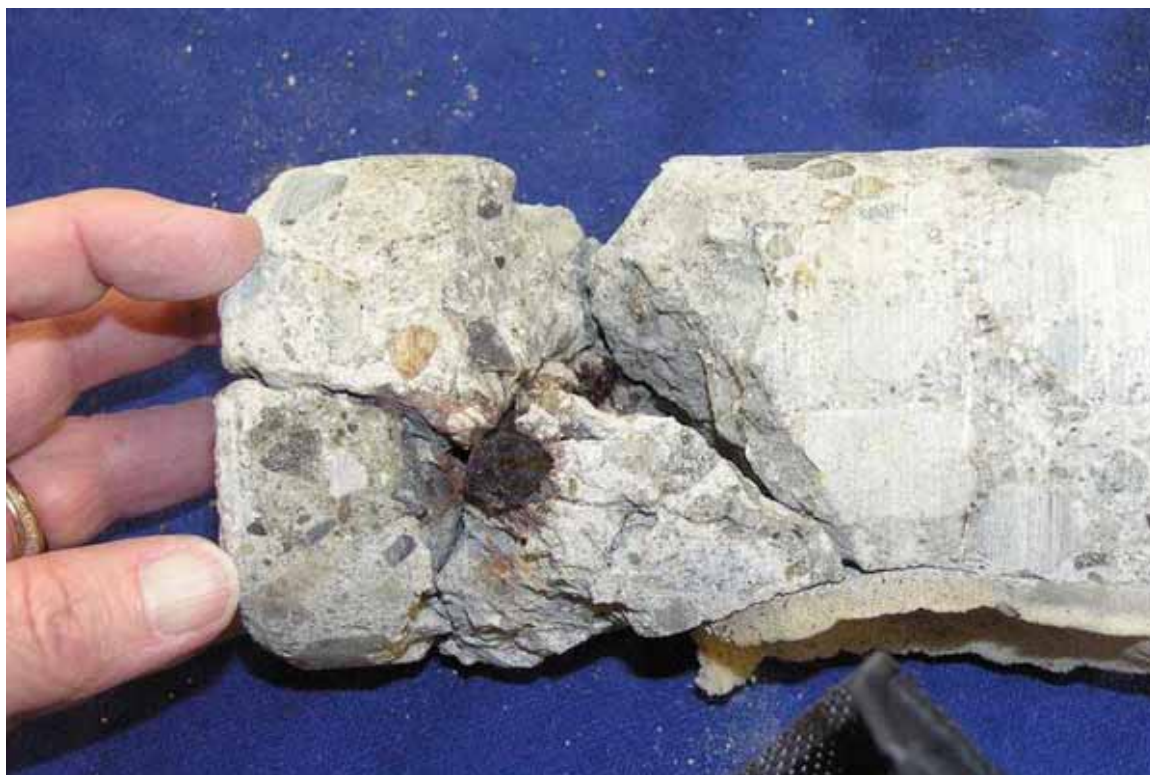
Figure 4.12. Core extracted from concrete stem wall showing cracking caused by swelling pressure generated by corroding reinforcing steel [Exponent].

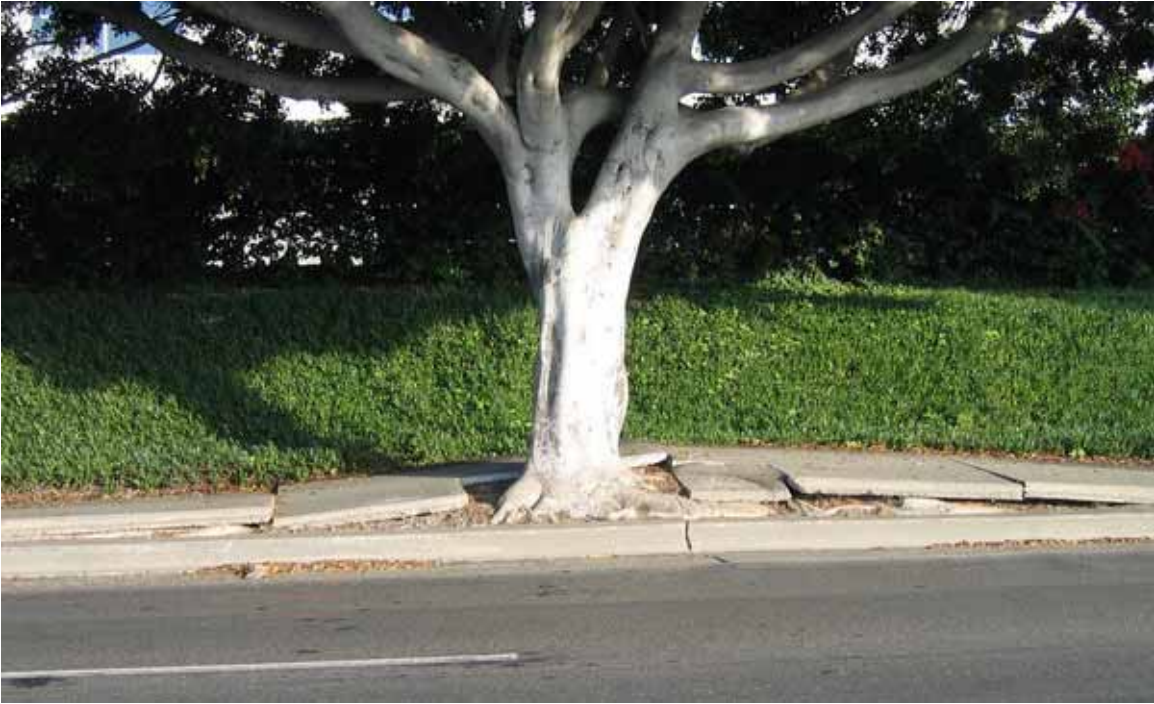
Figure 4.13. Uplift and cracking of concrete sidewalk caused by tree roots [Exponent].

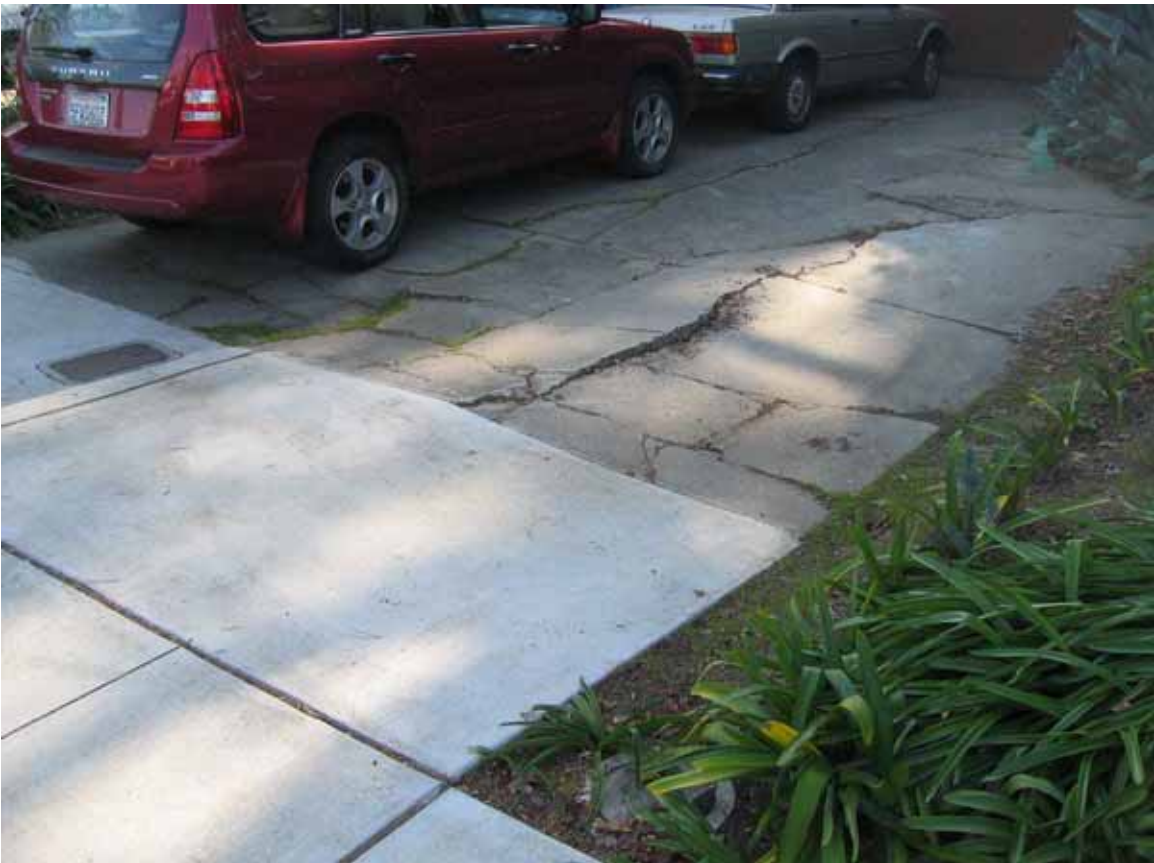
Figure 4.14. Cracking due to vehicle loads on a concrete driveway over soft soil [Exponent].

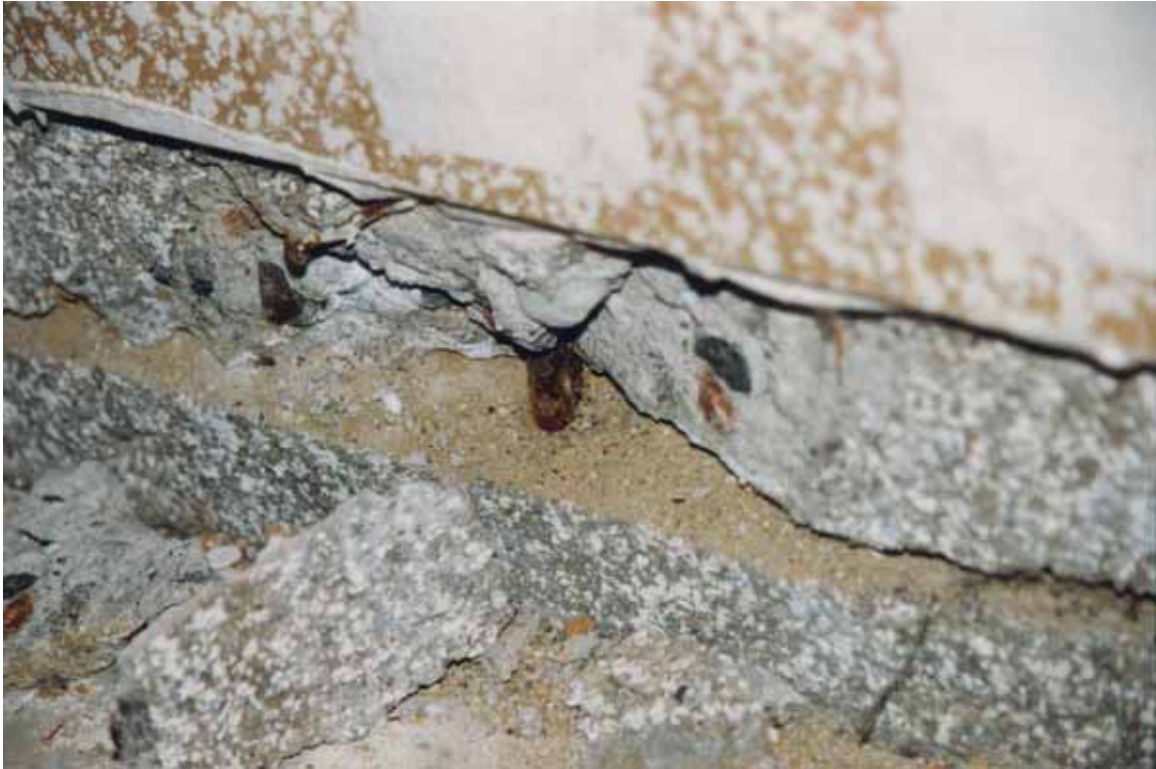
Figure 4.15. Earthquake-induced relative movement at slab/footing interface in two-pour slab-on-grade construction due to sand covering the footing during construction [Exponent].

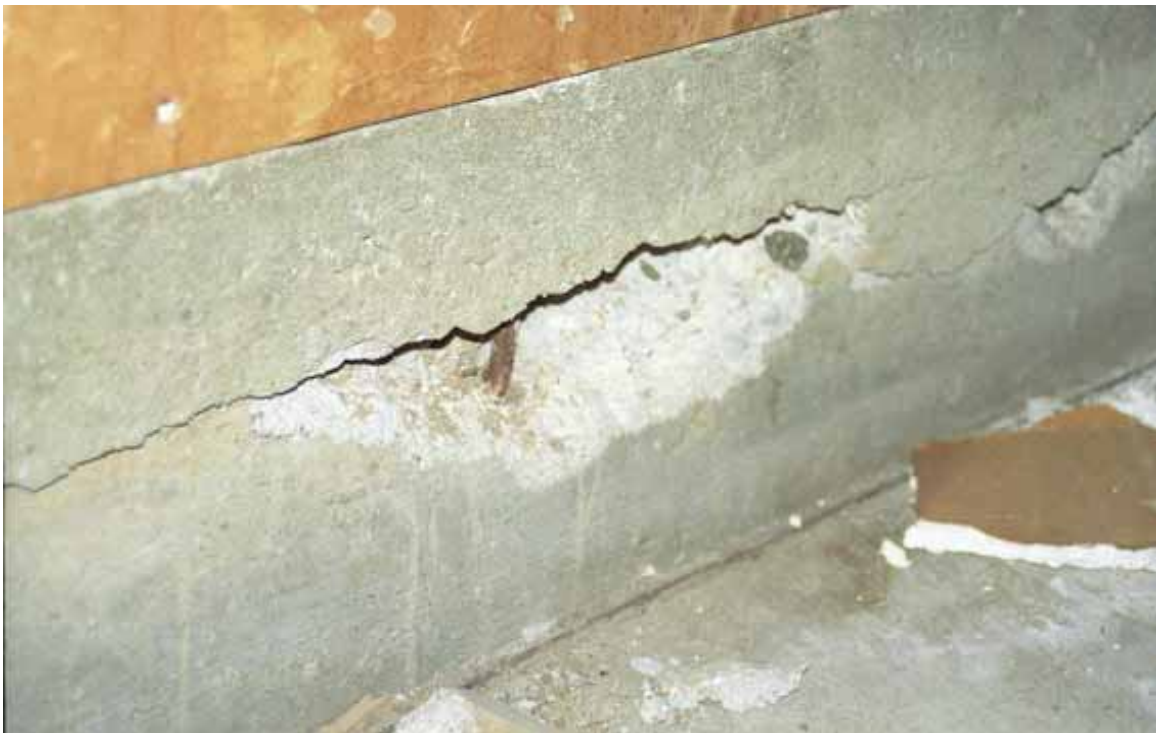
Figure 4.16. Earthquake-induced differential movement and spalling at cold joint between stem wall and slab in two-pour construction [Exponent].
