GENERAL GUIDELINES  
FOR THE ASSESSMENT AND REPAIR  
OF EARTHQUAKE DAMAGE  
IN RESIDENTIAL WOODFRAME BUILDINGS

Consortium of Universities for Research in Earthquake Engineering

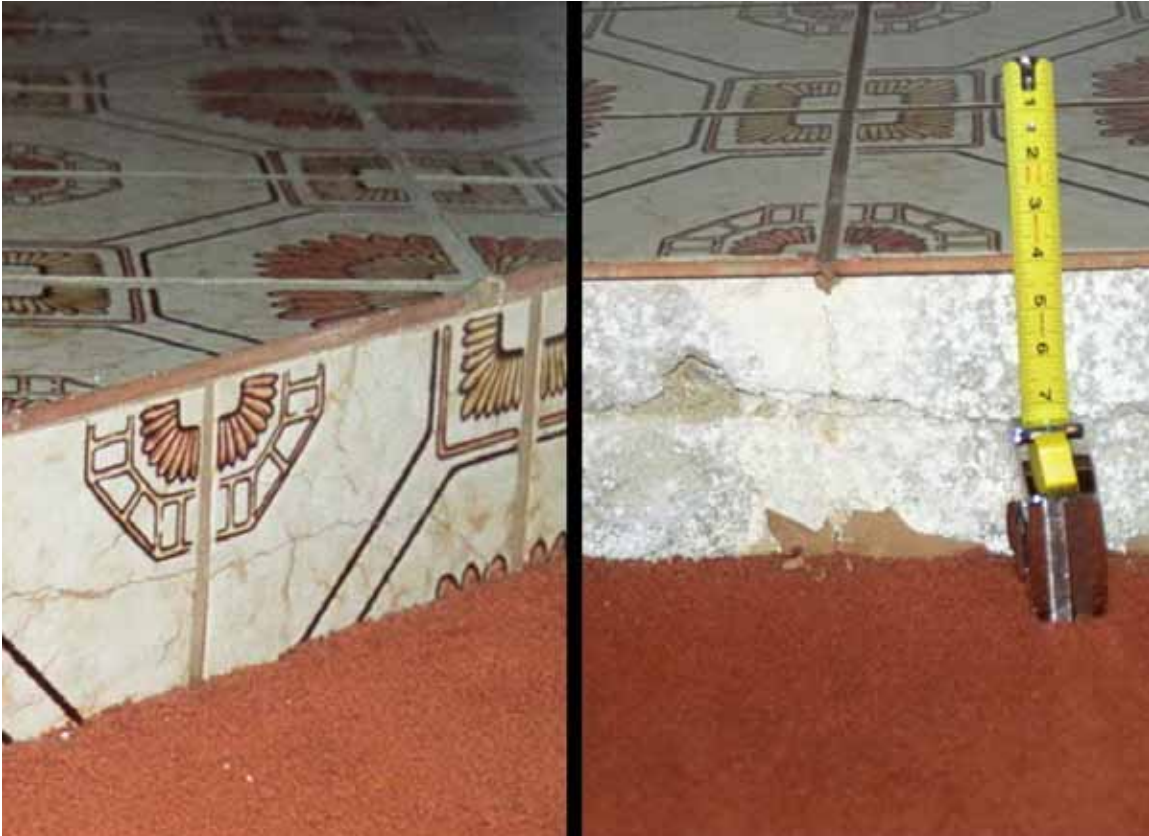
Figure 4.17. Earthquake-induced cracking of ceramic tile spanning the cold joint between the floor slab and the stem wall in a two-pour system [Exponent].

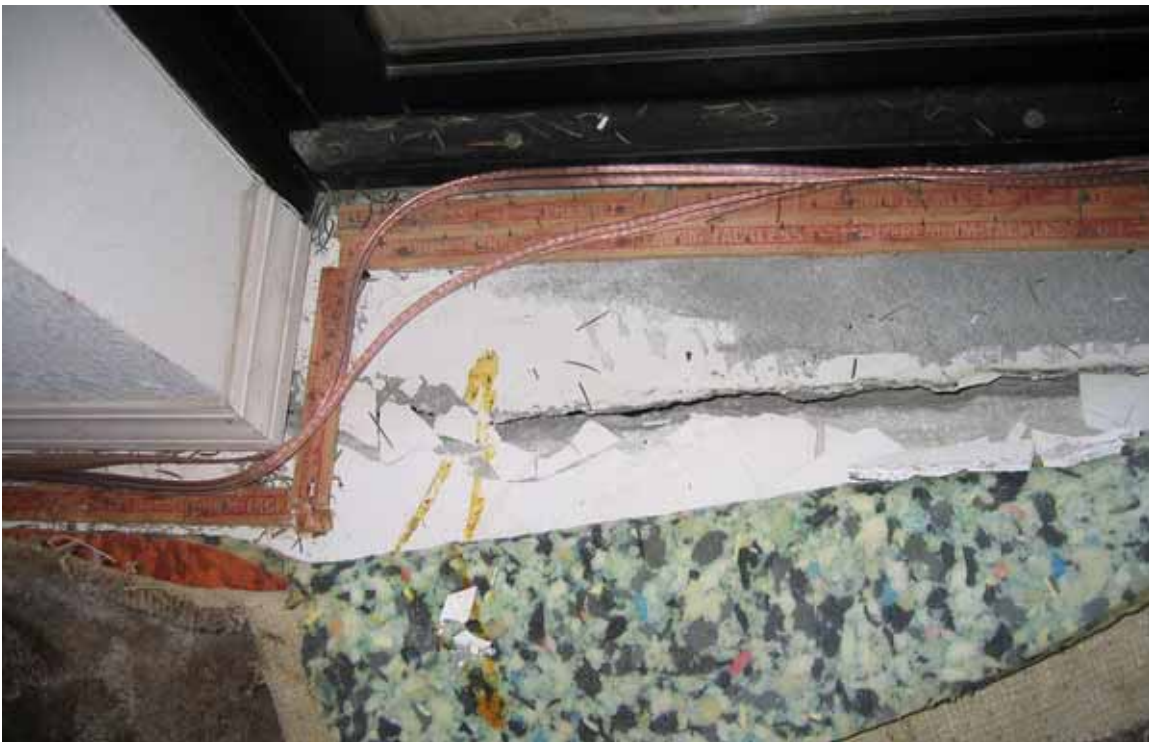
Figure 4.18. Opening of cold joint between floor slab and perimeter footing [Exponent].

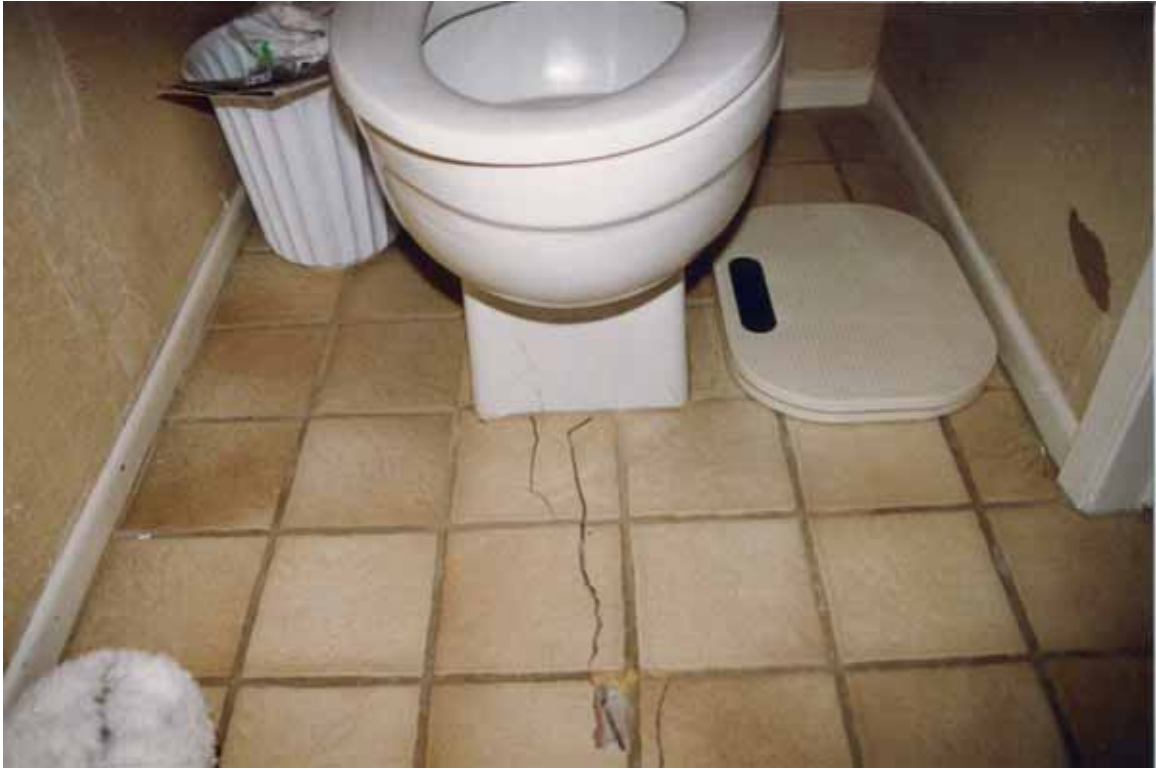
Figure 4.19. Earthquake-induced cracking of ceramic tile on a slab-on-grade [Exponent].

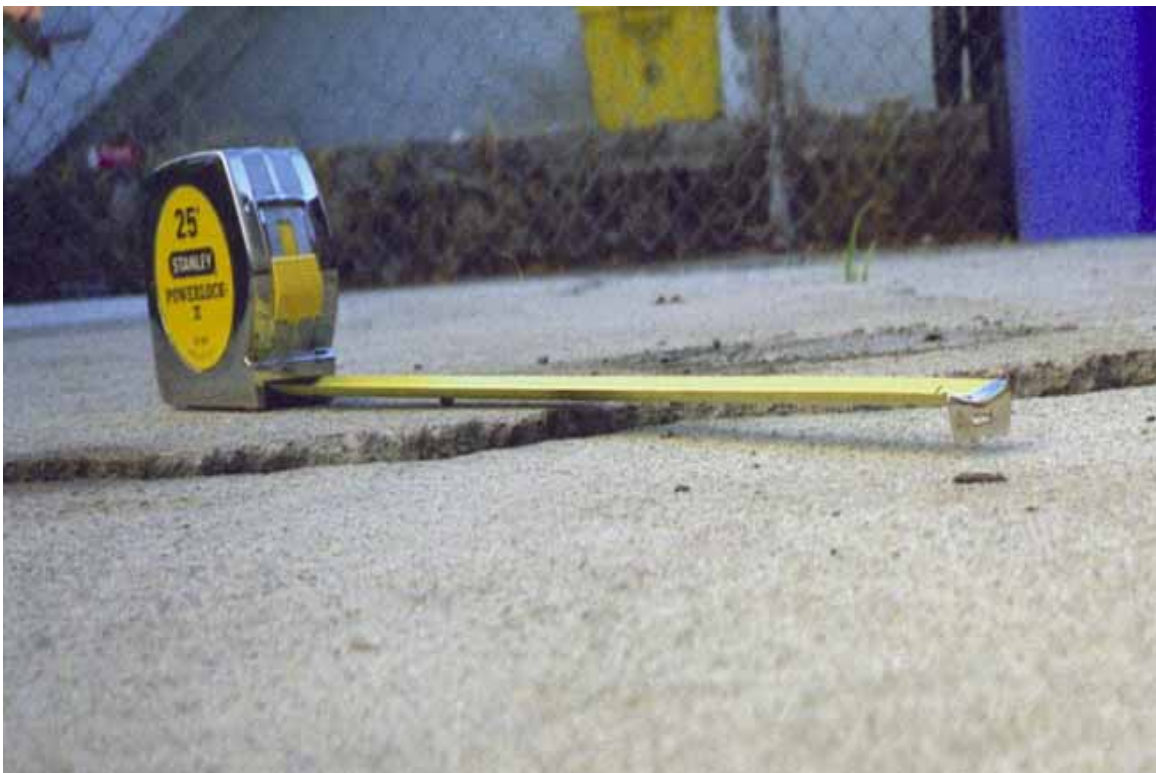
Figure 4.20. Illustration of out-of-plane offset in a concrete slab-on-grade [Exponent].

- Fresh-appearing cracks wider than 1/8 inch or offset by more than 1/16 inch out-of-plane (Figure 4.20) that are in exposed visible areas and had never been noticed before the earthquake.
- Extensive or large cracks (with signs of recent movement) in the foundation far in excess of what would be expected from normal shrinkage and settlement (see Section 4.5).

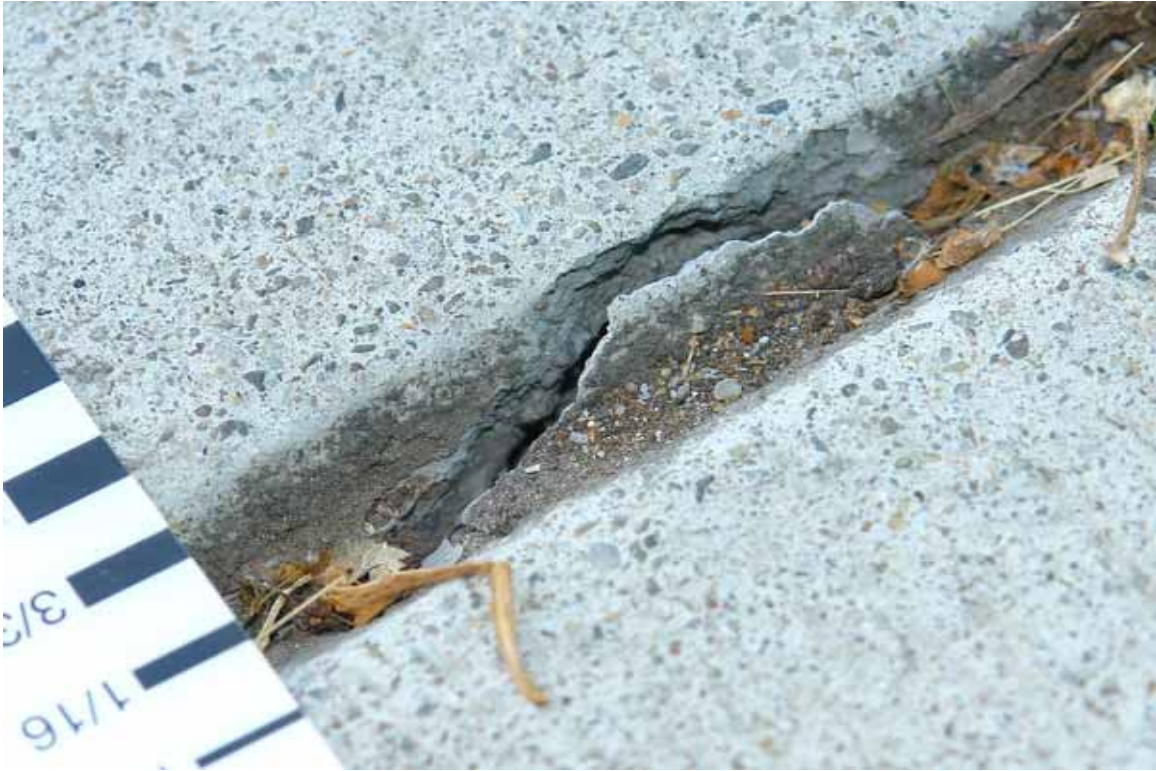
Figure 4.21. Fresh crack in concrete exhibiting sharp edges, crack faces free of contamination and gap clear of debris [Exponent].

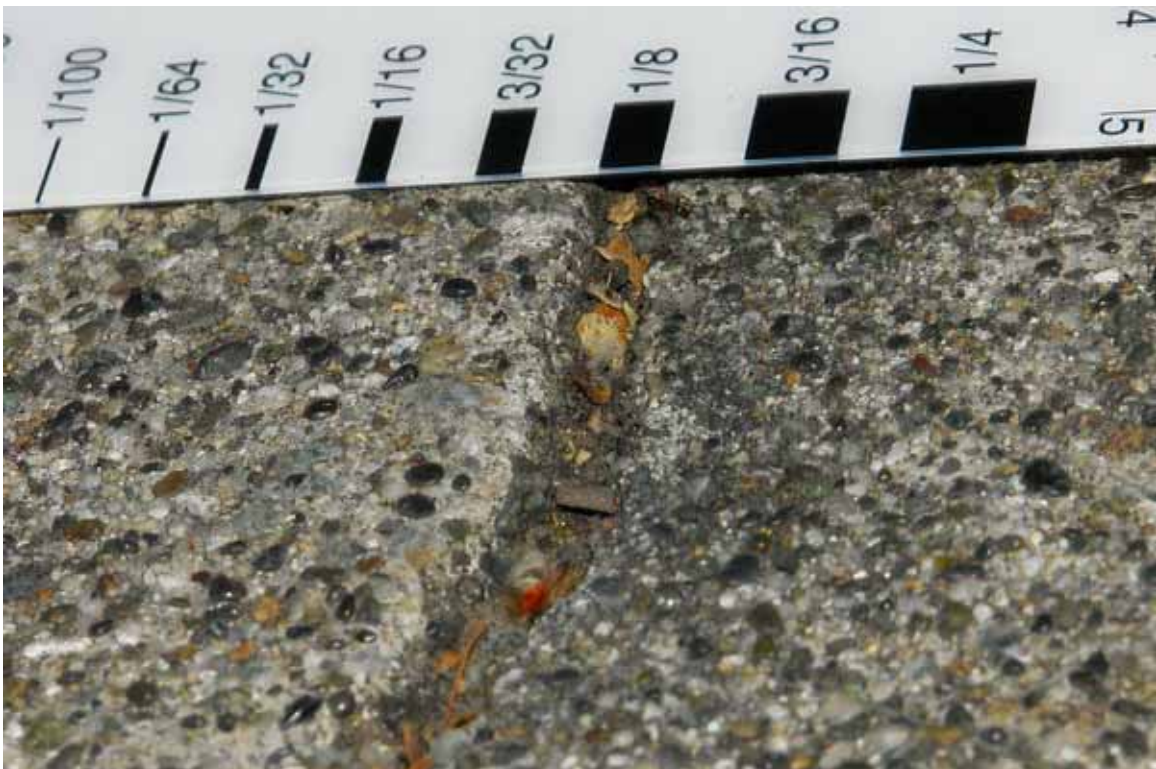
Figure 4.22. Older crack in concrete exhibiting worn and rounded edges [Exponent].

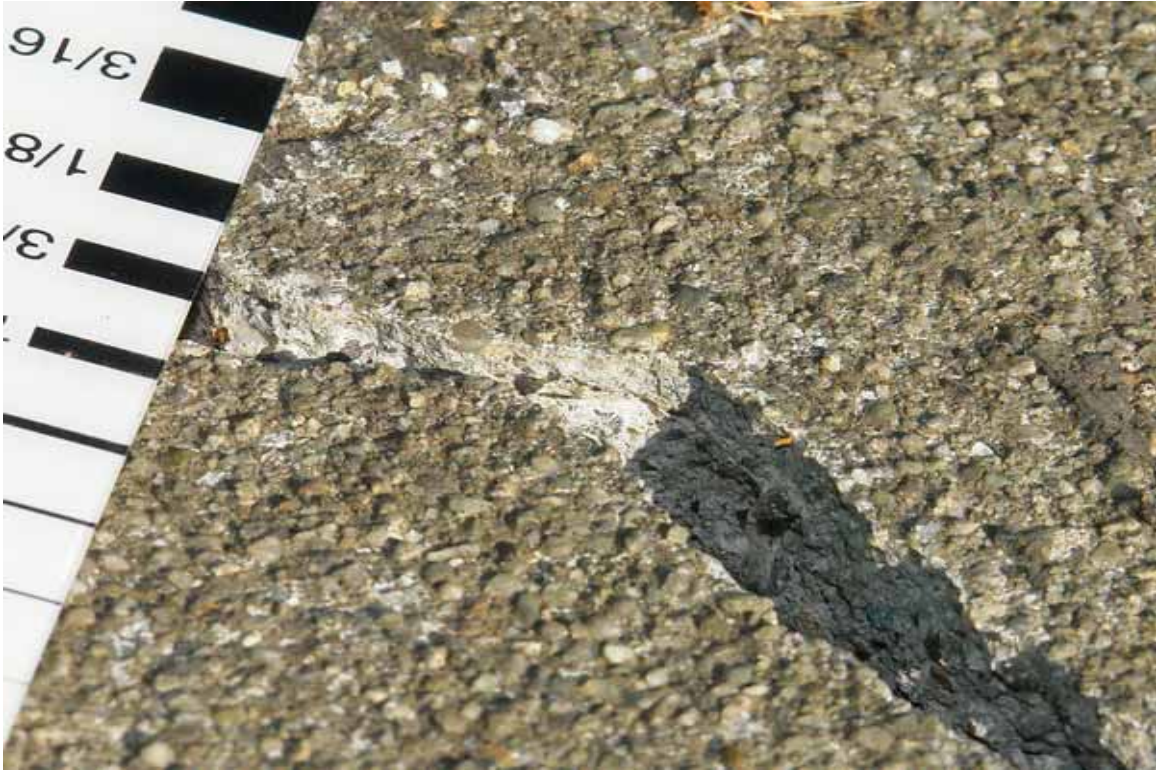
Figure 4.23. Fresh crack in concrete exhibiting lighter color on crack face relative to weathered surface [Exponent].

- Relative color of crack surfaces and exposed surface of the element: A fresh crack surface concrete will typically be a different shade than the exposed, weathered surface as shown in Figure 4.23.

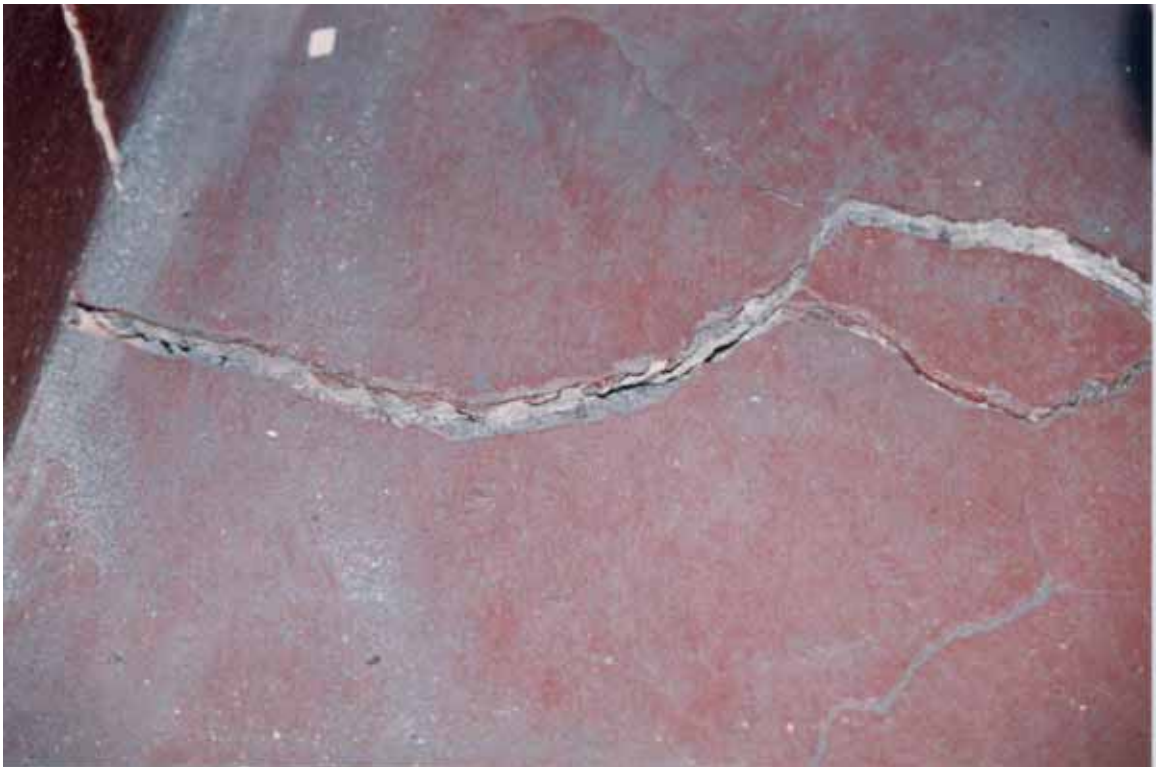
Figure 4.24. Older crack in concrete exhibiting worn and rounded edges contaminated with paint [Exponent].

- Condition of crack surfaces: Fresh cracks exhibit clean fracture surface. Older cracks may exhibit contamination with paint (Figure 4.24), oil, grease, floor covering adhesive (Figure 4.25 and Figure 4.26), sawdust, drywall joint compound (Figure 4.27), or other foreign matter that may have accumulated since the crack initially developed.

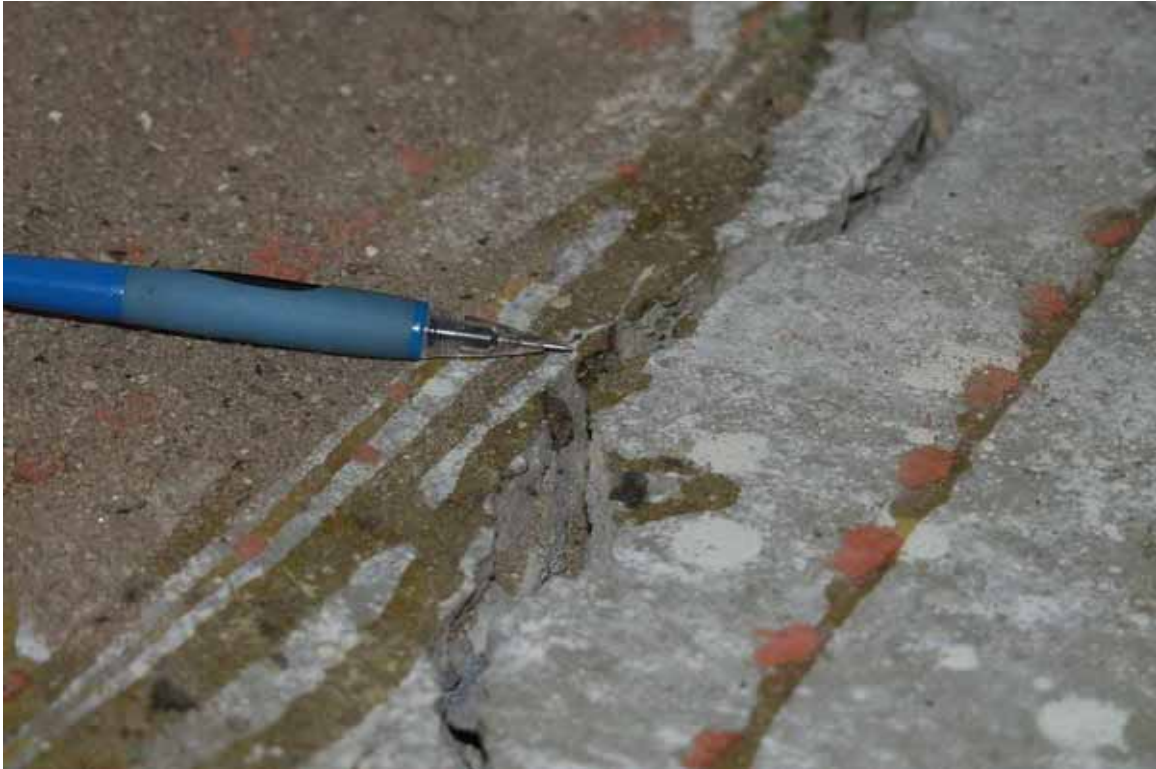
Figure 4.25. Older crack in concrete floor slab contaminated with carpet pad adhesive [Exponent].

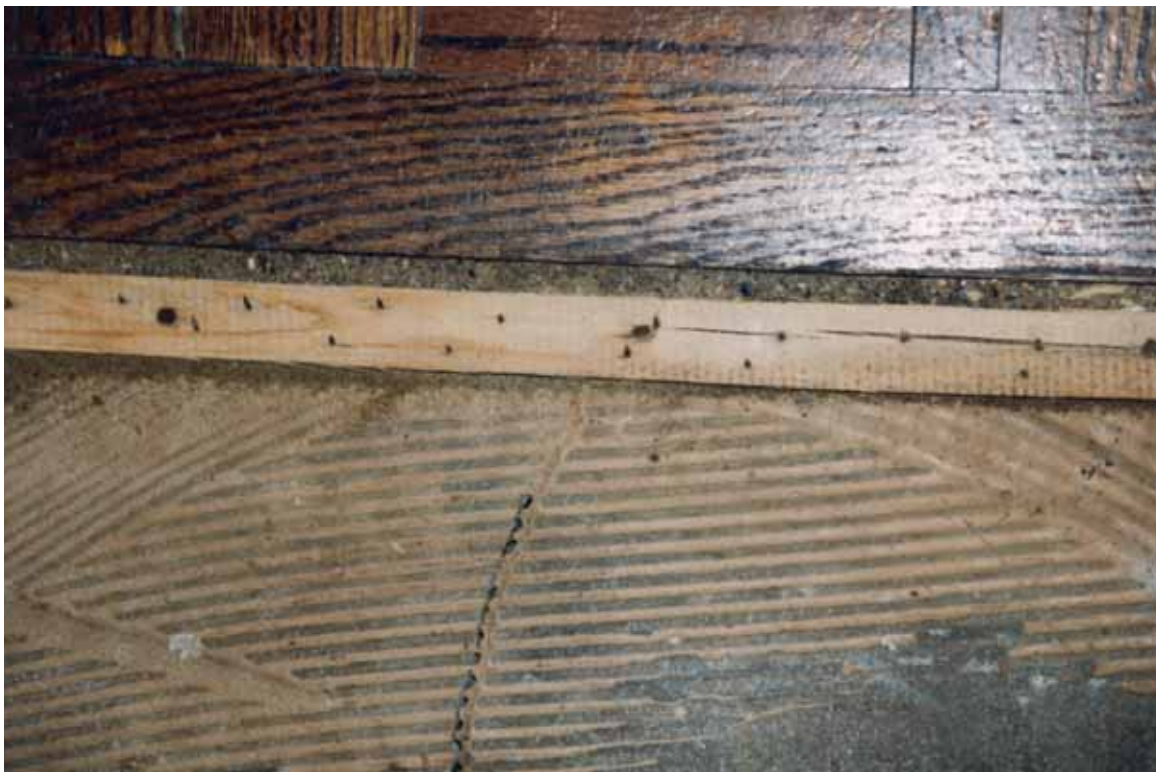
Figure 4.26. Parquet flooring adhesive filling crack in concrete slab [Exponent].

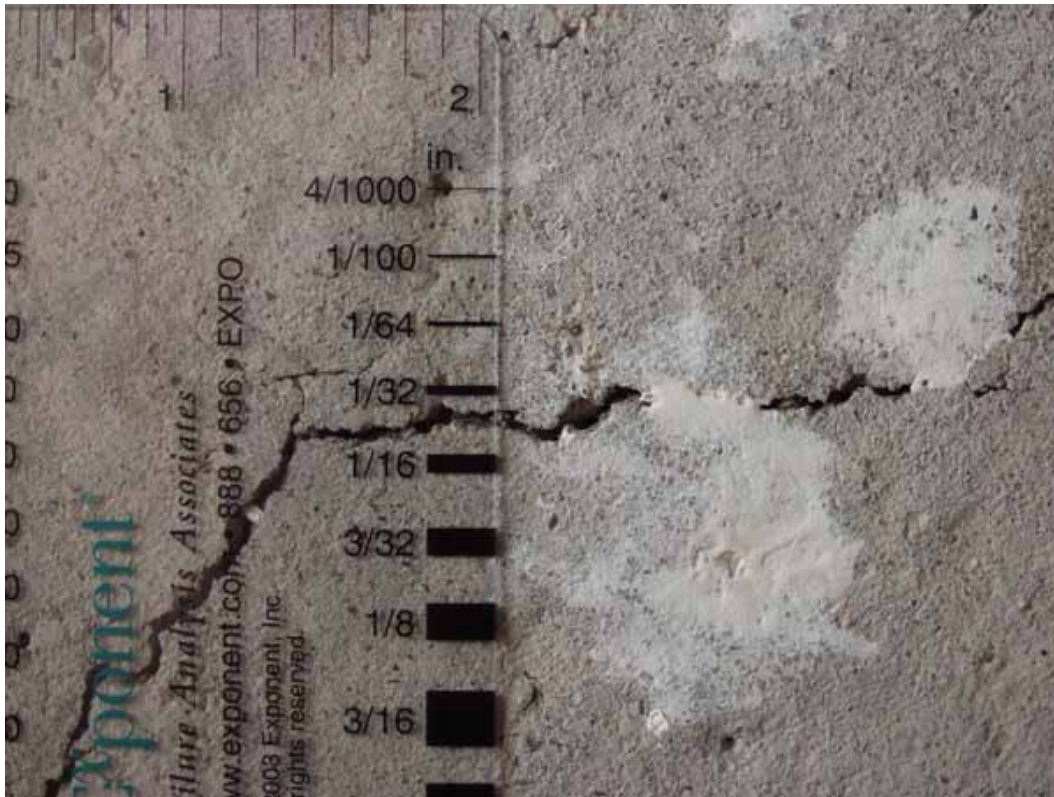
Figure 4.27. Dabs of drywall joint compound within shrinkage crack in concrete slab-on-grade floor [Exponent].

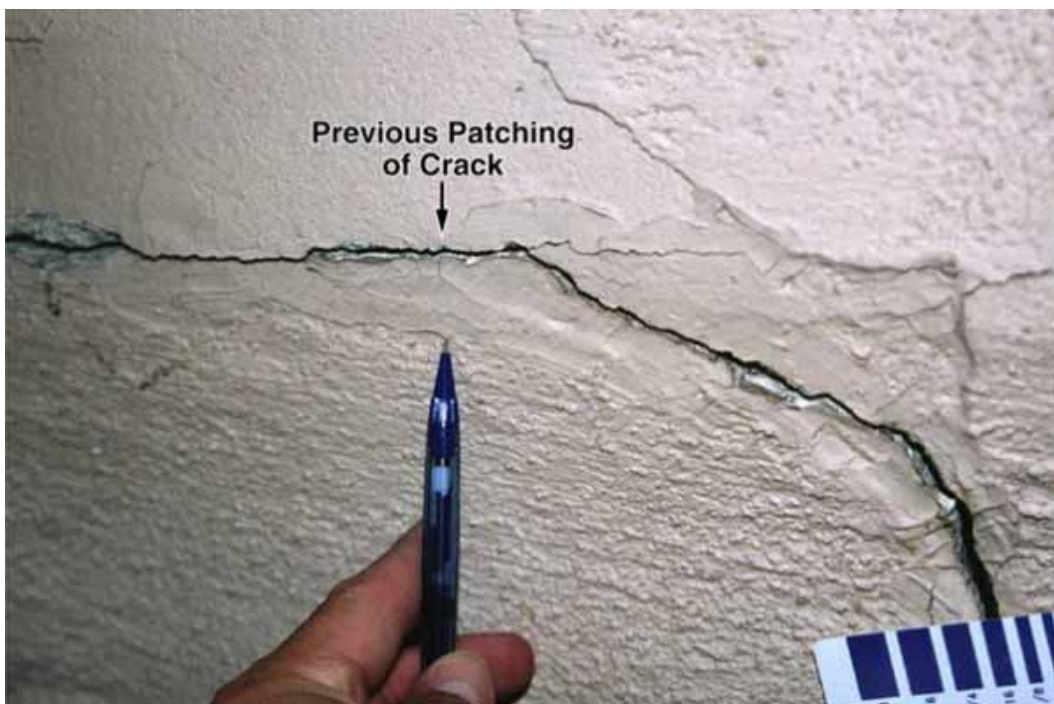
Figure 4.28. Older crack in foundation stem wall exhibiting prior patching and painting [Exponent].

- Grout, caulk, or other patching or repair material in the crack as shown in Figure 4.28 through Figure 4.30
- Leveling material adjacent to or spanning the crack as shown in Figure 4.31.

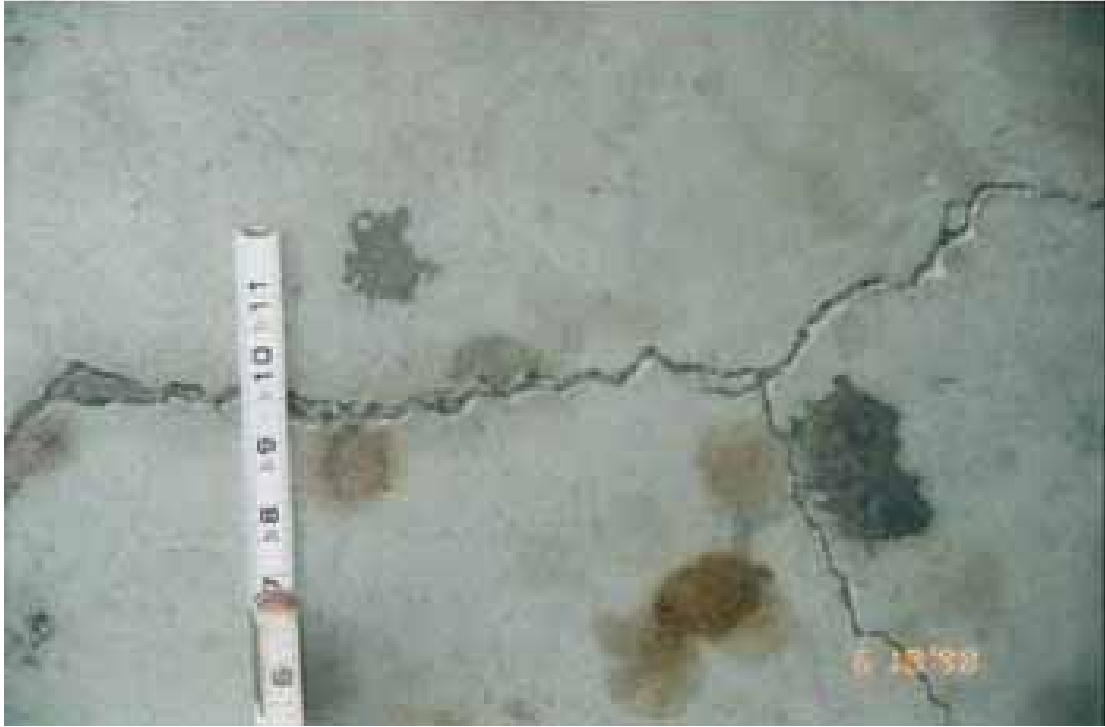
Figure 4.29. Mortar within garage slab-on-grade crack indicates previous patching of crack (not earthquake damage) [Exponent].

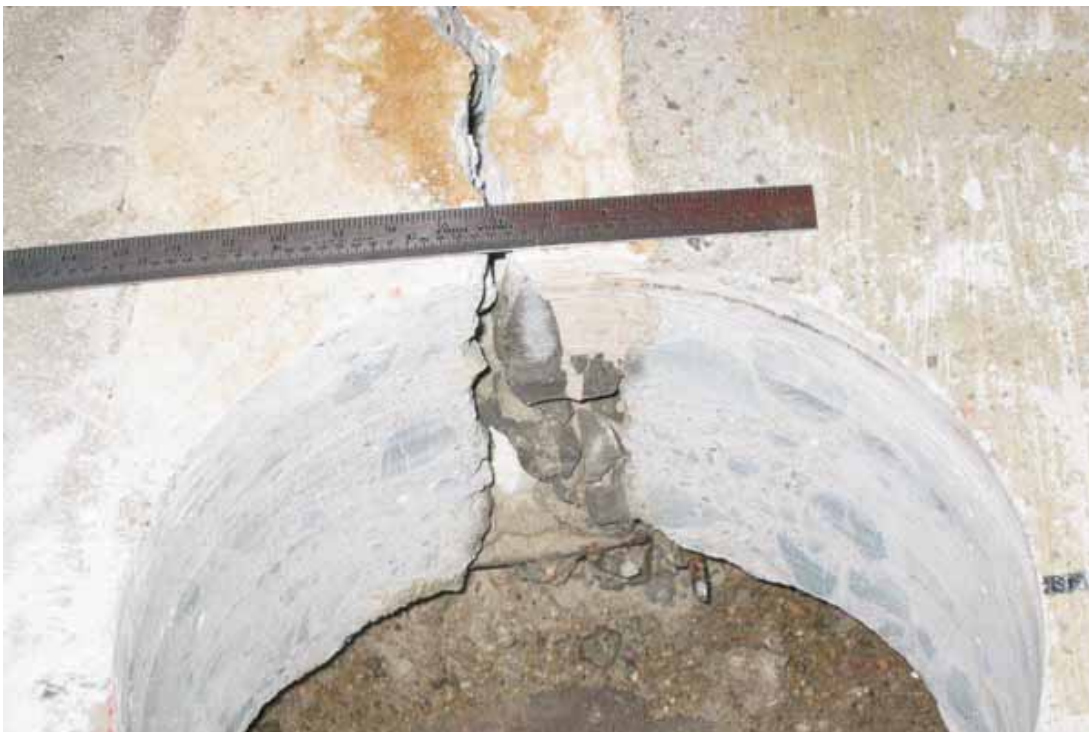
Figure 4.30. Crack in concrete slab-on-grade floor that exhibits two prior generations of patching as well as opening since last patching (not earthquake damage) [Exponent].

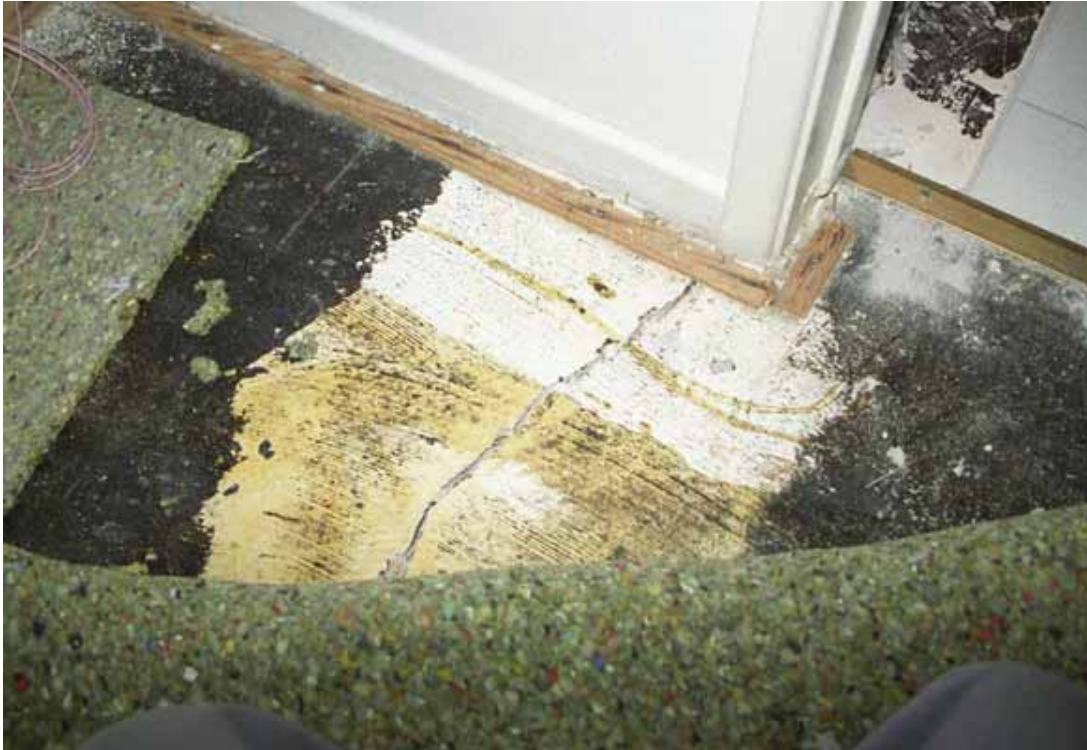
Figure 4.31. White leveling compound spread across existing crack at time of carpet installation [Exponent].

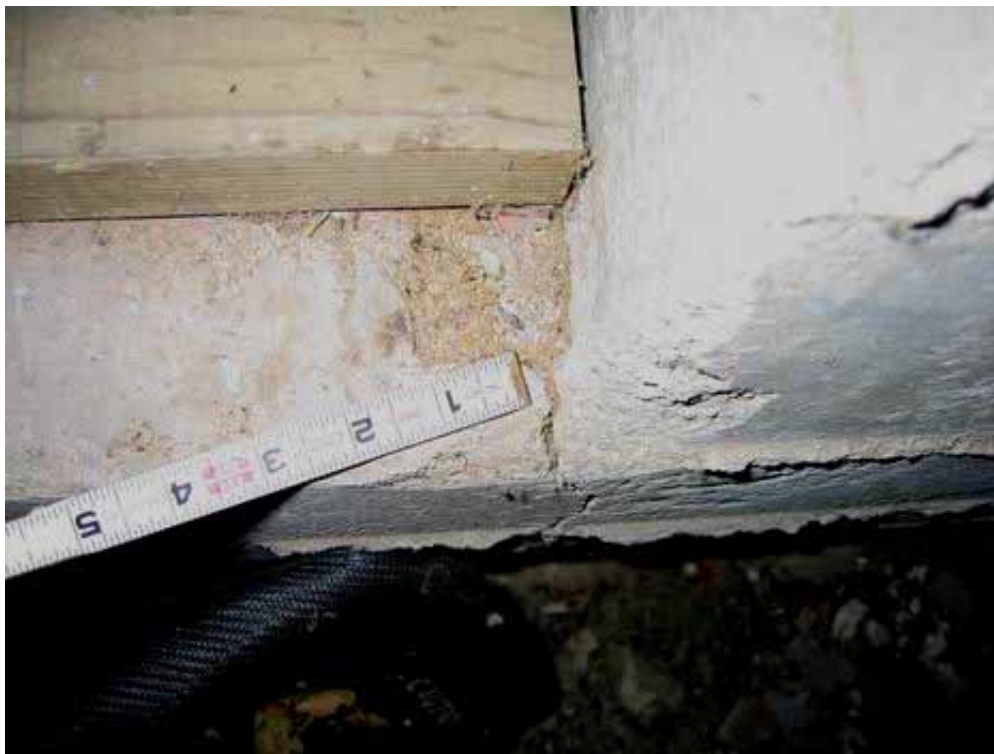
Figure 4.32. Debris (sawdust) from original construction in foundation crack observed shortly following the 2003 San Simeon Earthquake (not earthquake damage) [Exponent].

- Dirt, dust, debris, or vegetation in the crack as shown in Figure 4.32 through Figure 4.34.
- Where slabs are covered with an adhered floor finish, setting mortar or adhesive may extend into the crack (Figure 4.36), or the bottom side of finish material that spanned a pre-existing crack may show an impression of the crack in the pattern of adhesive trowel marks or setting mortar as shown in Figure 4.36.

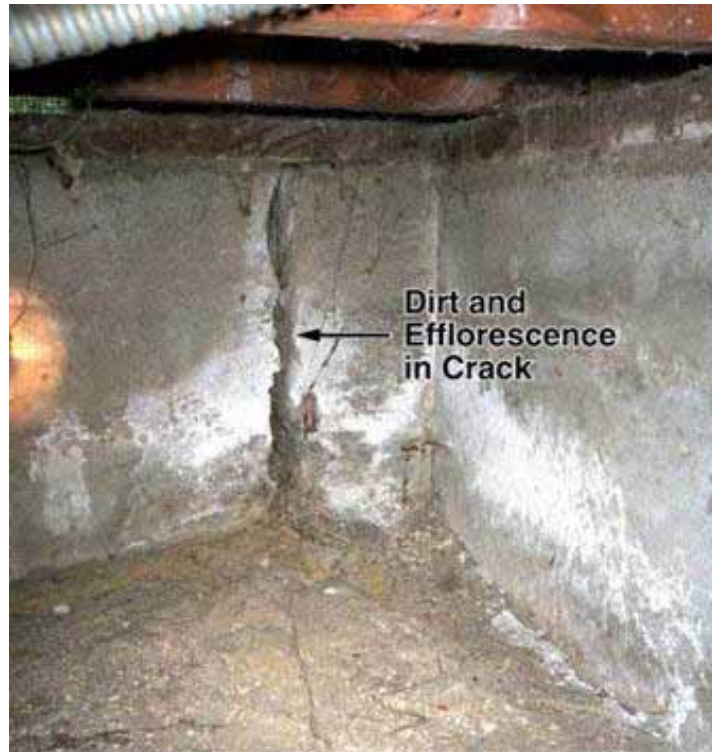
Figure 4.33. Dirt and efflorescence indicates age of foundation wall crack is not recent (not earthquake damage) [Exponent].

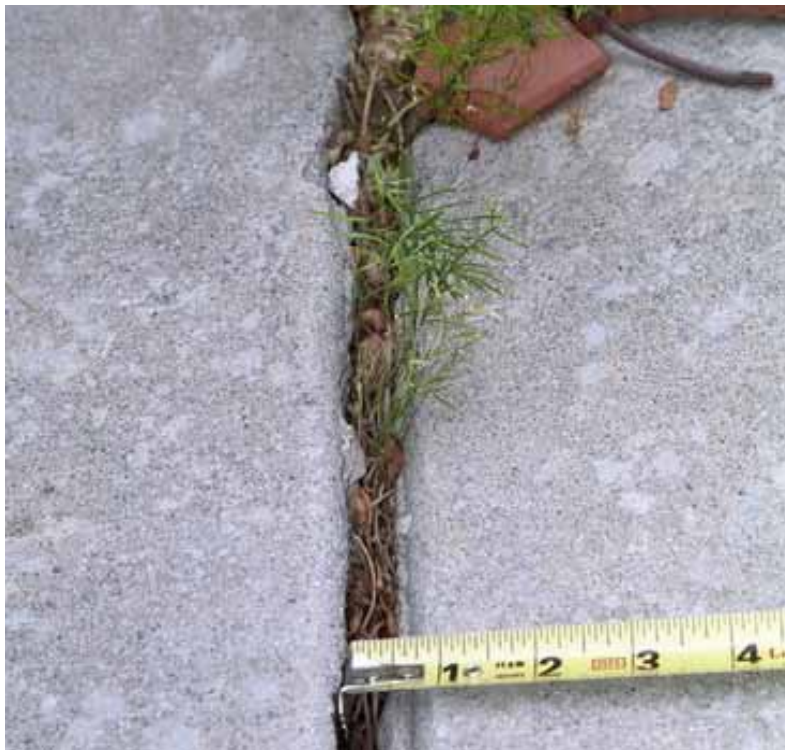
Figure 4.34. Debris and vegetation in older crack (not earthquake damage) [Exponent].

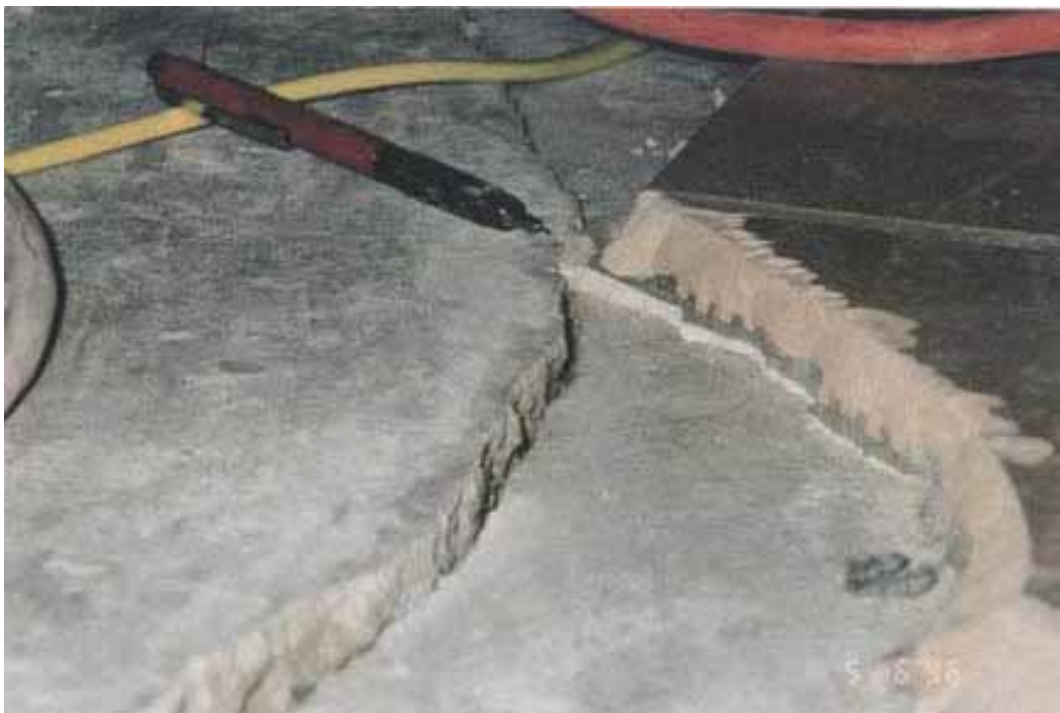
Figure 4.35. Grout completely filling slab-on-grade crack (indicated by pen) indicates that slab crack was present at the time of the tile installation and has not experienced movement since tile installation (not earthquake damage) [Exponent].

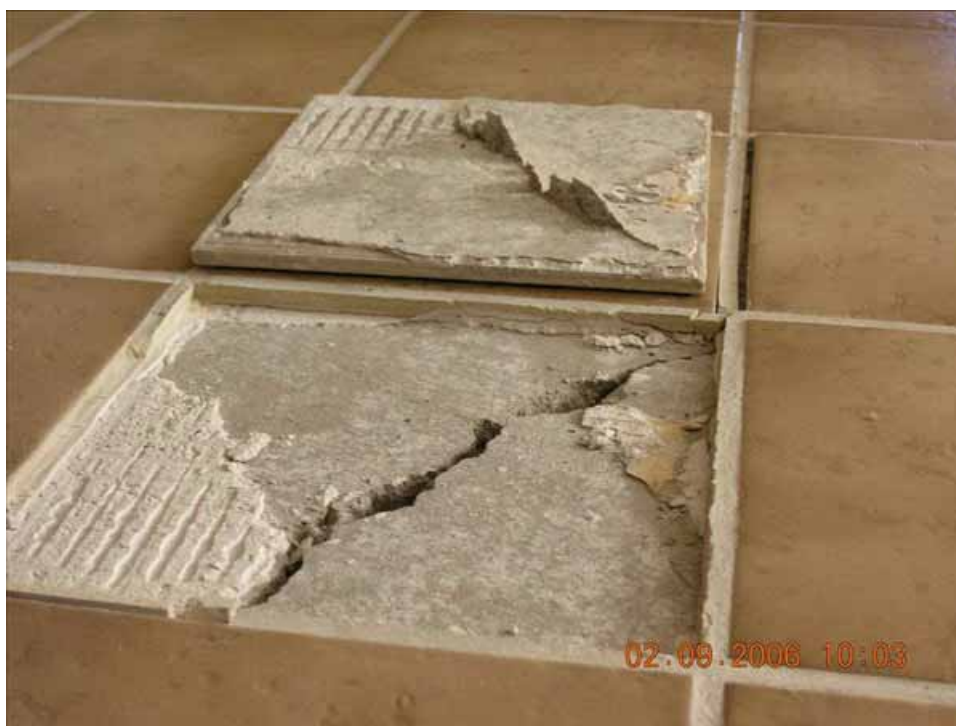
Figure 4.36. Setting mortar that had flowed into an existing slab crack that remained bonded to the backside of a ceramic tile when the tile was removed, a clear indication that the concrete slab was cracked when the tile was installed [Exponent].

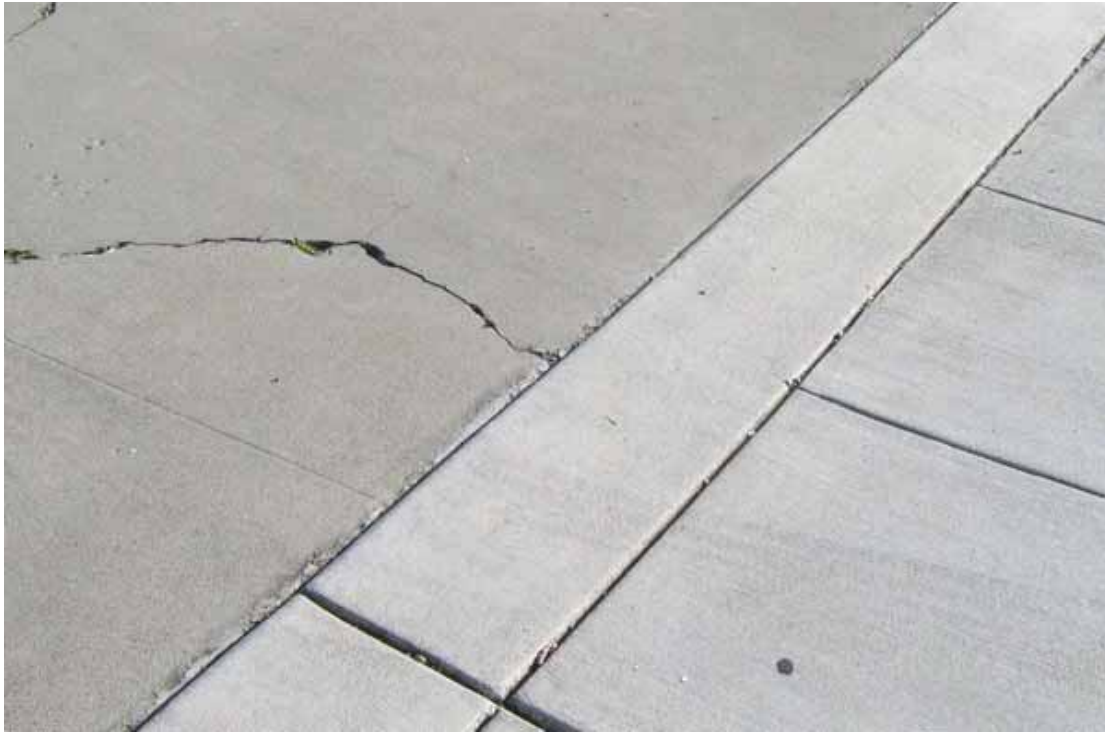
Figure 4.37. Termination of crack in older concrete (upper left) where it abuts newer concrete (lower right) indicates that crack existed prior to the installation of the newer concrete [Exponent].

- Examination of the interface where two vintages of concrete meet can indicate the relative age of cracks. Recent cracks will extend through both vintages of concrete, while older cracks will be present only in the older vintage of concrete as shown in Figure 4.37.

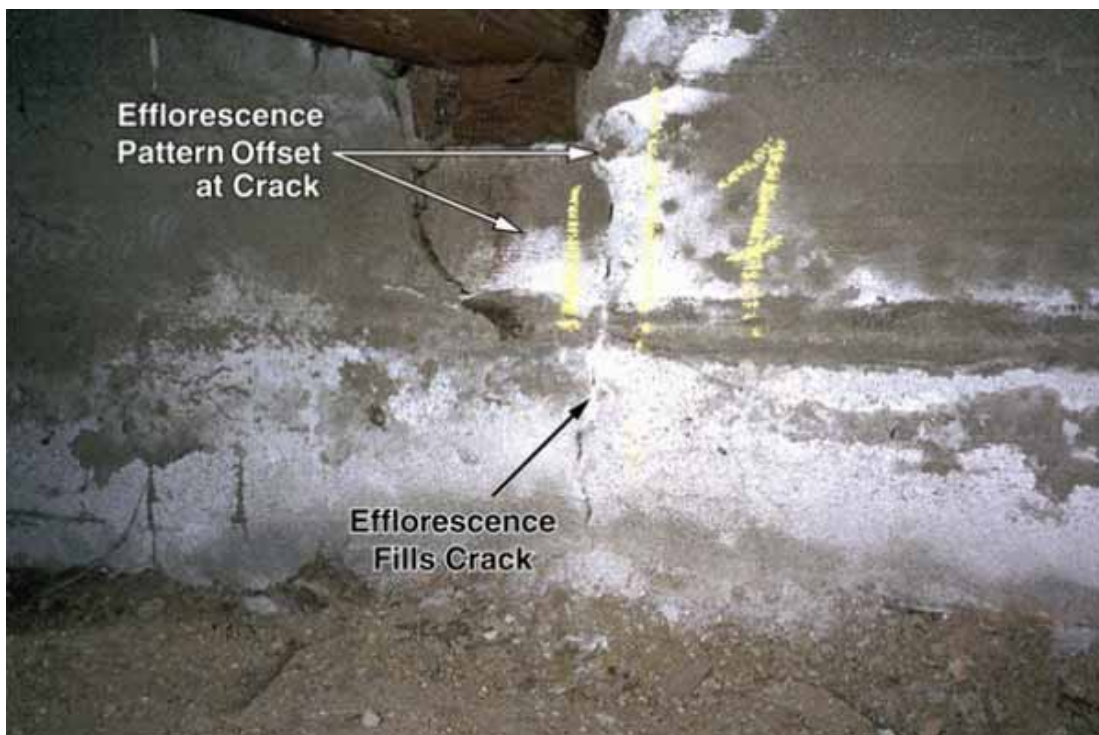
Figure 4.38. Pattern of efflorescence around crack in stem wall indicates that crack is not of recent origin [Exponent].

- If the pattern of a stain or efflorescence<sup>43</sup> is markedly different on two sides of a crack, then the crack was present before the stain developed as shown in Figure 4.38.
- Typical shrinkage crack patterns for concrete slabs-on-grade were described previously. In addition, concealed control joints (formed with “zip strips”) as shown in Figure 4.39 and construction joints associated with additions or modifications look like very straight shrinkage cracks. A very straight shrinkage crack can also indicate where slab reinforcing was not properly lapped or was intentionally separated.

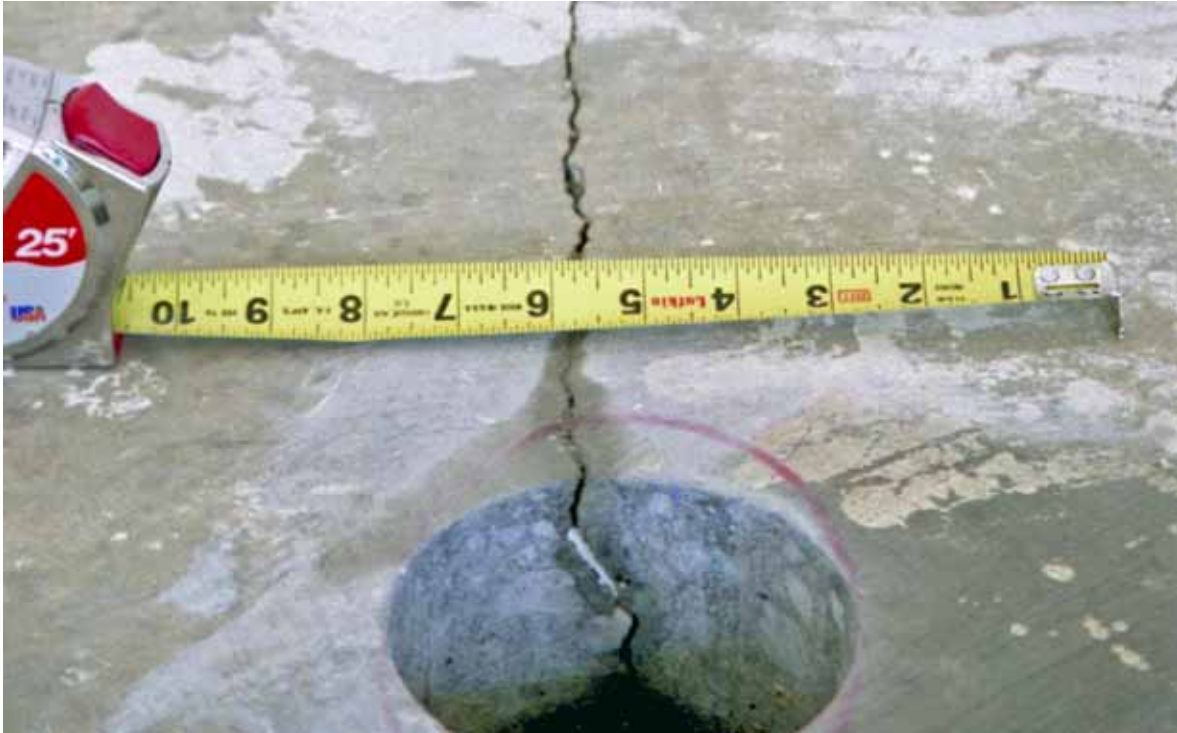
Figure 4.39. Linear shrinkage crack in concrete floor slab at location of a concealed control joint created by a “zip strip” [Exponent].

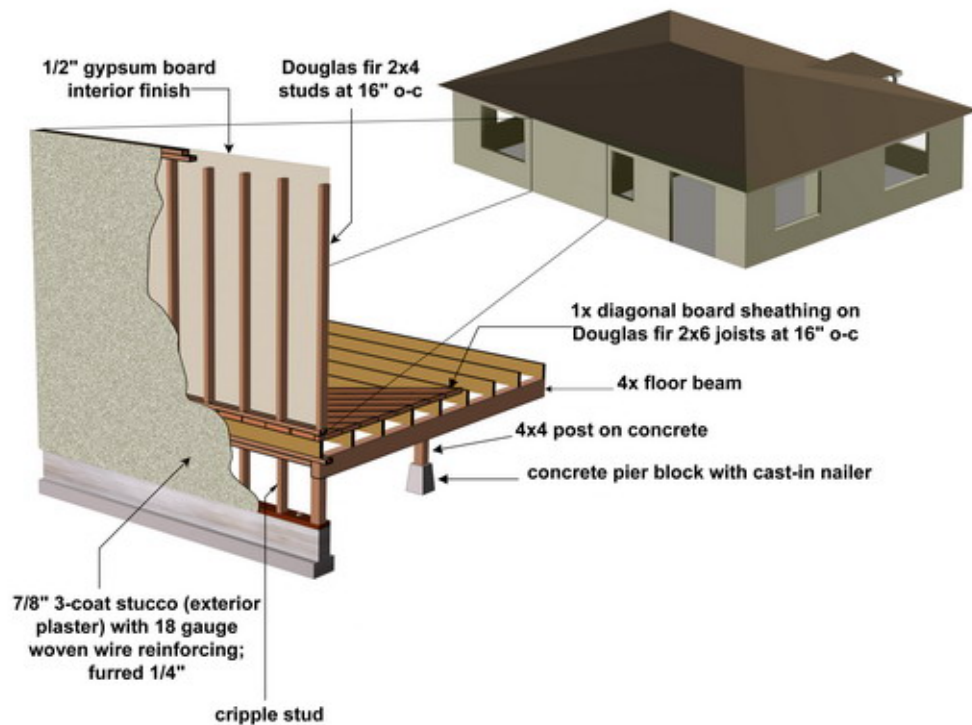
Figure 5.1. Typical wall construction for older single-story houses in California – sheathing materials may vary [CUREE].

The overwhelming majority of California houses have walls of conventional wood stud framing consisting of 2×4 vertical studs (which actually measure 1-1/2 inch by 3-1/2 inch in modern construction) spaced at 16 inches with structural sheathing or a nonstructural finish applied to each face, as illustrated in Figure 5.1 and Figure 5.2. The framing typically includes diagonal bracing (let-in wood bracing or steel straps) or blocking (cut-in bracing) beneath the sheathing. Newer houses, especially two-story houses, can be expected to have plywood or OSB sheathing beneath a finish of stucco, siding, or stone veneer. Where present, plywood or OSB provides the structural bracing to resist lateral loads and the stucco and drywall/plaster serve only as nonstructural finishes. Accordingly, repairs to the finishes may be nonstructural. However, it should generally be assumed that all wall surface materials serve a structural function until determined otherwise by a structures specialist.

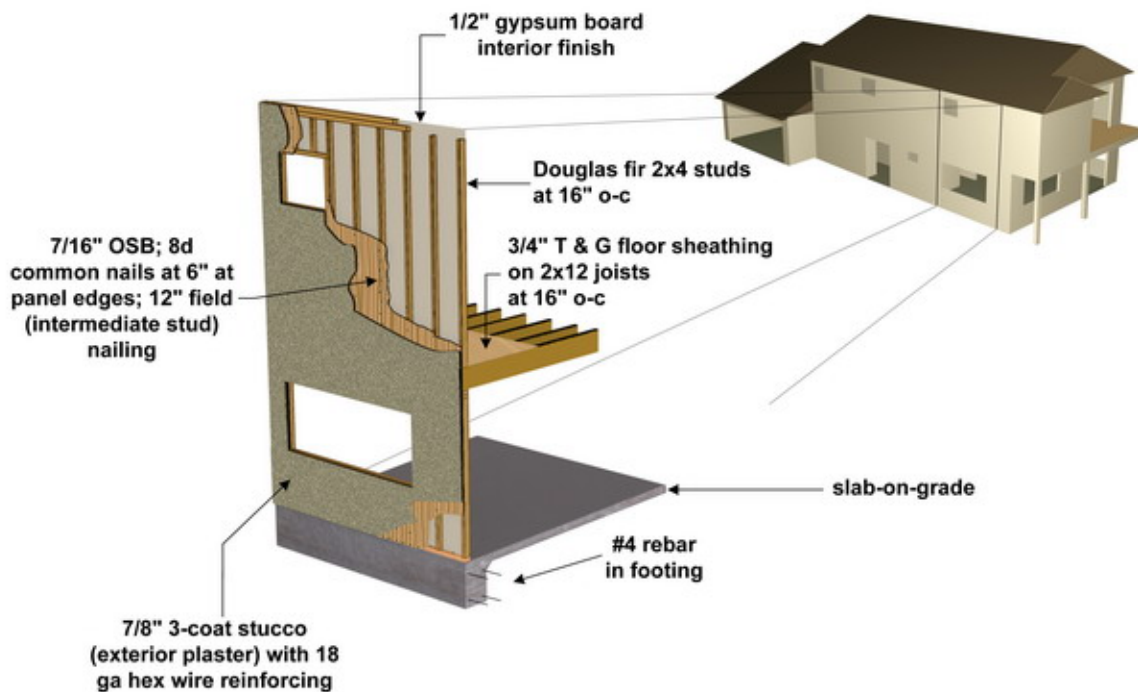
Figure 5.2. Typical wall construction for more modern two-story houses in California – sheathing materials may vary [CUREE].

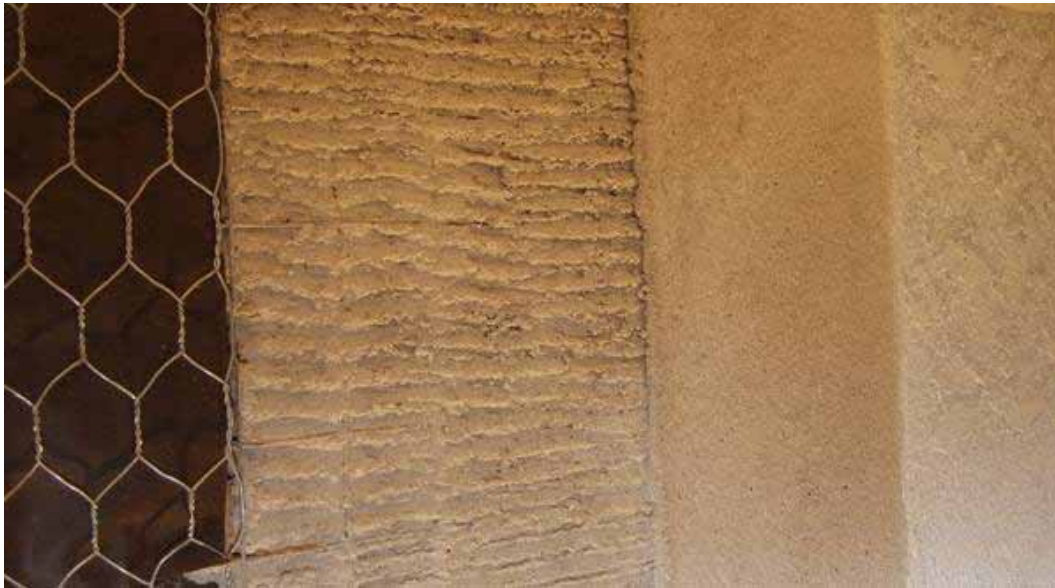
Figure 5.3. Mock-up of typical three-coat stucco showing building paper, wire lath, scratch coat, brown coat, and finish or color coat [Exponent].

Conventional stucco is typically a 7/8-inch thick layer of Portland cement plaster reinforced with wire mesh that is sprayed or troweled onto the wall in three layers and cures to a hard, durable finish, as illustrated in Figure 5.3. The three layers are termed scratch, brown and finish or color coat. Stucco may be applied to open framing or over wood sheathing. Where applied to open framing, regularly spaced line wire is stretched across the framing to provide temporary support for the building paper during the application of the scratch coat of stucco. Wire mesh nailed or stapled to the wall framing or sheathing provides both reinforcement of the cement plaster and attachment of the stucco to the building.
