GENERAL GUIDELINES  
FOR THE ASSESSMENT AND REPAIR  
OF EARTHQUAKE DAMAGE  
IN RESIDENTIAL WOODFRAME BUILDINGS

Consortium of Universities for Research in Earthquake Engineering

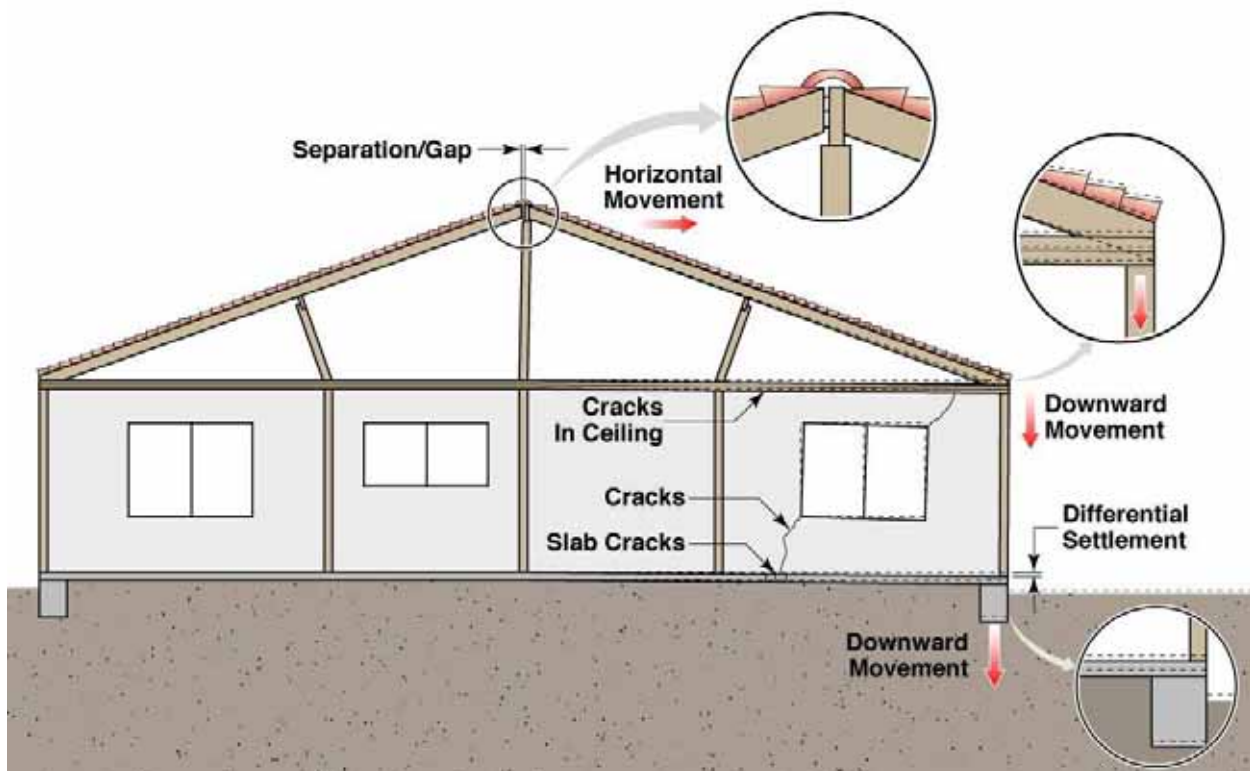
Figure 5.4. Illustration of common effects of differential settlement [Exponent].

in Figure 5.4. The upper end of the crack will point toward the portion of the building that is down relative to that portion in the direction of the bottom end of the crack. The cracking will also be concentrated above the areas of greatest differential foundation movement.

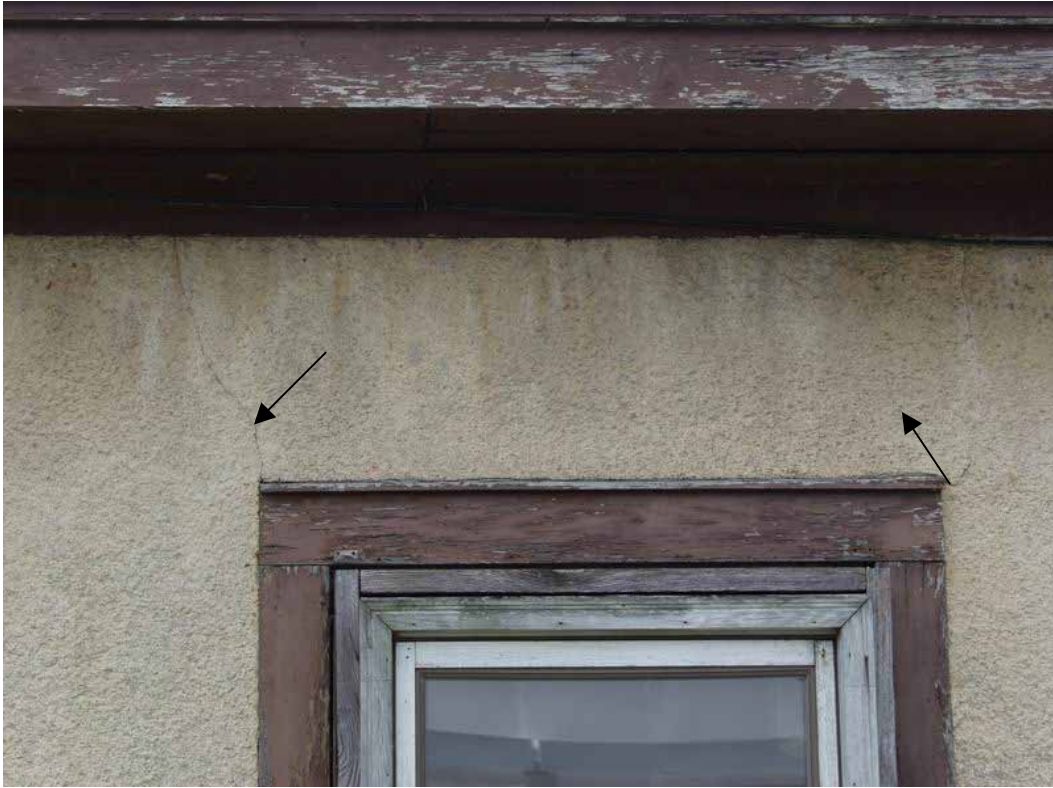
Figure 5.5. Diagonal shrinkage cracks extending from the corners of a wall opening in stucco (not earthquake damage) [Exponent].

- Diagonal cracks extending from the corners of door and window openings as shown in Figure 5.5. Where openings are close together, cracks will tend to extend from the corner of one opening to the next, rather than extending diagonally.

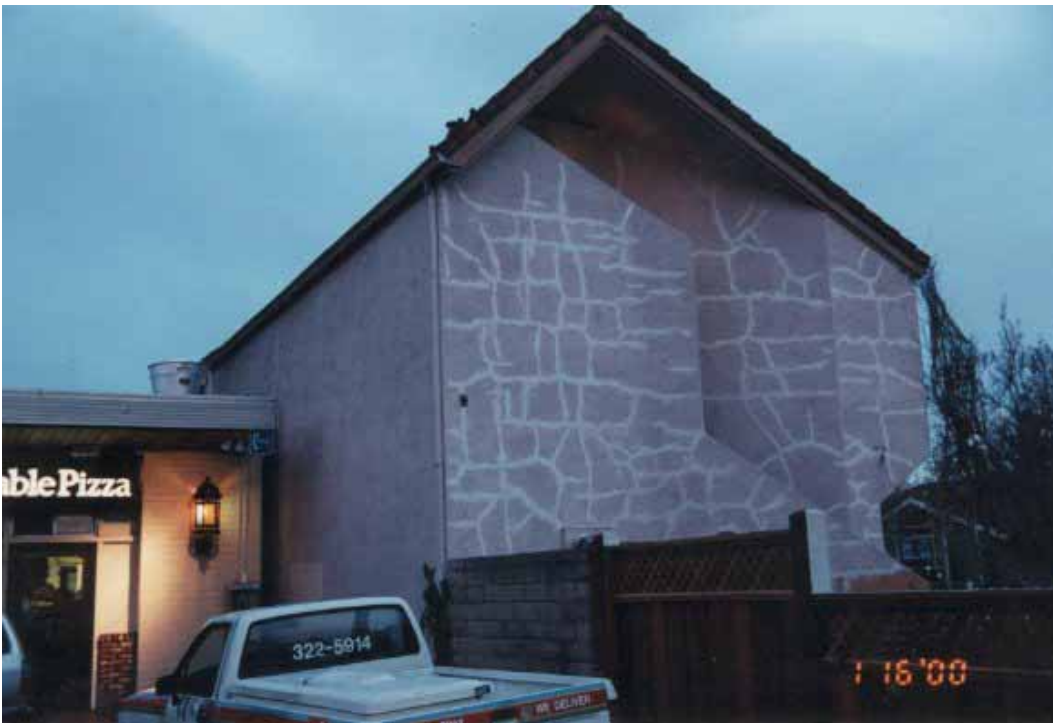
Figure 5.6. Semi-random, semi-orthogonal grid work of non-earthquake shrinkage cracks in stucco – note that cracks are highlighted by patching material applied in the course of repainting the building [Exponent].

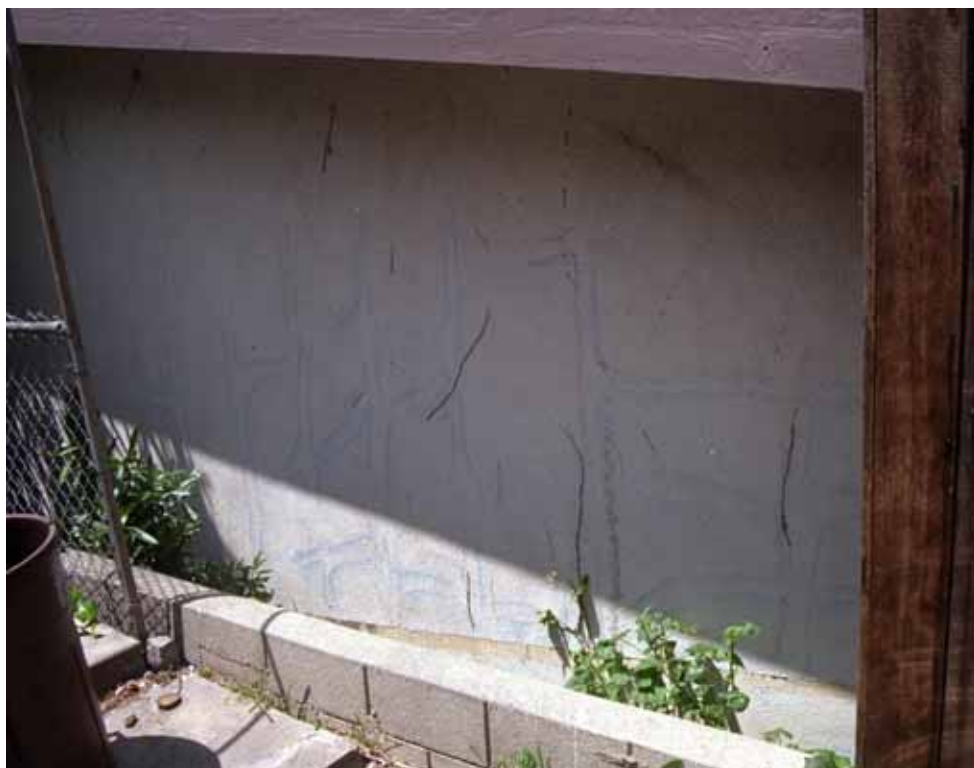
Figure 5.7. Roughly linear vertical non-earthquake shrinkage cracks corresponding to the locations of underlying studs; crack locations have been highlighted with parallel lines of blue chalk [Exponent].

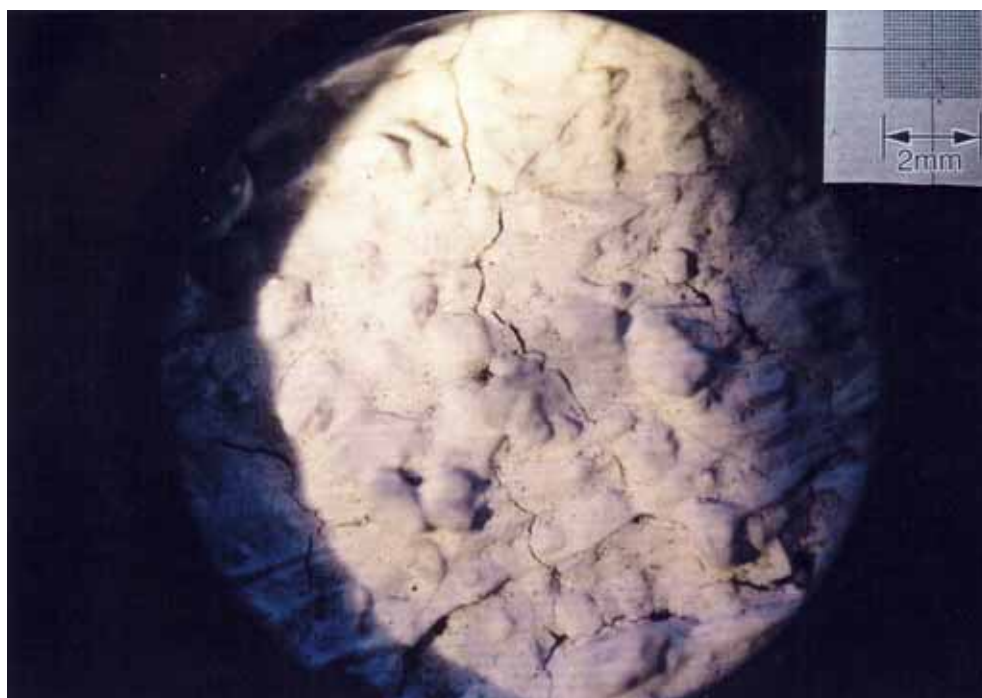
Figure 5.8. Magnified crazing cracking (not earthquake damage) in stucco – circle is 5/8-inch across; bumps are grains of sand in stucco texture [Exponent].

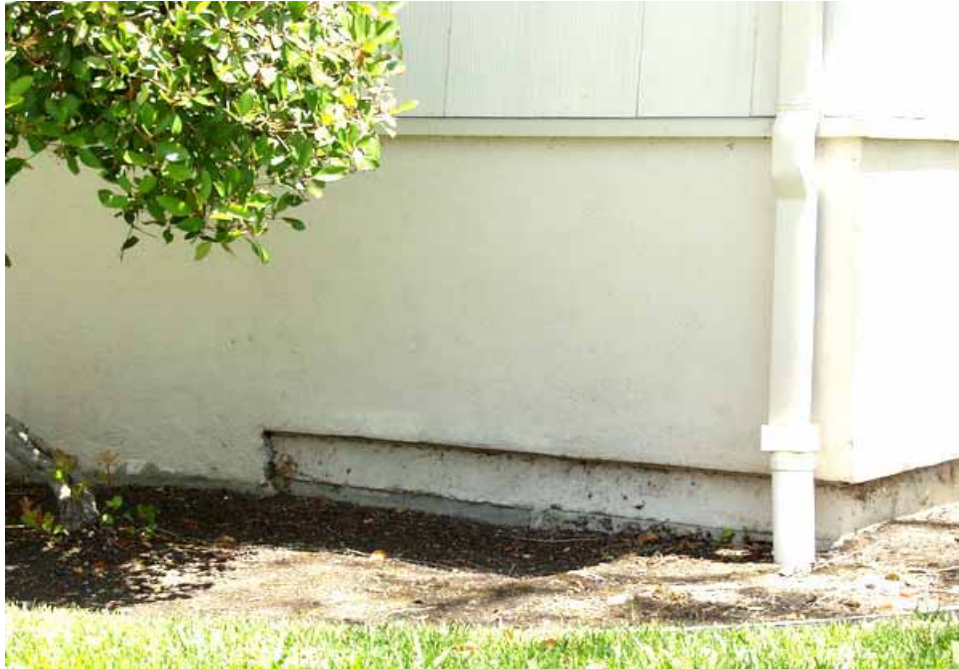
Figure 5.9. Stucco terminated at weep screed on mudsill of recent addition (right) juxtaposed with stucco extended down onto the original foundation (left), as was commonly done prior to the early 1970s – slab-on-grade floor with continuous perimeter footings shown (not earthquake damage) [Exponent].

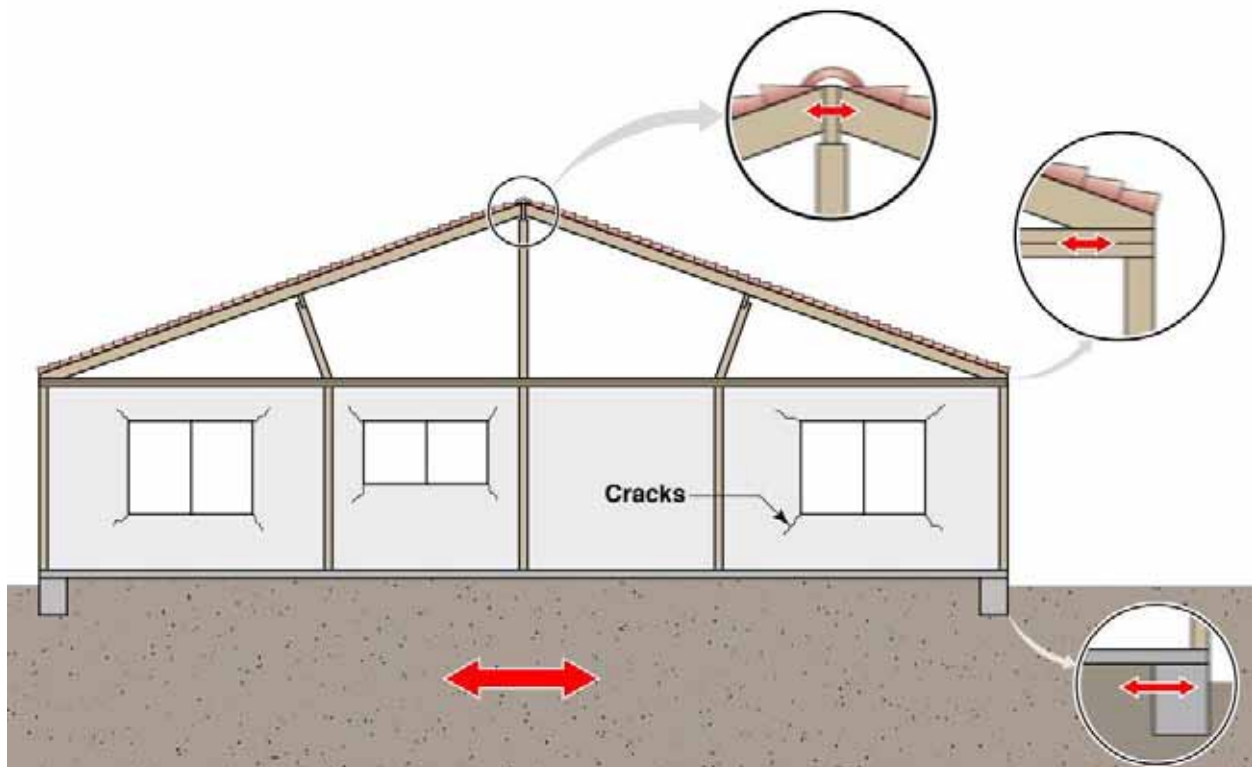
Figure 5.10. Typical crack pattern in wall finishes due to minor earthquake shaking [Exponent].

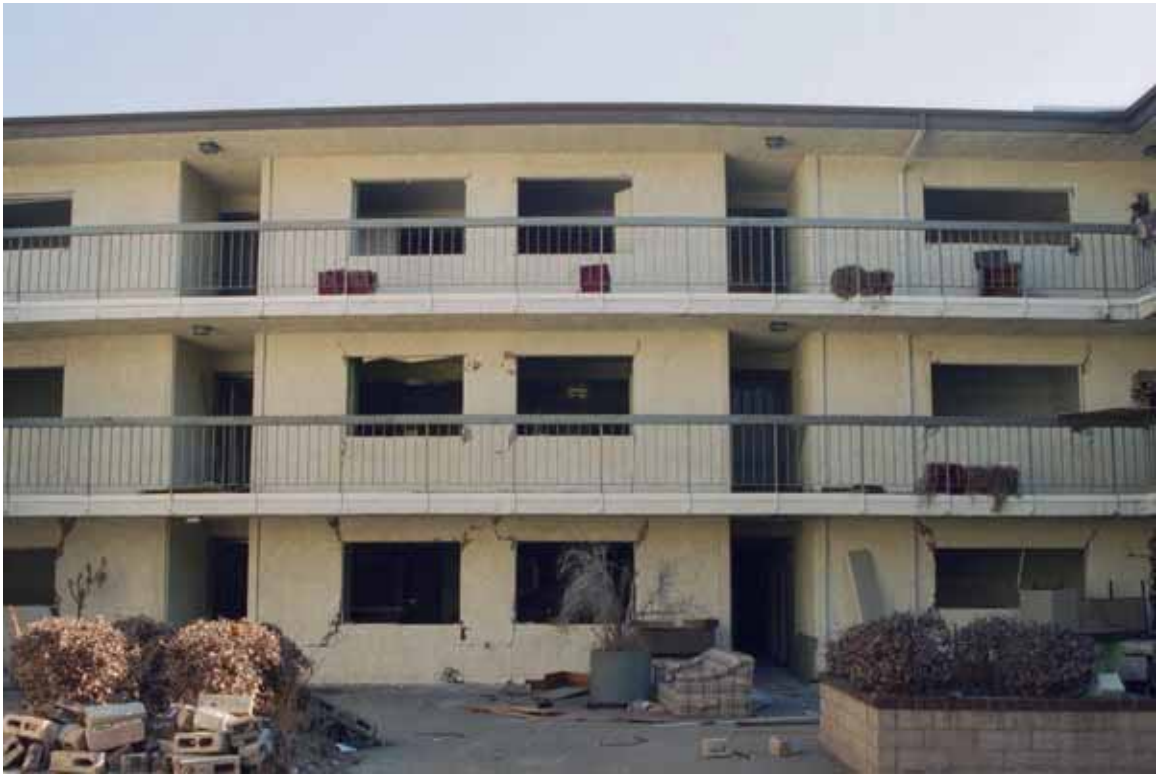
Figure 5.11. Severity of earthquake-induced cracking of wall finishes of multi-story buildings generally decreases at upper stories [Exponent].

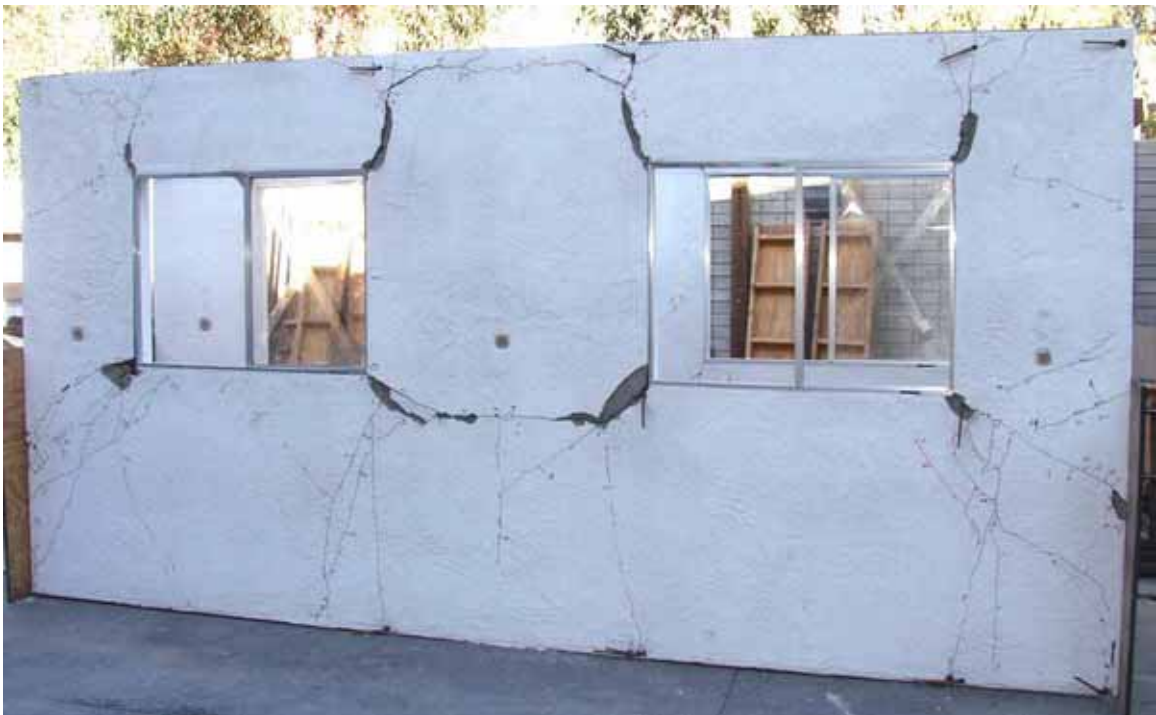
Figure 5.12. Severe cracking and spalling of stucco wall test specimen after earthquake load testing [Exponent].

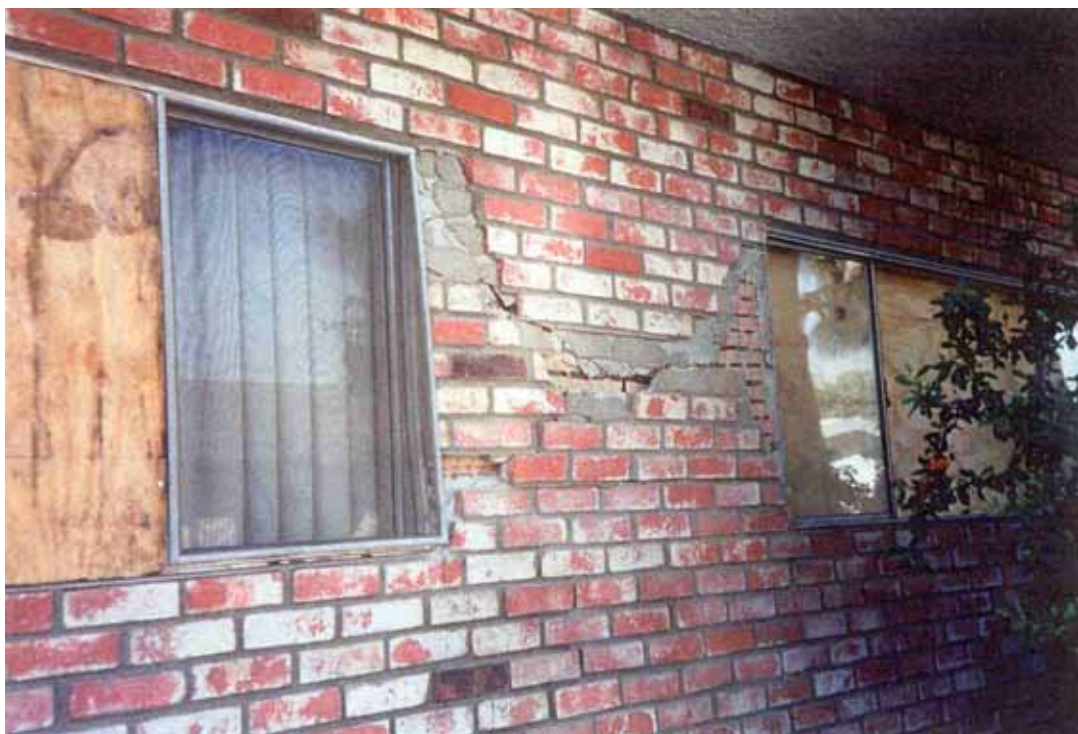
Figure 5.13. Earthquake-induced “X” cracking in stucco panels between windows (thin brick veneer had been installed over stucco).

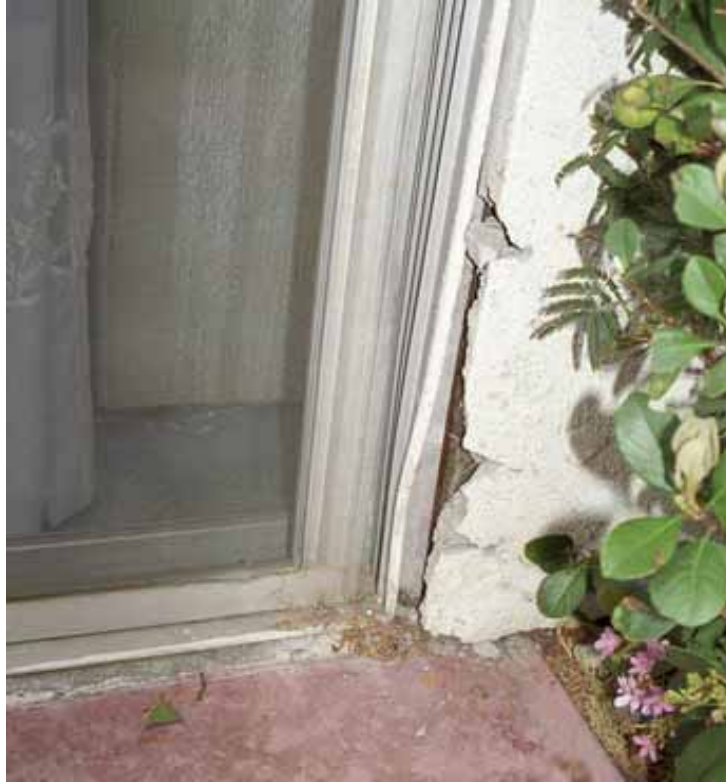
Figure 5.15. Earthquake-induced delamination of stucco from woodframing and associated damage to aluminum door frame [Exponent].

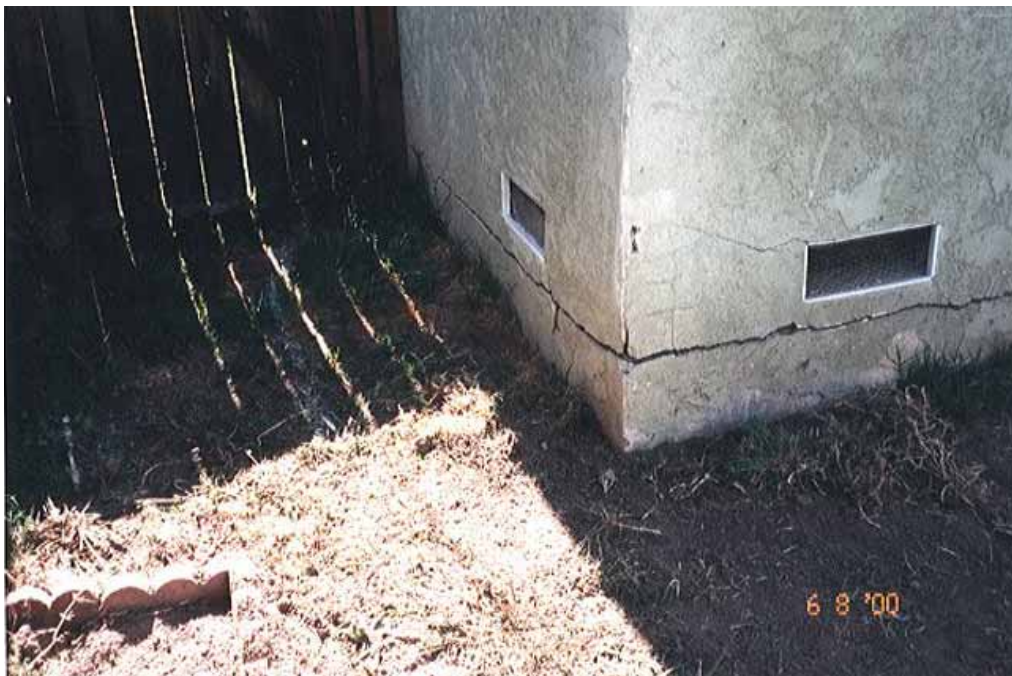
Figure 5.16. Earthquake-induced crack in stucco at sill line where stucco was extended down over the foundation, as commonly done prior to the early 1970s (concealed framing is raised wood floor over continuous perimeter concrete stem wall) [Exponent].

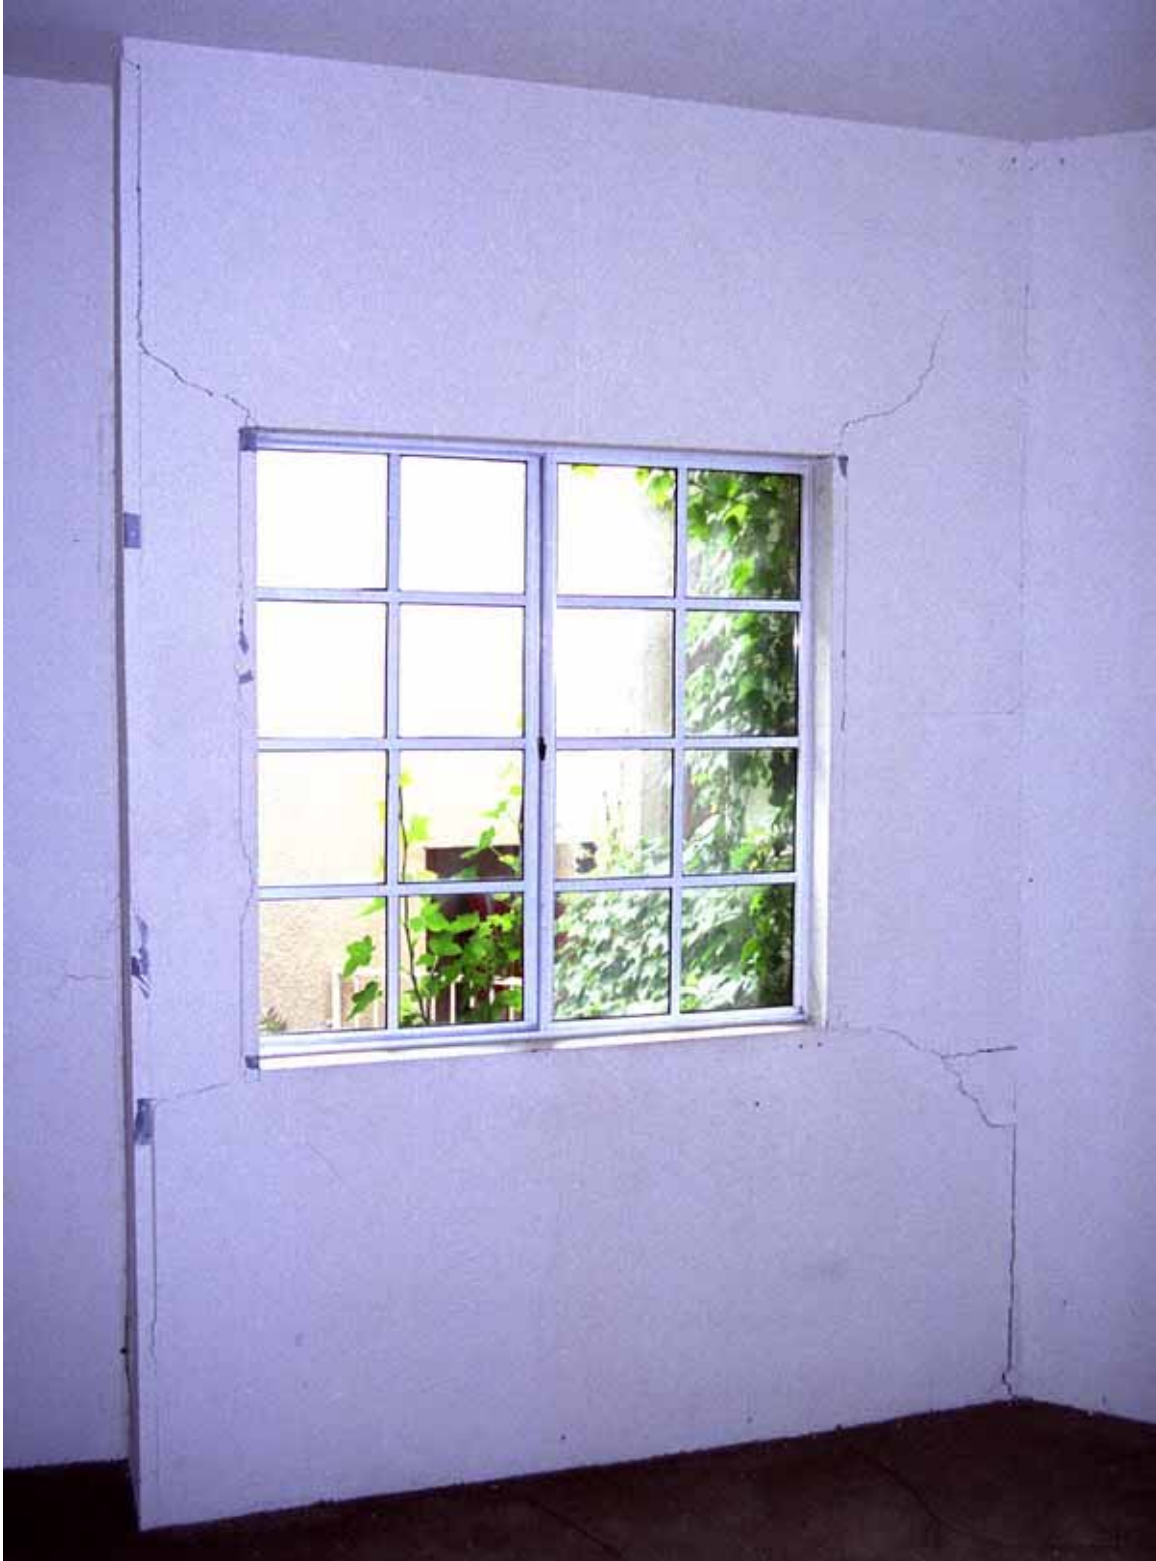
Figure 5.17. Earthquake-induced cracking of drywall as a result of strong shaking [Exponent].

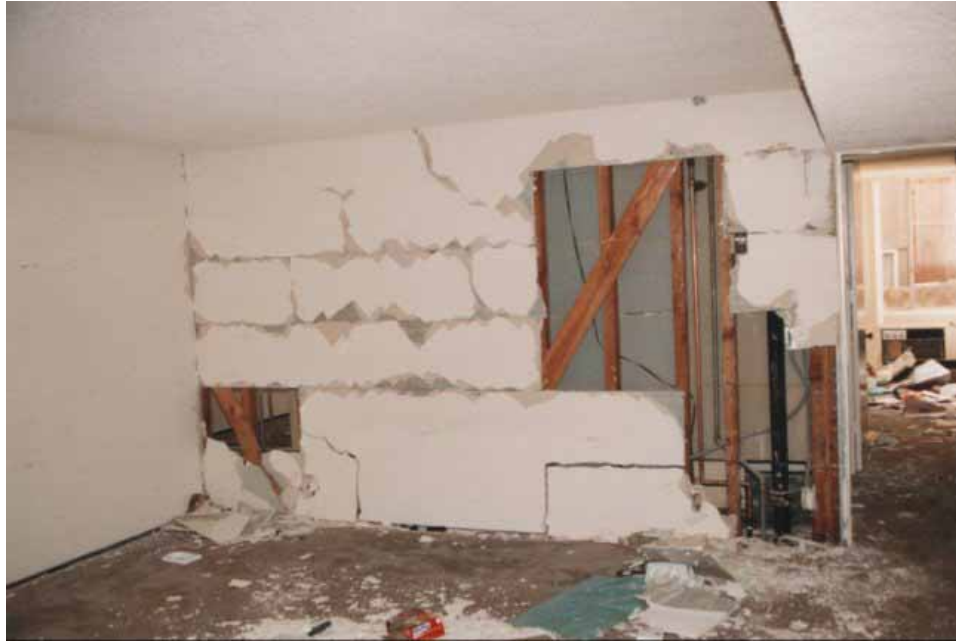
Figure 5.18. Earthquake-induced cracking and delamination of gypsum lath and plaster [Exponent].

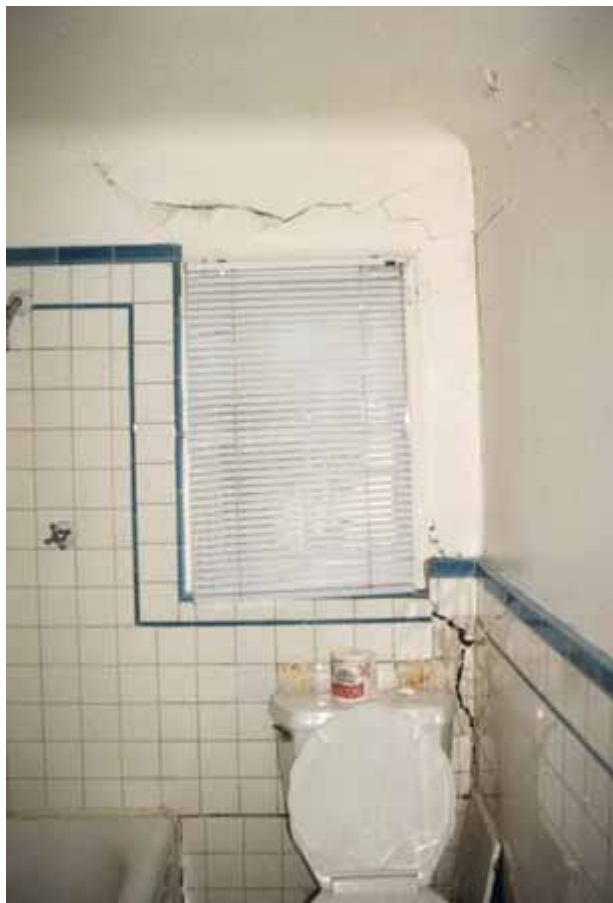
Figure 5.19. Earthquake-induced cracking of ceramic tile [Exponent].

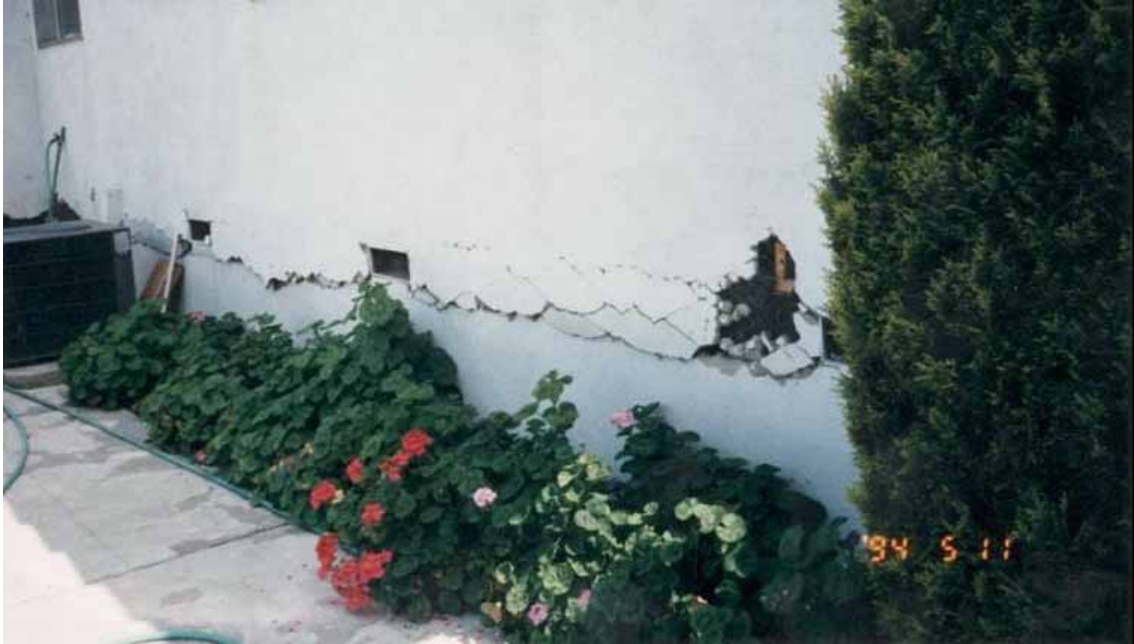
Figure 5.20. Earthquake-induced cracking and buckling of stucco at the plate line where stucco was extended onto the perimeter concrete stem wall [Exponent].

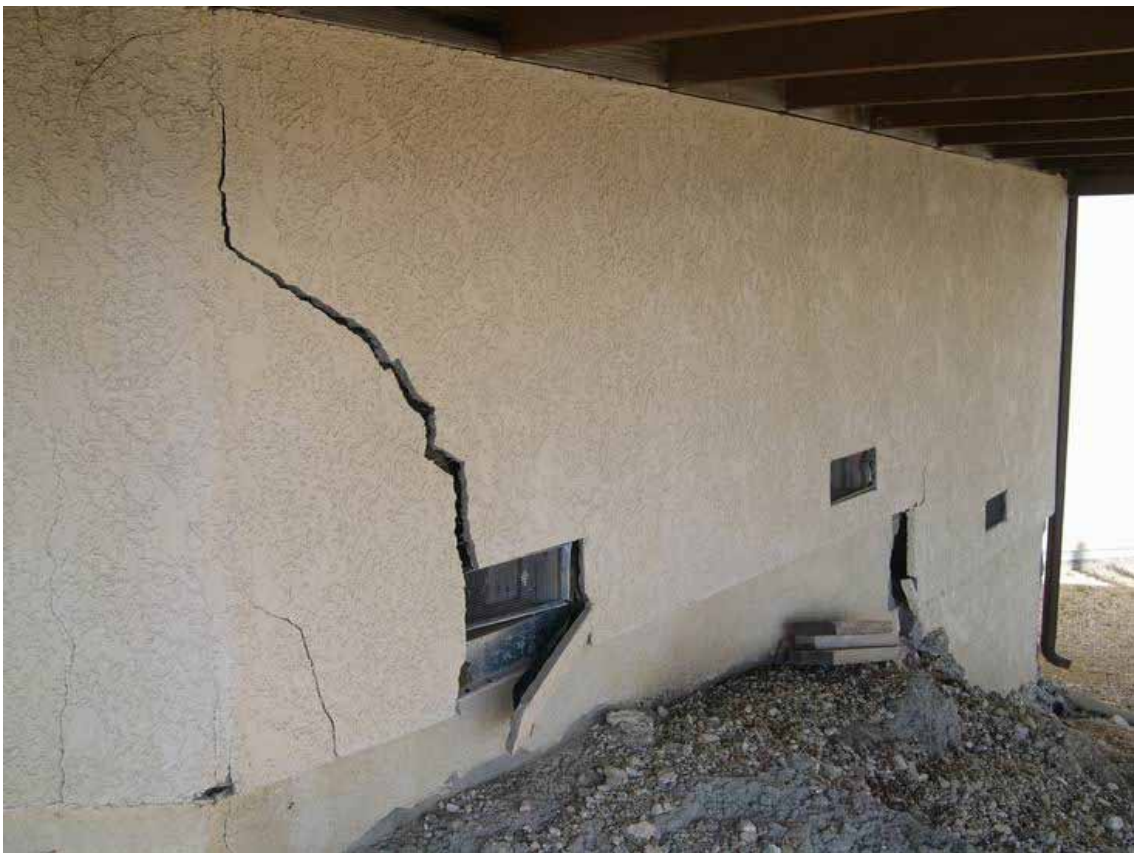
Figure 5.21. Stucco cracking and buckling at cripple wall following the 2003 San Simeon Earthquake [Exponent].

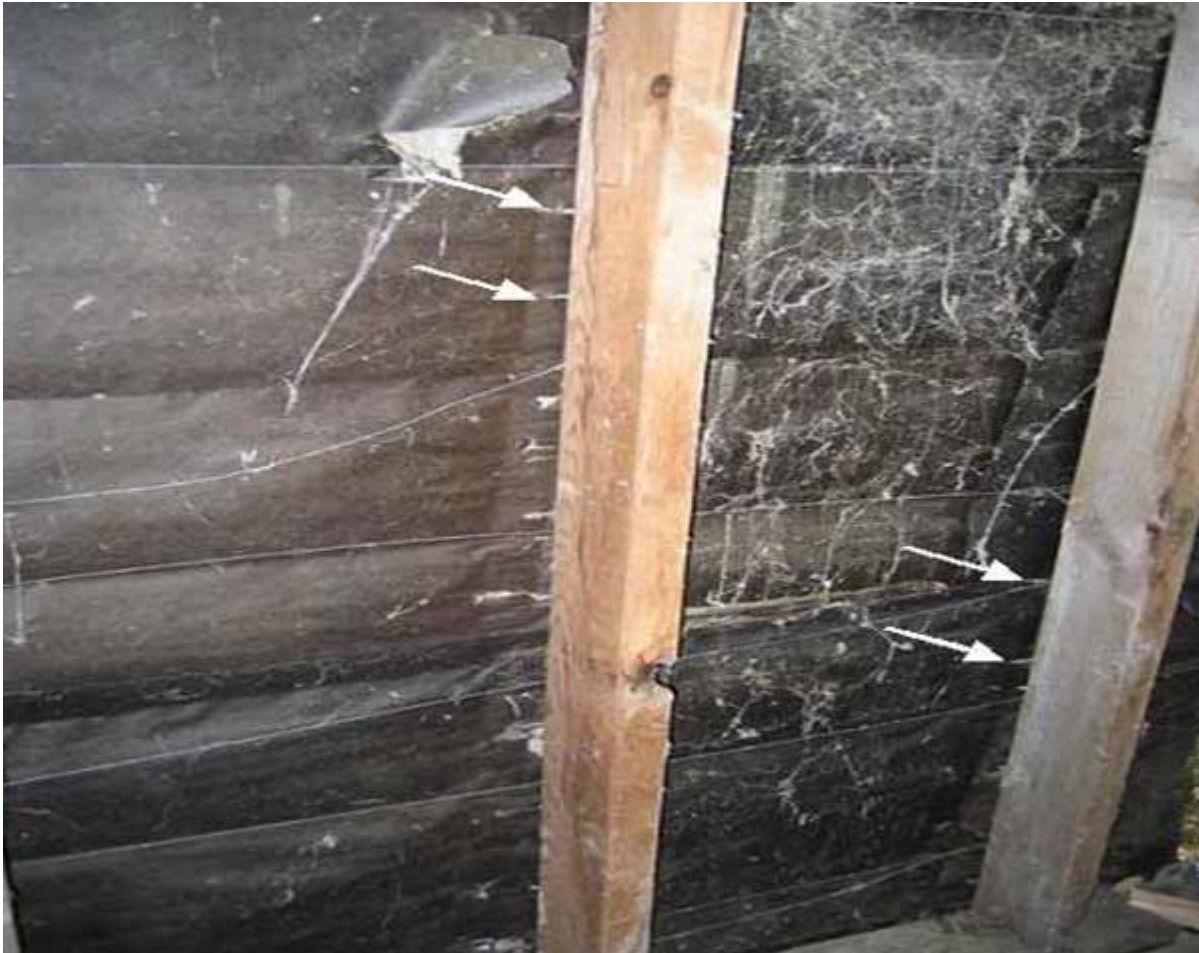
Figure 5.22. Earthquake-induced racking and delamination of stucco as viewed from backside (garage) [Exponent].

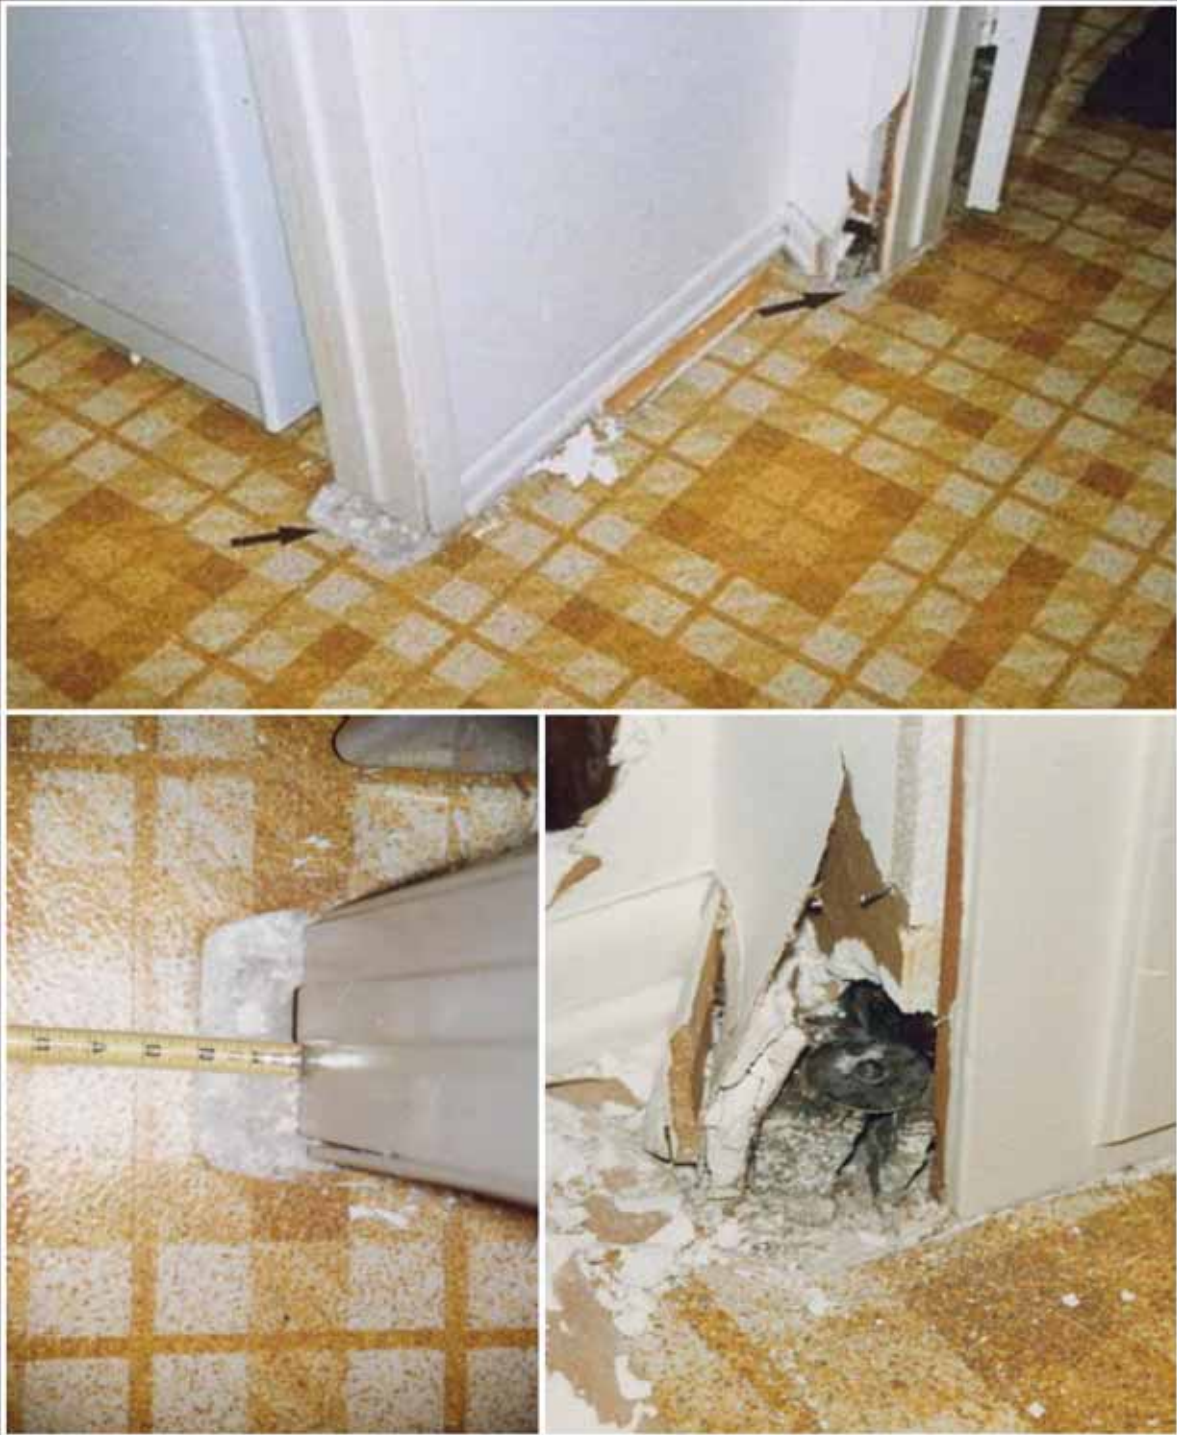
Figure 5.23. Earthquake-induced displacement of an interior partition due to inadequate attachment to floor slab [Exponent].

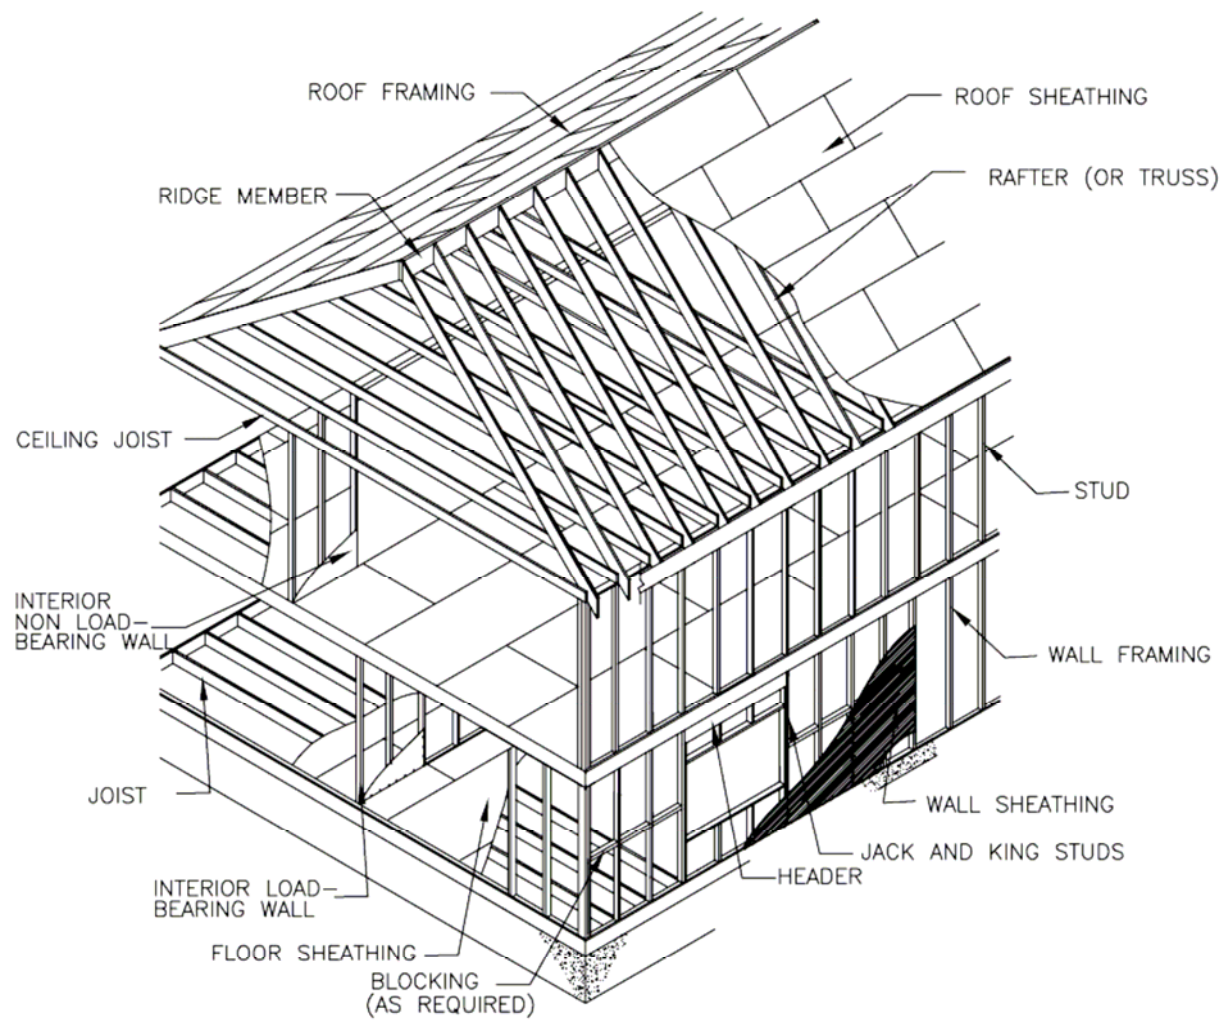
Figure 6.1. Elements of typical woodframe house [HUD].

Roof, ceiling, and floor elements in typical woodframe residential buildings in California are constructed of woodframing (joists and rafters) supporting sheathing (wood boards, plywood or OSB panels, plaster or drywall) and connected with nails (Figure 6.1). Roofs, ceilings, and floors serve several functions. As aesthetic elements, most are finished or decorated. As nonstructural elements, roofs protect the living space from the elements, and floors and ceilings subdivide the living space. As structural elements, roofs, ceilings, and floors support vertical loads that include their own weight as well as the weight of people, contents, and occasionally snow. However, they also carry horizontal loads and tie the building together, thus playing a role in the earthquake resistance of woodframe homes. These elements are often referred to as horizontal diaphragms. Their function is similar to that of a beam loaded from the side – they collect the lateral inertial loads and distribute them to the walls and foundation (Figure 6.2).

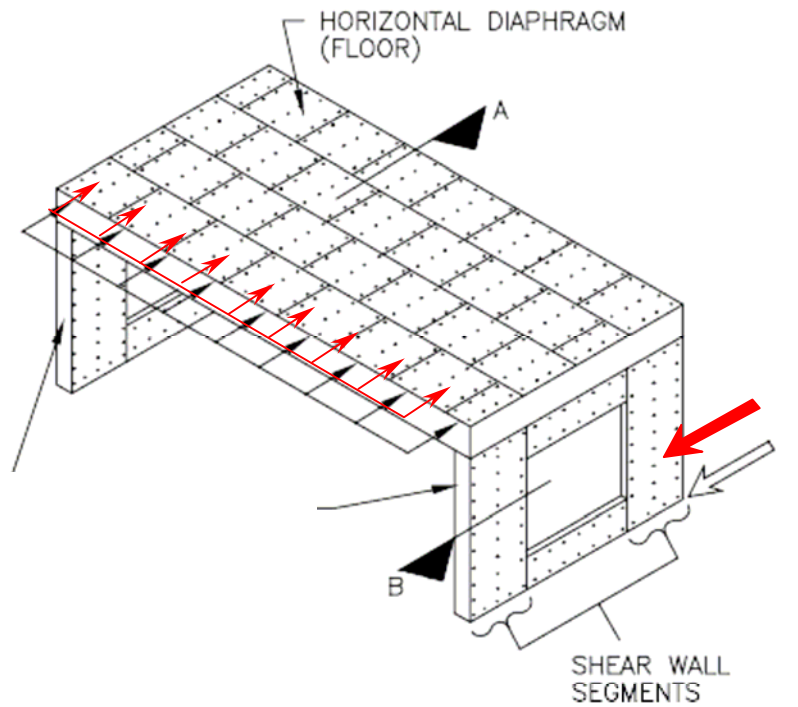
Figure 6.2. Schematic of the role of horizontal diaphragms (floors or roofs) as structural elements resisting earthquake forces [HUD].

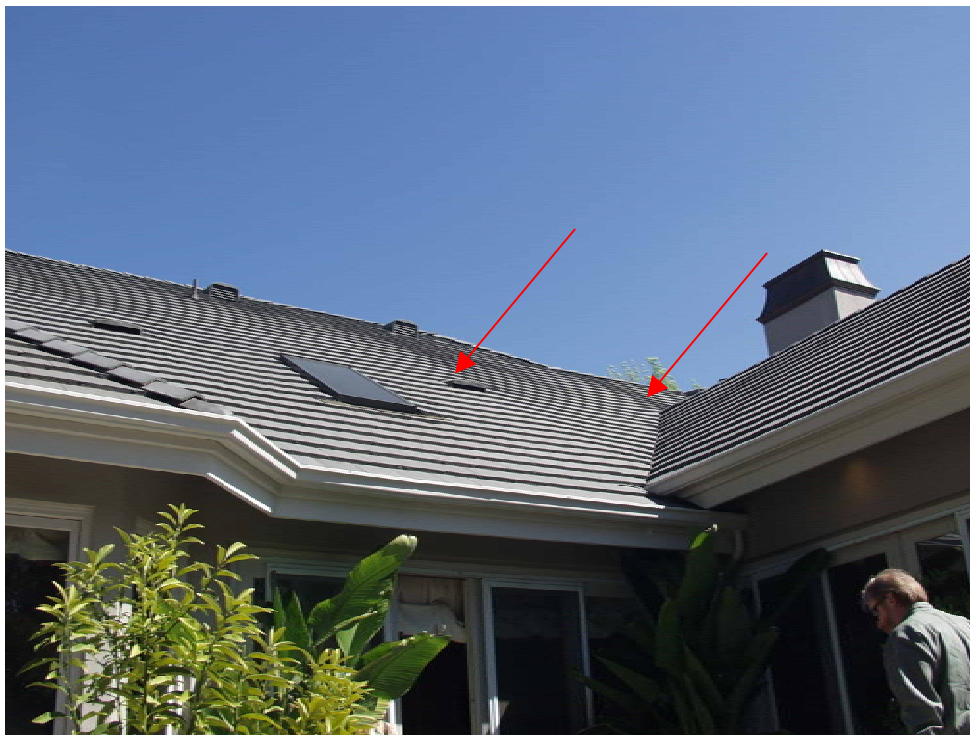
Figure 6.3. Heavy tile roof sags between wall supports, located by arrows (not earthquake damage) [Exponent].

In non-snow areas, roof structures are typically designed to be as light as possible with little or no consideration of deflection. As a result, many roofs will exhibit some degree of sag, which will increase with time. Without reinforcing the roof structure, installation of multiple layers of roofing or replacement of wood shakes with concrete tile will exacerbate the visible sag. Sag will often be most noticeable in areas where support conditions of the roof change, such as where a wall intersects the roof framing (Figure 6.3). Sag in the roof is generally not an indication of a serious structural defect.

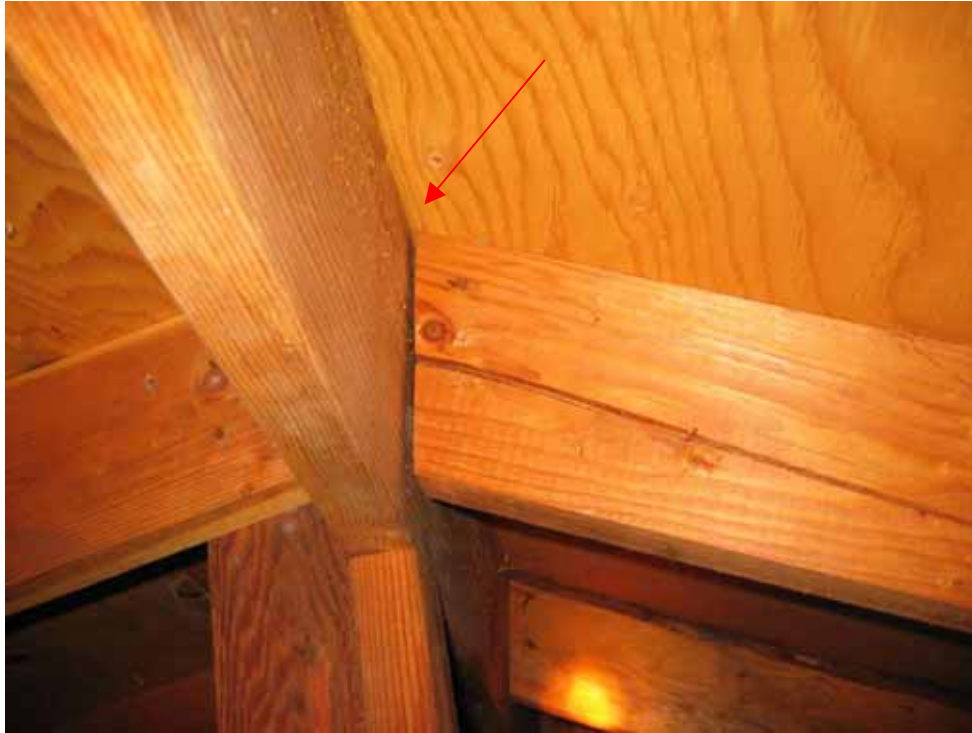
Figure 6.4. Poor fit-up of roof framing at rafter to ridge board junction (not earthquake damage) [Exponent].

Neither master craftsman nor the finest materials are generally employed in the construction of roofs. Thus, it is common to find nails that have missed their target, poorly made joints and misaligned framing in attics (Figure 6.4). In addition, framing lumber will shrink, twist, and split as it dries. Due to the fact that wood shrinks much more across the grain than it does along the

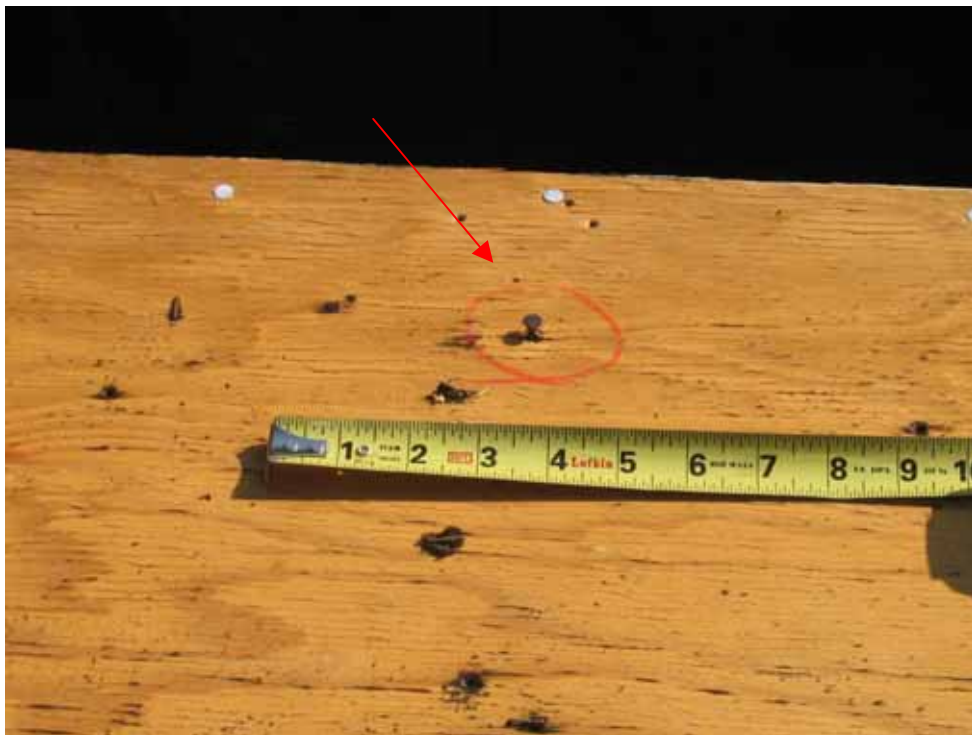
Figure 6.5. Nail withdrawal from plywood roof sheathing due to long-term moisture cycling (not earthquake damage) [Exponent].

In the course of reroofing, it is not unusual to find some nails that had been driven flush sticking up slightly (Figure 6.5). This condition can result from shrinkage of the framing lumber, but is more commonly driven by thermal cycling of the roof, which causes nails to back out of the framing over time.
