GENERAL GUIDELINES  
FOR THE ASSESSMENT AND REPAIR  
OF EARTHQUAKE DAMAGE  
IN RESIDENTIAL WOODFRAME BUILDINGS

Consortium of Universities for Research in Earthquake Engineering

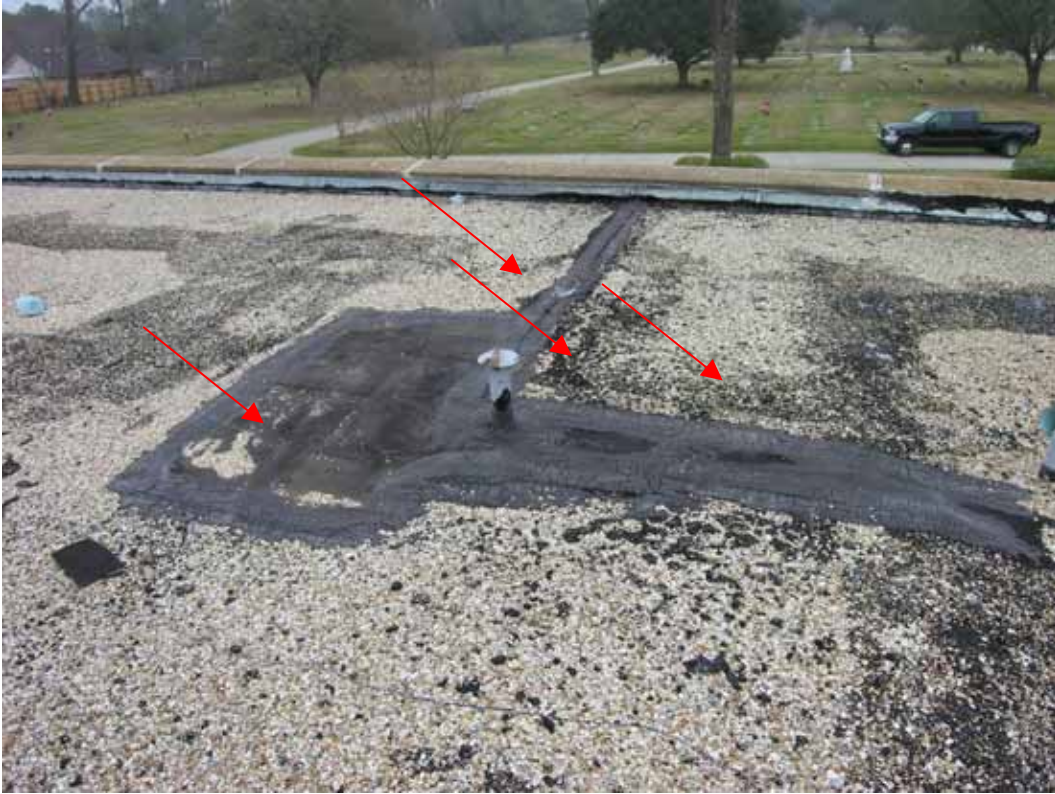
Figure 6.6. Deteriorated mastic at repair of built-up roof (not earthquake damage) [Exponent].

Cracking of mastic used for roofing repairs or penetration seals is very common, often due to large thermal strains at discontinuities and long-term deterioration such as photo-degradation or embrittlement (Figure 6.6).

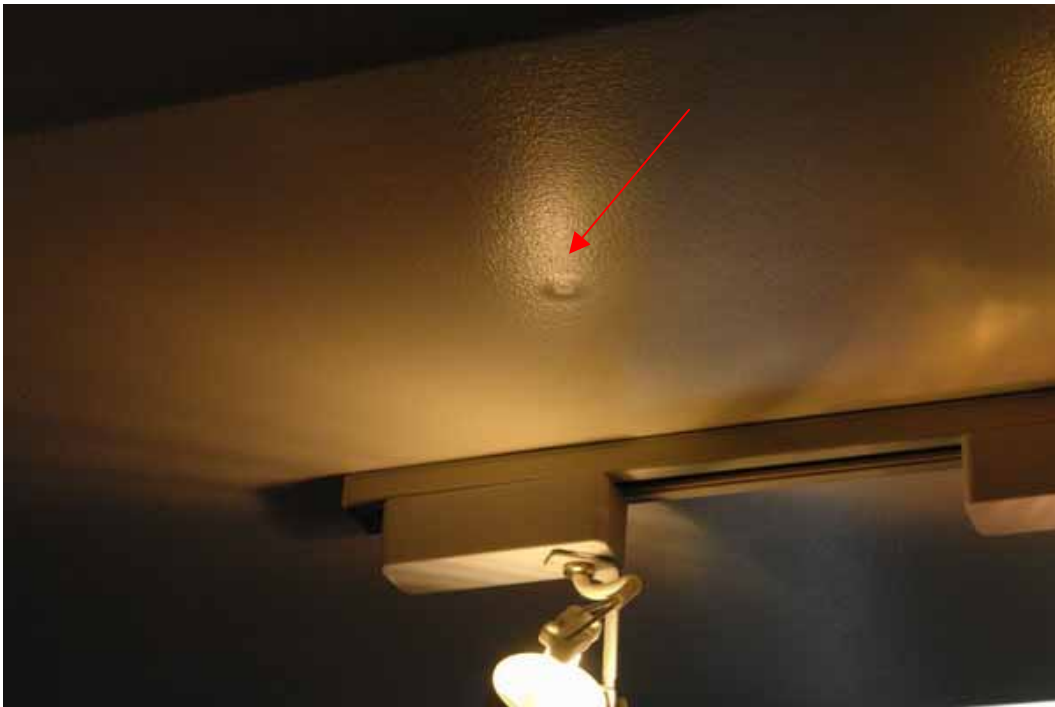
Figure 6.7. Nail pop visible in ceiling (not earthquake damage) [Exponent].

The most common imperfection with drywall ceilings is tape joints that are visible under low light angles on ceilings with smooth finish. Joints will be spaced at 4 feet in one direction and 8 to 12 feet in the other direction. Related is the problem of “nail pops” and dimpling at fasteners, which develop over time and are generally associated with changes in moisture content in the woodframing (Figure 6.7). The difficulty of preventing nail pops or dimpling and making inconspicuous tape joints over large ceiling areas is one of the reasons that heavy texture finishes are so widely used for ceilings. A related problem is irregularity of ceiling framing which shows up as surface irregularities in the drywall finish.

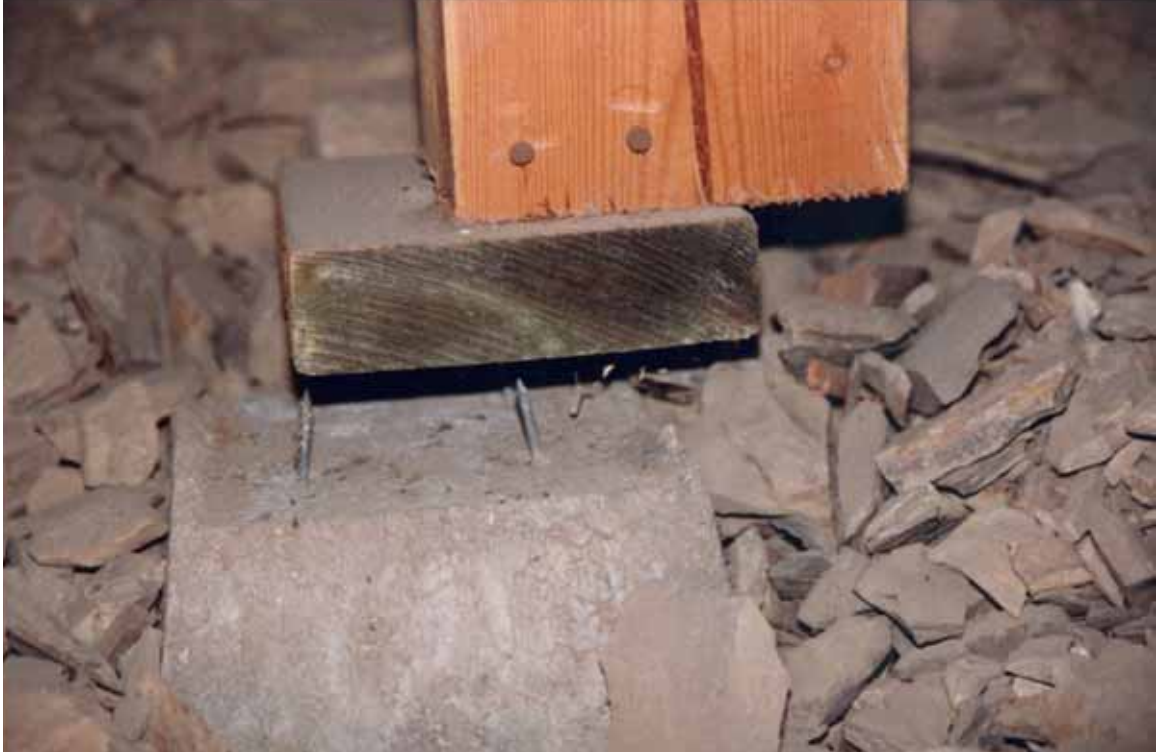
Figure 6.8. Gap between post and pier foundation in crawlspace (not earthquake damage) [Exponent].

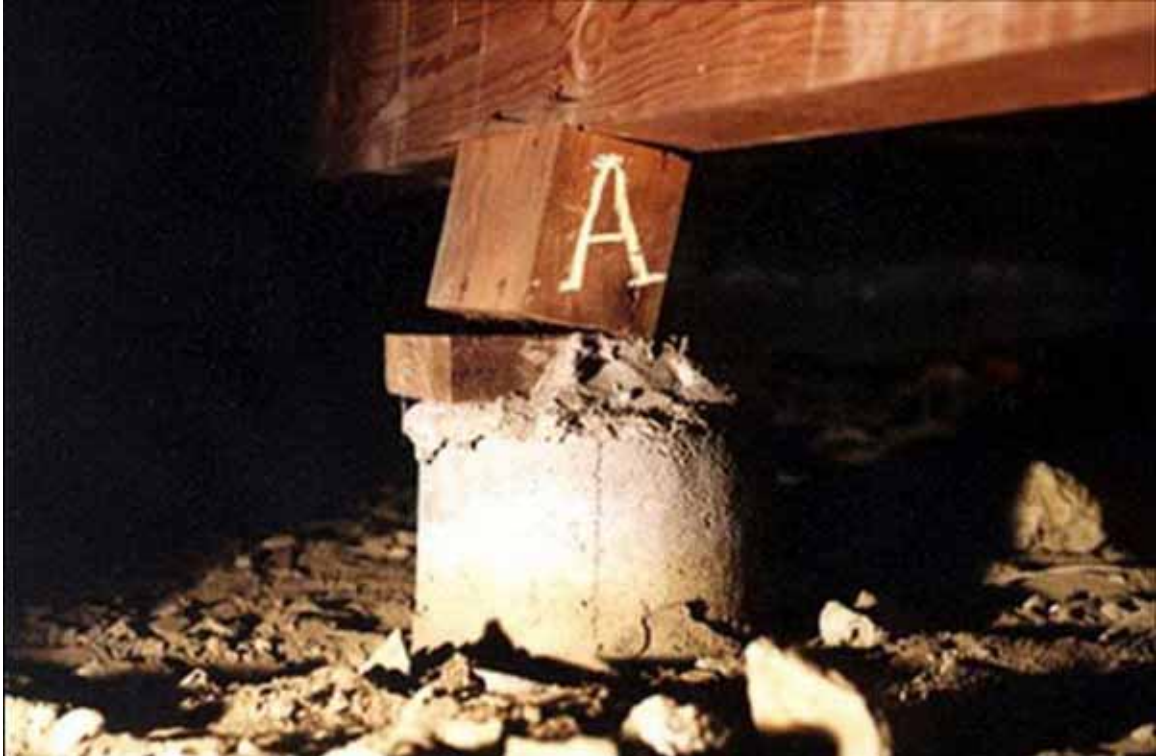
Figure 6.9. Tilted support posts in crawlspace (not earthquake damage) [Exponent].

Many homes in California, especially older homes, are built on unstable soils which, over time, can lead to differential movement of the foundation and superstructure. The result will often be floors that are out of level (i.e., more than 1-1/2 inches between high and low point across the building) with noticeable slope (i.e., greater than 1 inch in 20 feet). Differential foundation movement can also result in gaps between posts and beams in the crawlspace (Figure 6.8). Those gaps leave the beams unsupported, resulting in a sag and bounce in the floor in the vicinity. Soils on or near the tops of slopes can creep or move laterally over time, stretching foundation and the raised wood floor, resulting in tilted support posts (Figure 6.9), cracked mudsills (Figure 6.10), and gaps or cracks in floor finish materials (Figure 6.11).

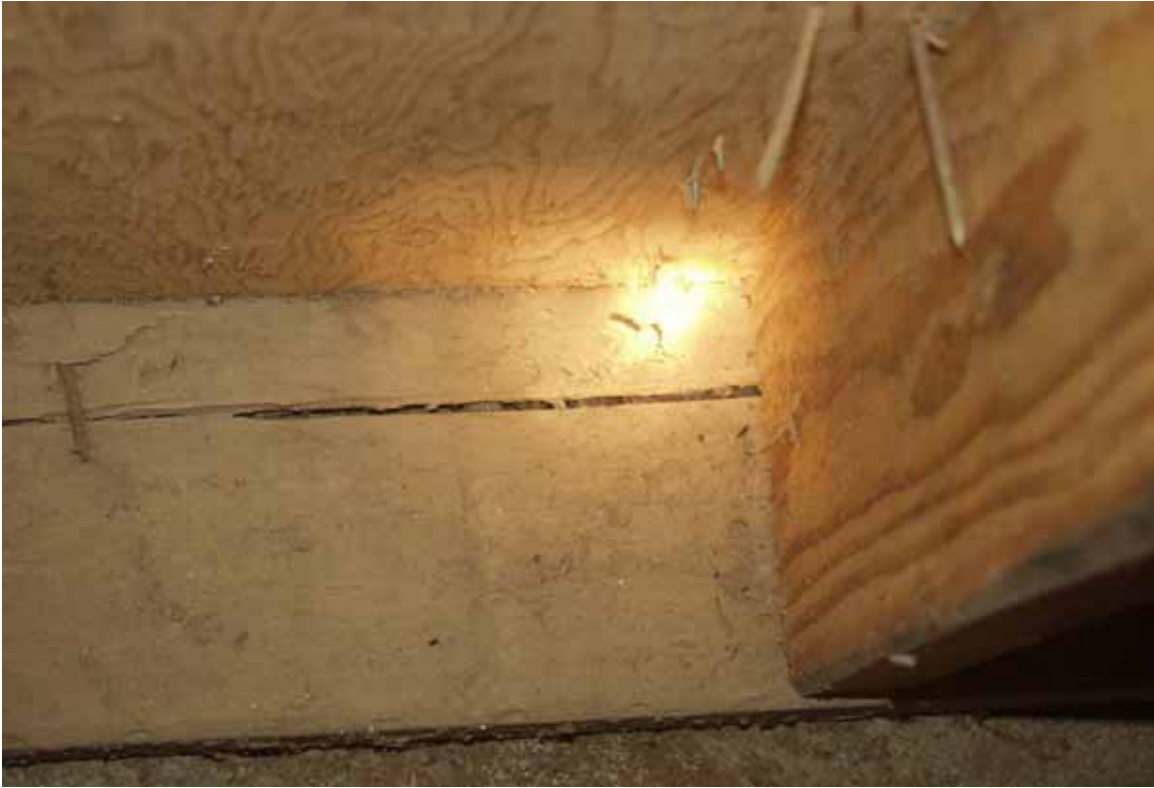
Figure 6.10. Cracked mudsill and missed nails (not earthquake damage) [Exponent].

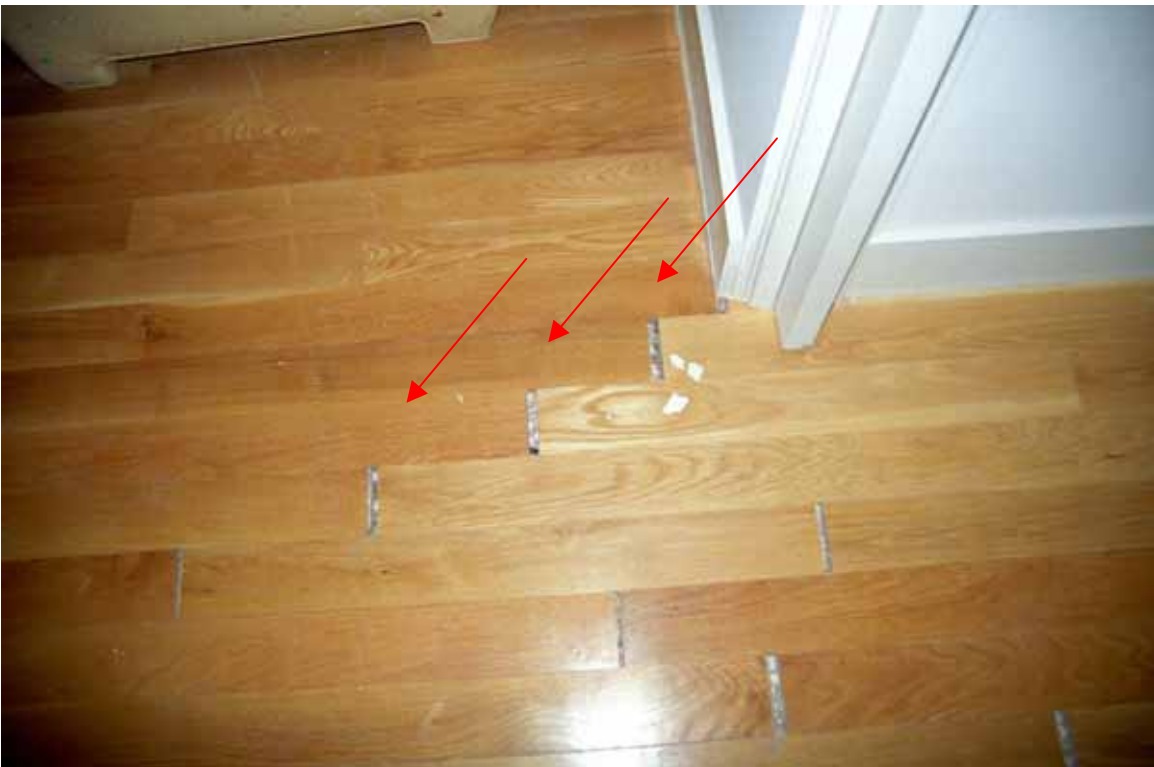
Figure 6.11. Gaps in flooring due to elongation of floor diaphragm caused by earthquake-induced slope movement [Exponent].

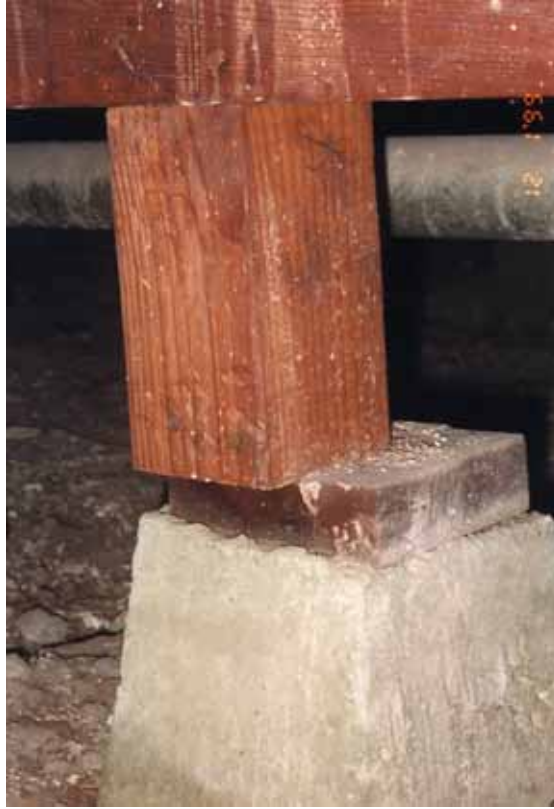
Figure 6.12. As-built misalignment between girder and footing accommodated with offset post (not earthquake damage) [Exponent].

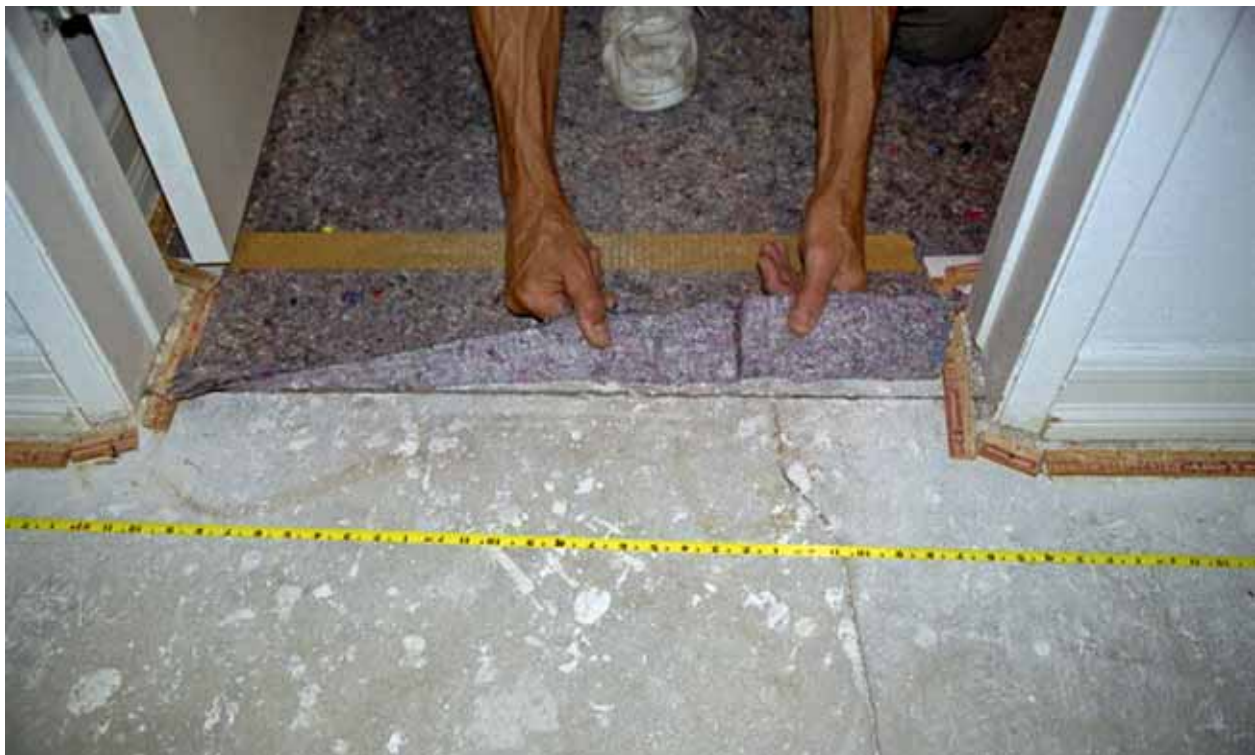
Figure 6.13. Shrinkage cracks in lightweight concrete fill (not earthquake damage) [Exponent].

While not common in single-family dwellings, a 1-1/2-inch thick layer of lightweight concrete is often used in place of underlayment for sound control in multi-family woodframe buildings. That fill is unreinforced, is placed with a high water content, and is of low strength, resulting in the development of cracks from shrinkage or traffic loads and deterioration (Figure 6.13).

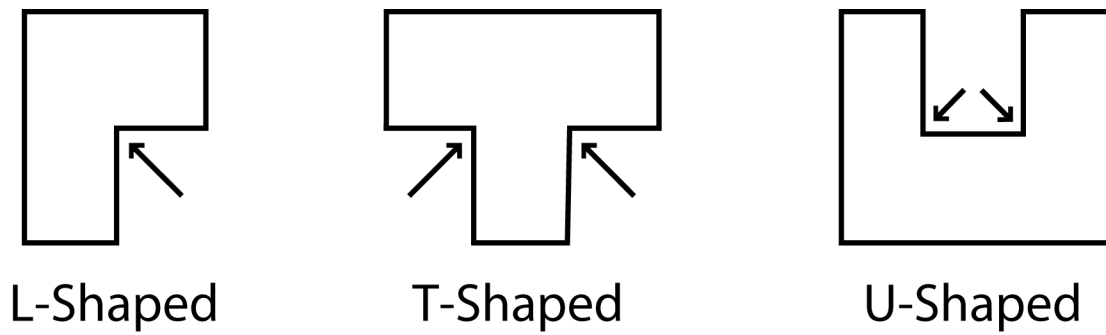
Figure 6.14. Reentrant corners of plan irregularities are likely locations of damage in horizontal diaphragms during strong shaking.

one-story to two-story transitions, additions, porches, etc.), and plan irregularities that create reentrant corners (**L**, **T**, and **U** shaped floor plans) as shown in Figure 6.14.

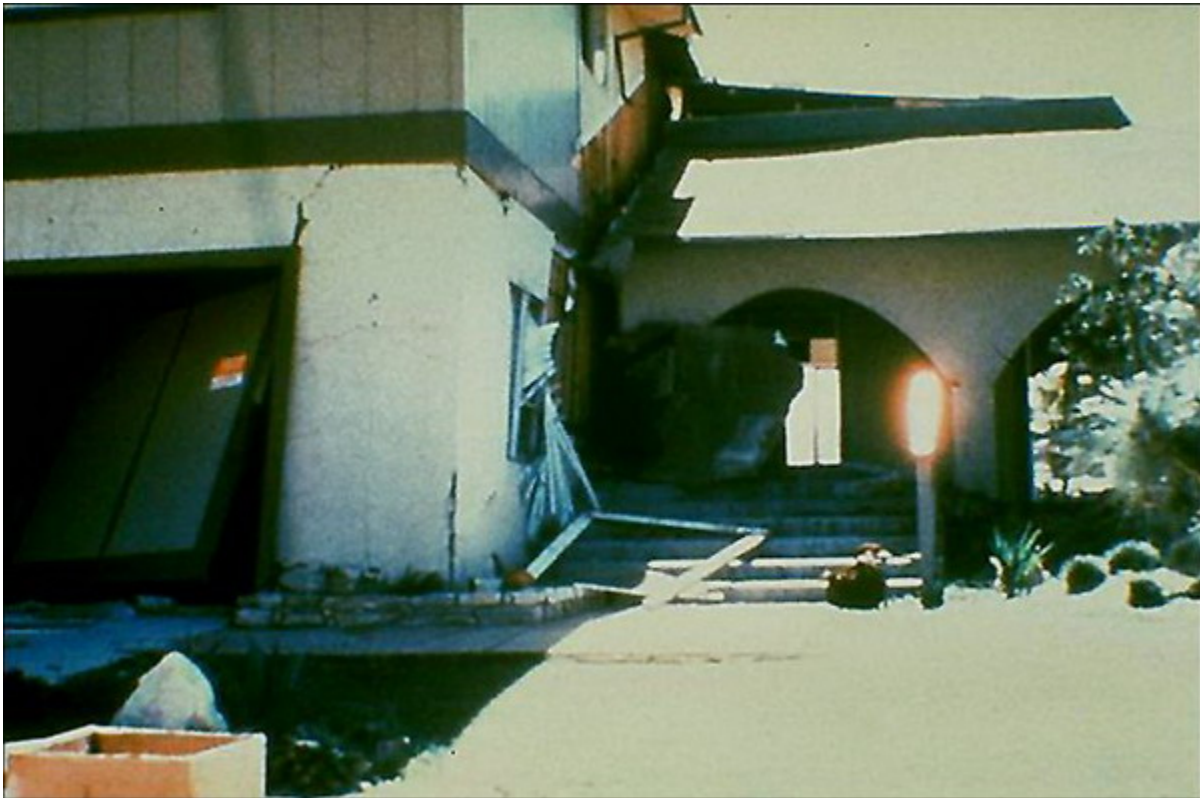
Figure 6.15. Earthquake-induced separation across discontinuous floor and roof diaphragms of a split level house.

Damage at vertical irregularities occurs when the portions of the building on either side of the irregularity move in opposing directions. If the structural tie across the irregularity is not sufficiently strong (a common situation, especially in older buildings), separation will occur at the discontinuity of the structural diaphragms, with damage ranging from minor finish damage to complete structural separation. Split-level homes represent vertical irregularities in the lateral load path that can lead to separation in discontinuous floor and roof framing (i.e., the horizontal diaphragms). In the past, split-level homes have suffered serious damage due to this discontinuity as shown in Figure 6.15. Modern seismic design principals discourage this condition, or provide special detailing to accommodate it. Discontinuities in horizontal diaphragms should be inspected carefully for indications of framing separation.

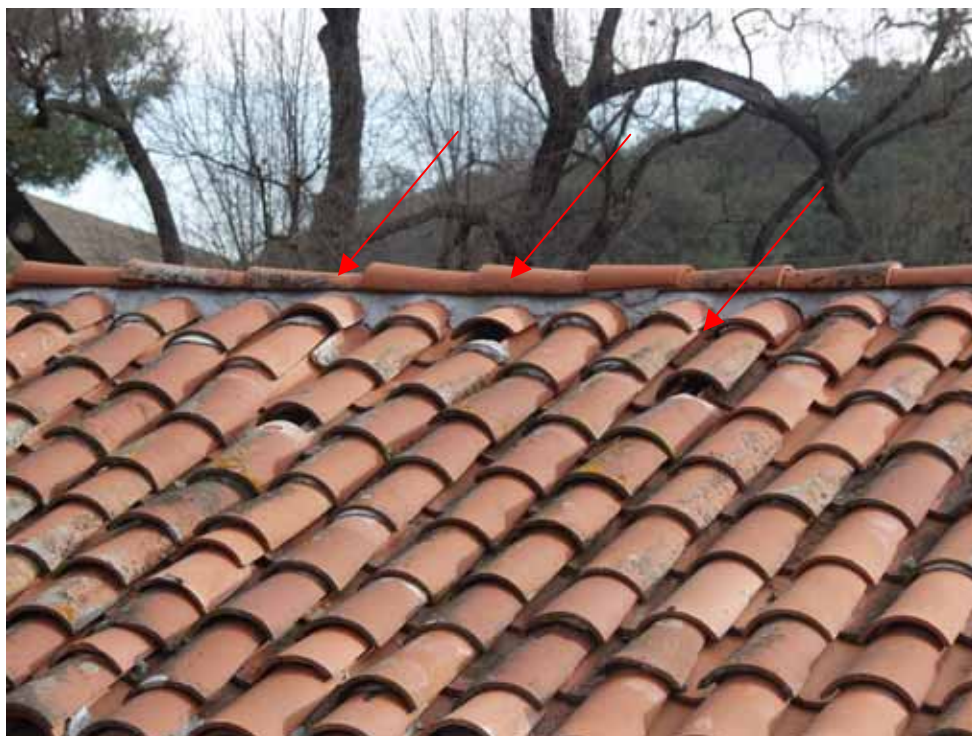
Figure 6.16. Clay roof tile and mortar joints shifted by earthquake shaking [Exponent].

commonly displaced (Figure 6.16) and may fall from the roof. Even where all tiles are intended to be secured, there are often pieces that, for a variety of reasons were not secured and may shift or fall. Even tile that are secured may shift slightly.

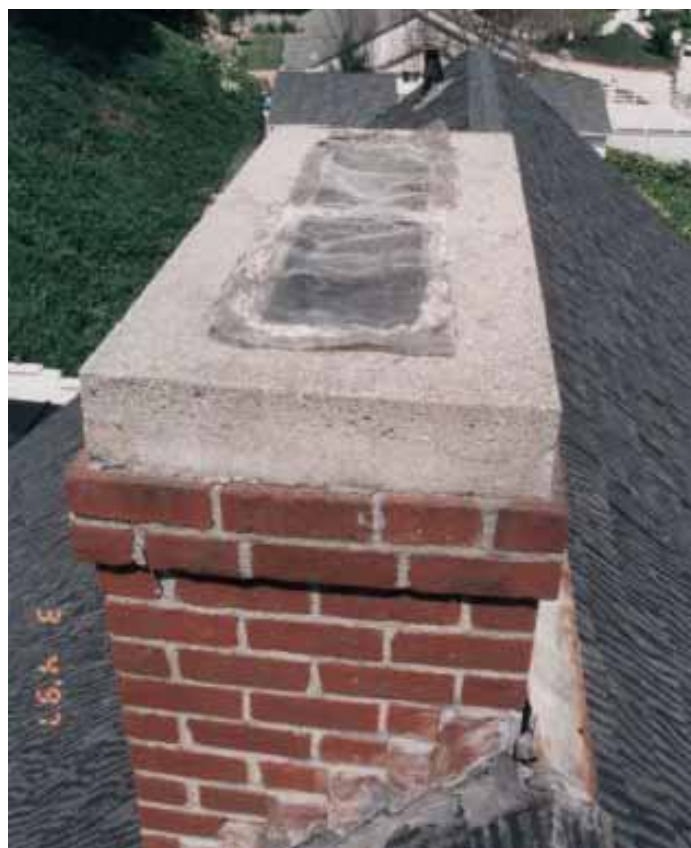
Figure 6.17. Buckled chimney flashing due to earthquake shaking [Exponent].

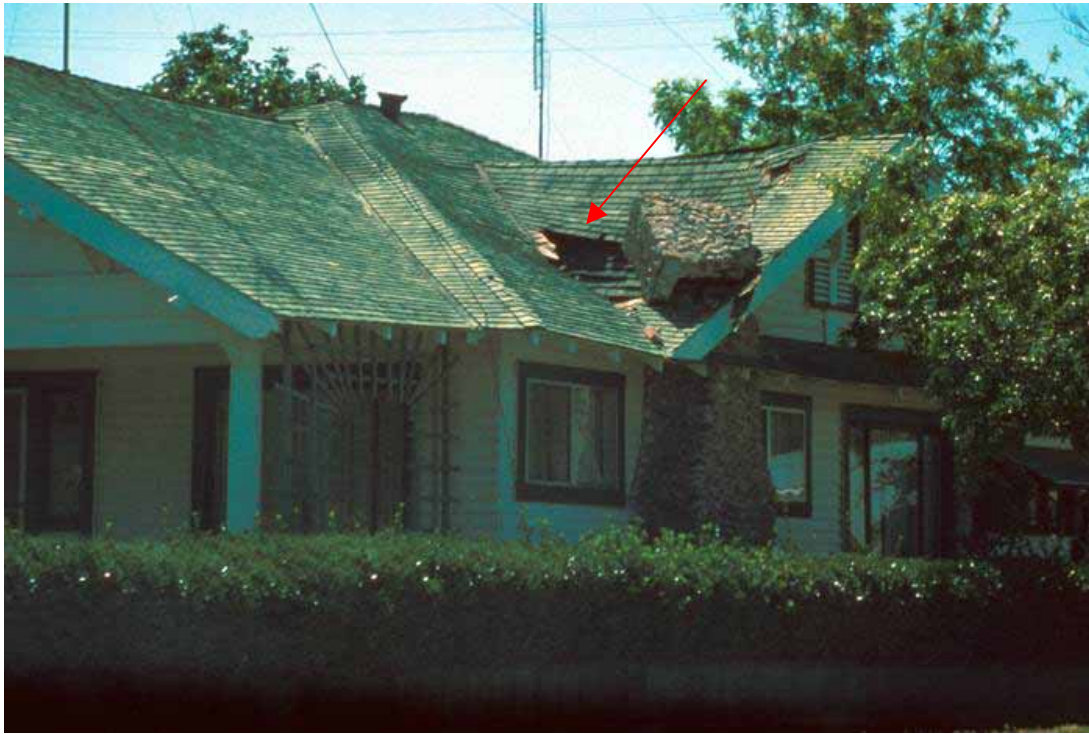
Figure 6.18. Earthquake damage from impact of falling masonry chimney [USGS].

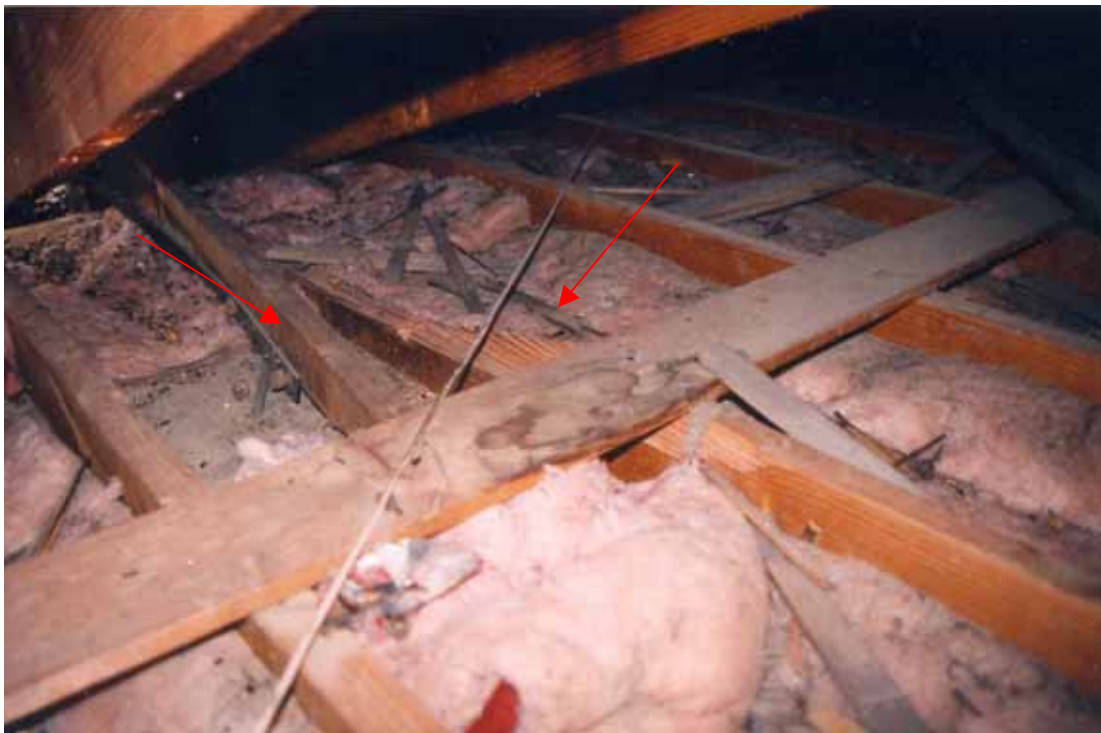
Figure 6.19. Earthquake-induced framing damage due to loads from chimney strap; note the strap was attached to the top of a ceiling joist (left arrow), which split from the bottom (right arrow) when the chimney, located just outside rafter ends in top left of photo, moved relative to the house [Exponent].

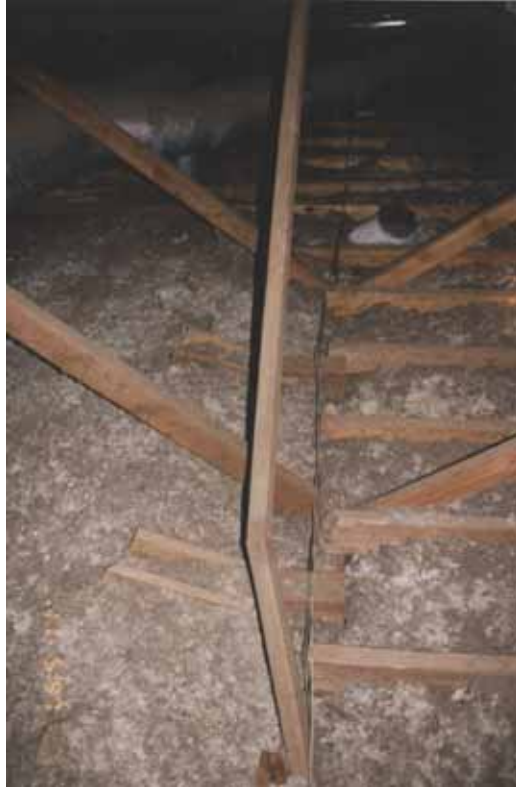
Figure 6.20. Diagonal ridge brace buckled due to earthquake; this brace is in line with the brace shown in Figure 6.21 [Exponent].

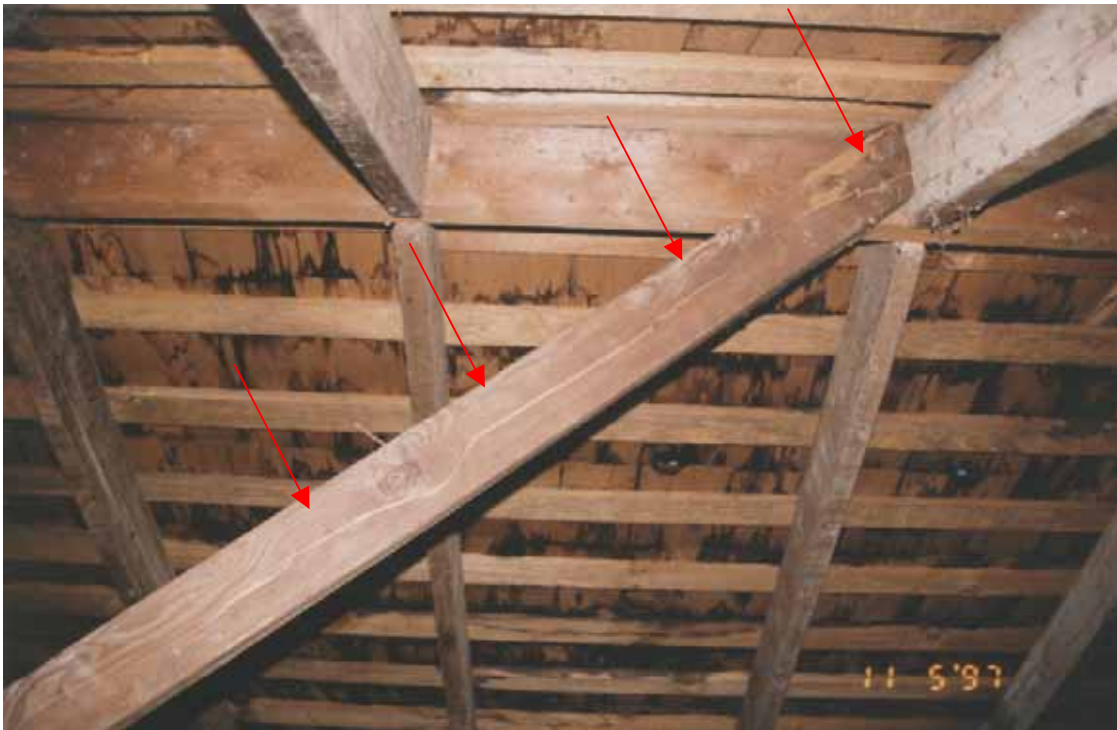
Figure 6.21. Diagonal ridge brace cracked during earthquake; this brace is in line with the brace shown in Figure 6.20 [Exponent].

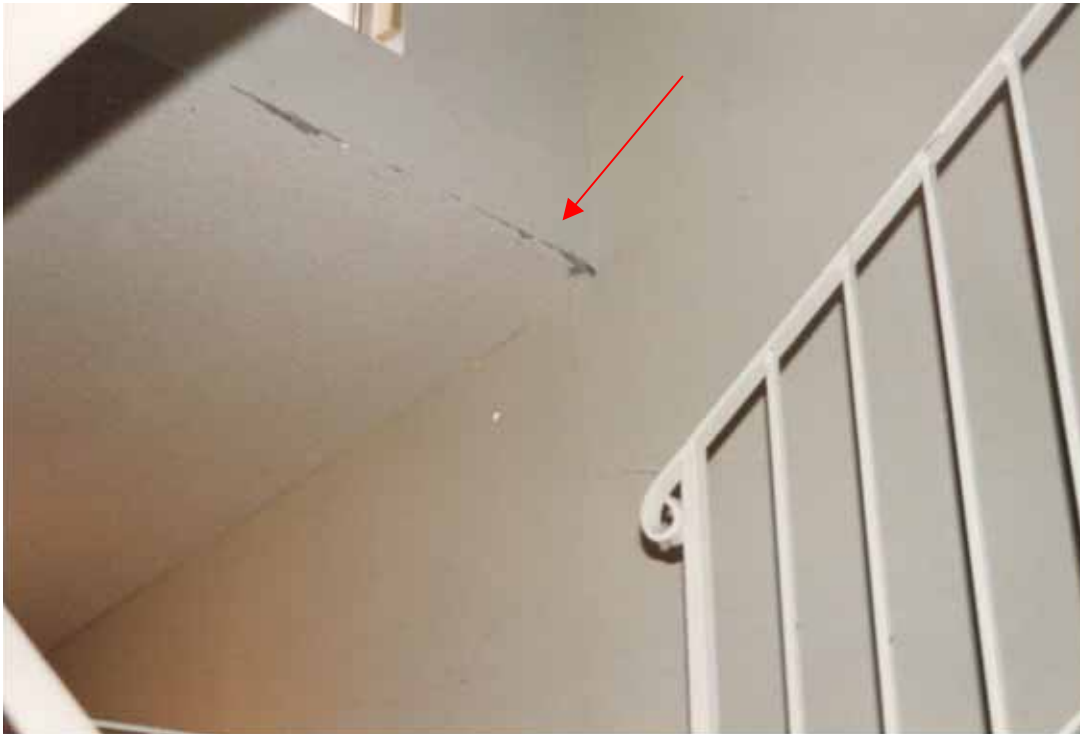
Figure 6.22. Earthquake damage to ceiling corner bead at stairwell [Exponent].

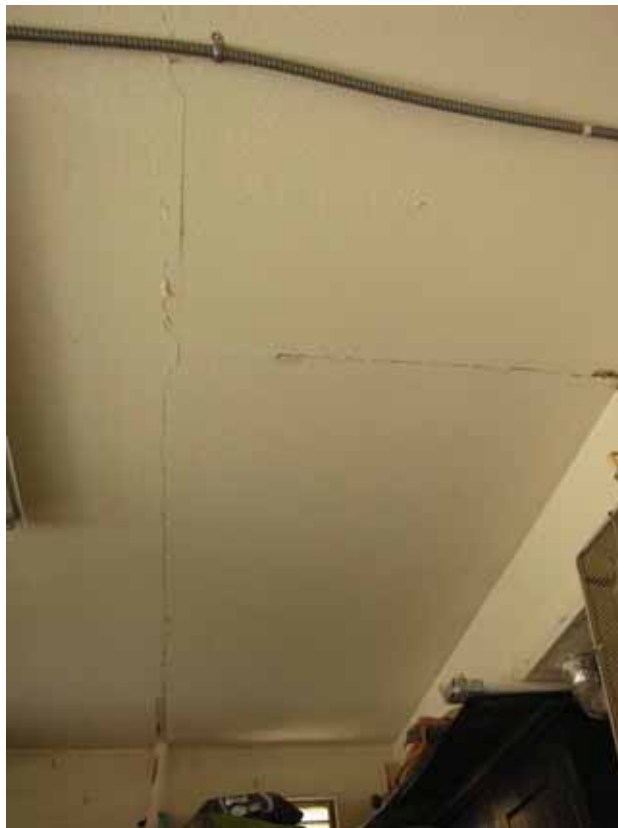
Figure 6.23. Earthquake damage to tape joints at vertical load path discontinuity [Exponent].

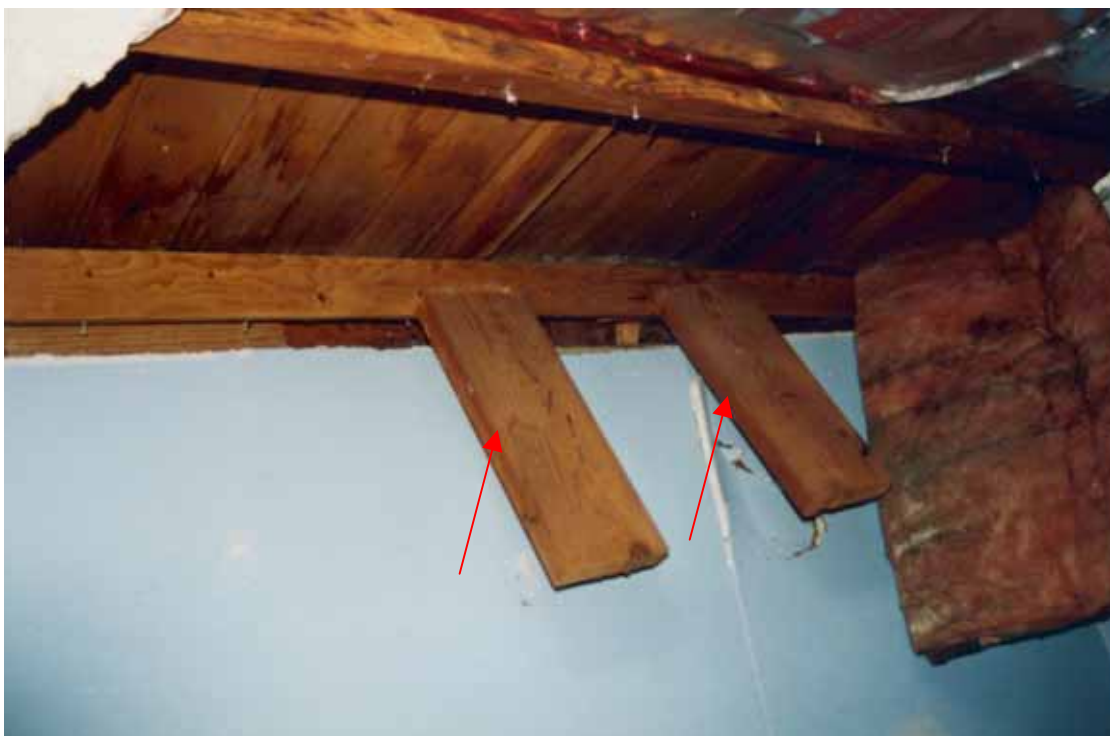
Figure 6.24. Significant earthquake damage to finishes where framing has failed (arrows identify blocking attached to chimney strap) [Exponent].

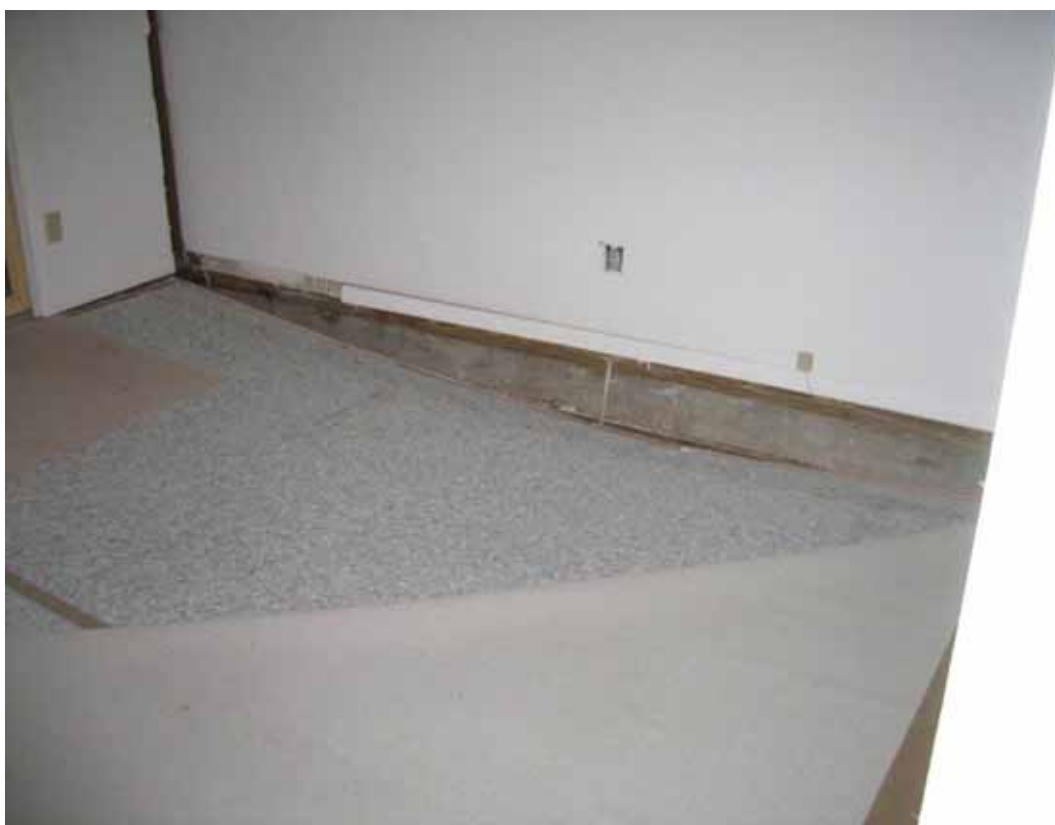
Figure 6.25. Sagging floor due to earthquake-induced shifting and loss of support [Exponent].

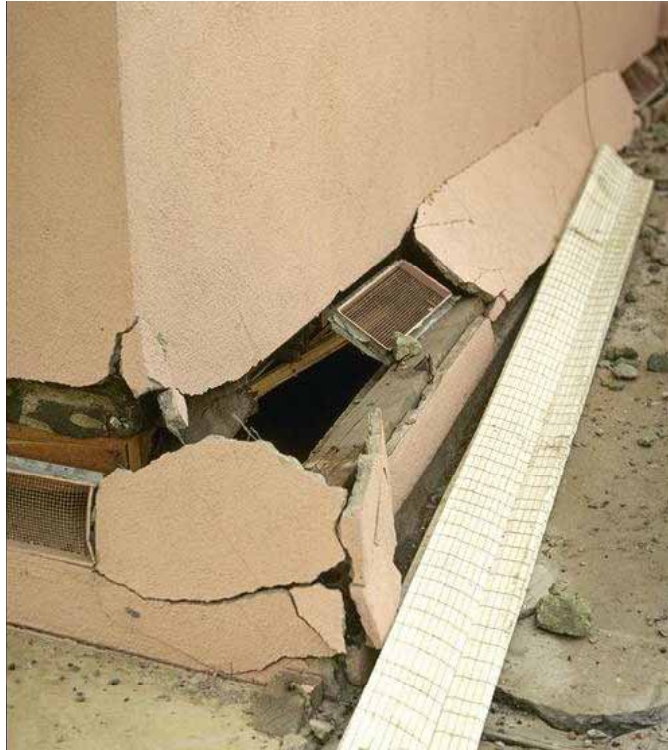
Figure 6.26. Sliding of joists on mudsill due to earthquake [NISEE].

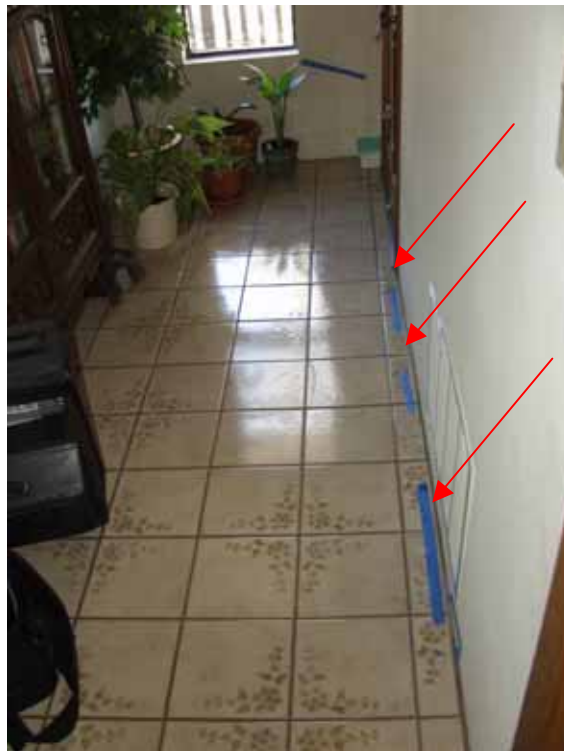
Figure 6.27. Earthquake-induced gap between floor and wall supported on retaining wall on uphill side of house on sloped lot [Exponent].

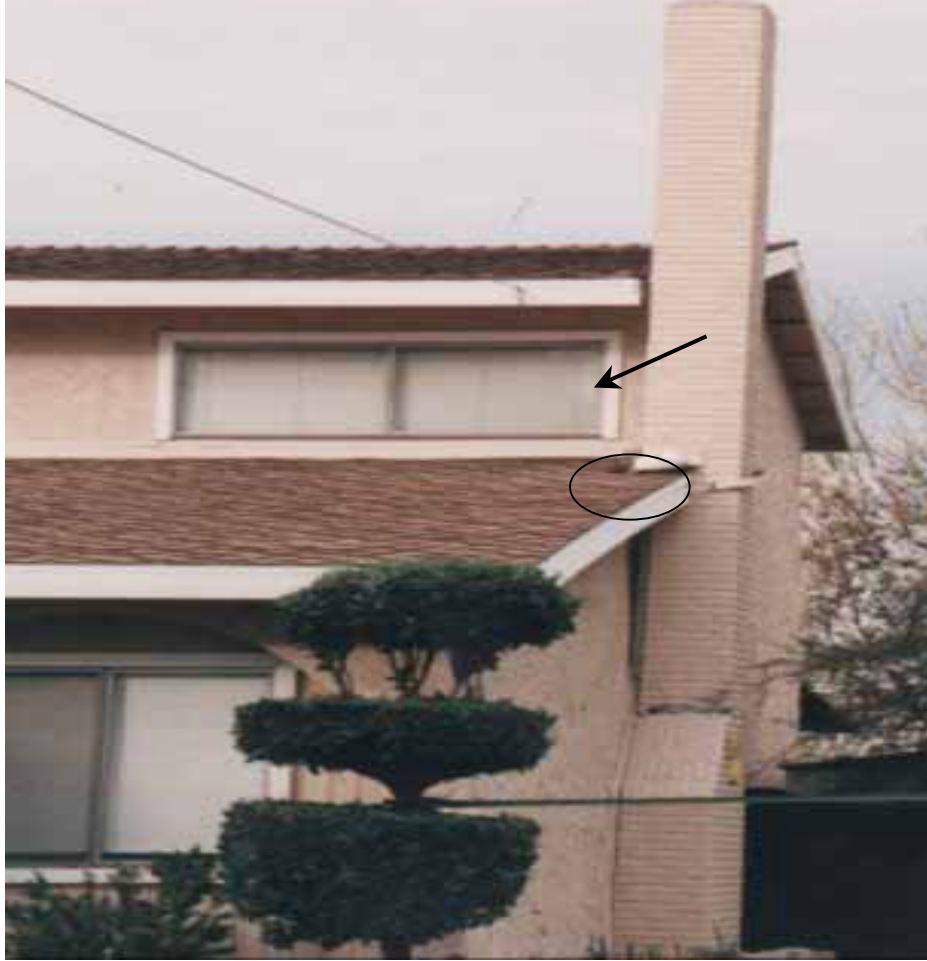
Figure 7.1. Monolithic precast concrete fireplace and chimney that cracked at the shoulder (oval) and pulled away from the building (arrow) due to earthquake.

4. Although not common, monolithic precast or cast-in-place concrete fireplace and chimney units were used in some housing developments in California (Figure 7.1).

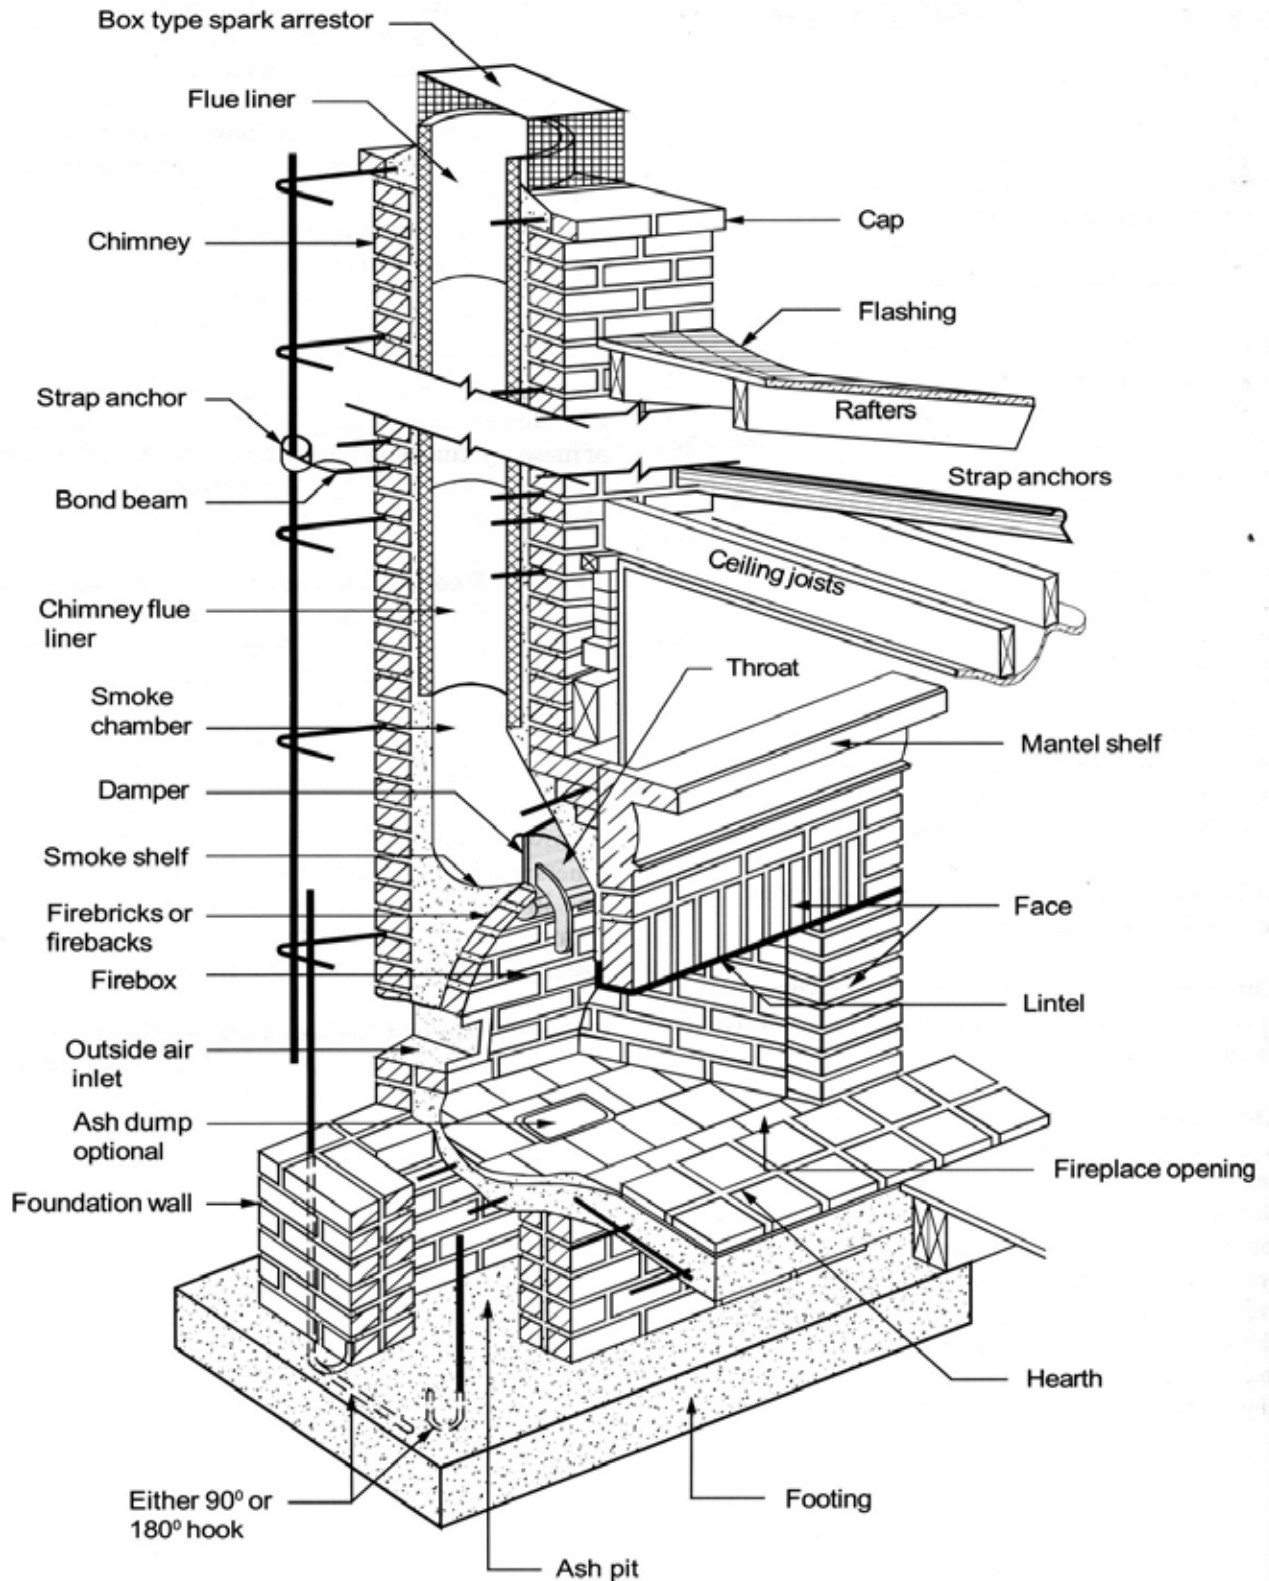
Figure 7.2. Schematic diagram of masonry fireplace and chimney structure [MIA].  
 [From *Masonry Fireplace and Chimney Handbook*, courtesy of the Masonry Institute of America, <http://www.masonryinstitute.org/>.]

As illustrated in Figure 7.2 through Figure 7.4, the main components of a masonry fireplace/chimney structure are:

- Foundation: Generally consists of a poured concrete footing.
- Hearth: Consists of the floor of the firebox and outer hearth which extends beyond the front of fireplace.

- Firebox: Consists of an open chamber lined with refractory brick.
- Face or facing: Is a decorative finish of brick or stone masonry applied over the front edge of the firebox and surrounding wall.
- Chimney: Extends from the top of the fireplace up through the roof.
- Flue liner:<sup>57</sup> Constructed of clay tile which are resistant to the detrimental effects of combustion products.
- Crown or cap: Tops the masonry chimney.
- Steel straps: Anchors the chimney to the building at the ceiling and/or roof level (Figure 7.4).
- Flashing: Seals the intersection between the chimney and the roofing.
- Spark arrester: A metal screen covering the flue to prevent the escape of burning embers.

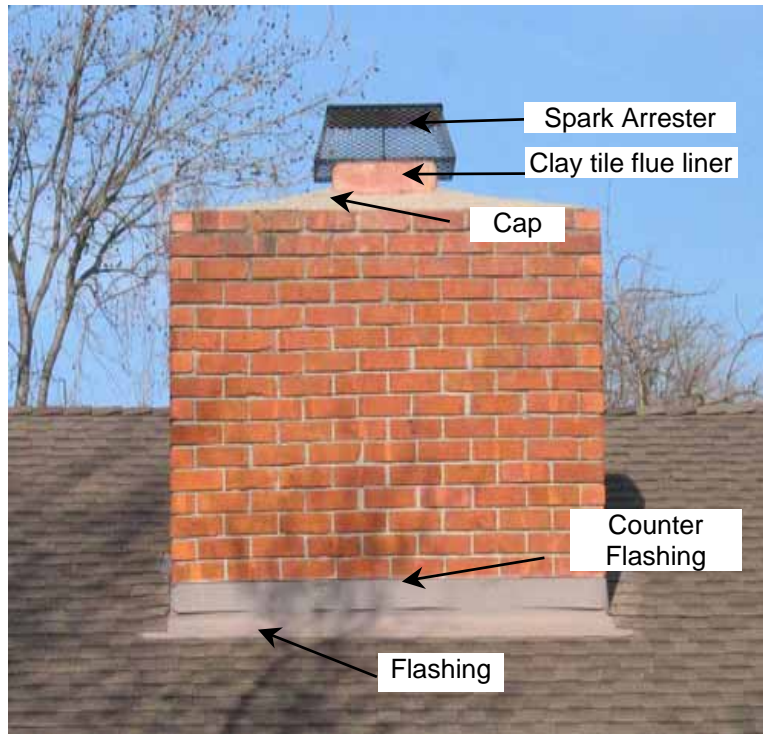
Figure 7.3. Masonry chimney above the roof (no damage) [Exponent].

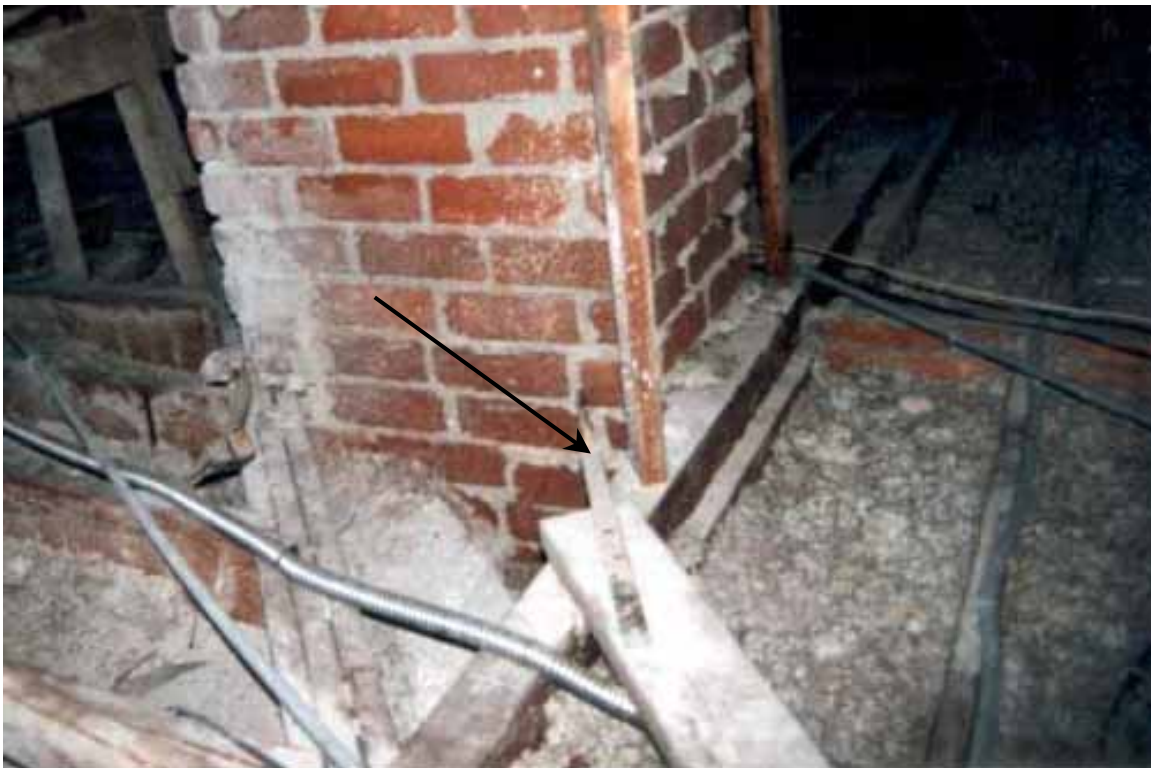
Figure 7.4. Chimney visible in attic – note undamaged steel tie strap between chimney and framing [Exponent].
