GENERAL GUIDELINES  
FOR THE ASSESSMENT AND REPAIR  
OF EARTHQUAKE DAMAGE  
IN RESIDENTIAL WOODFRAME BUILDINGS

Consortium of Universities for Research in Earthquake Engineering

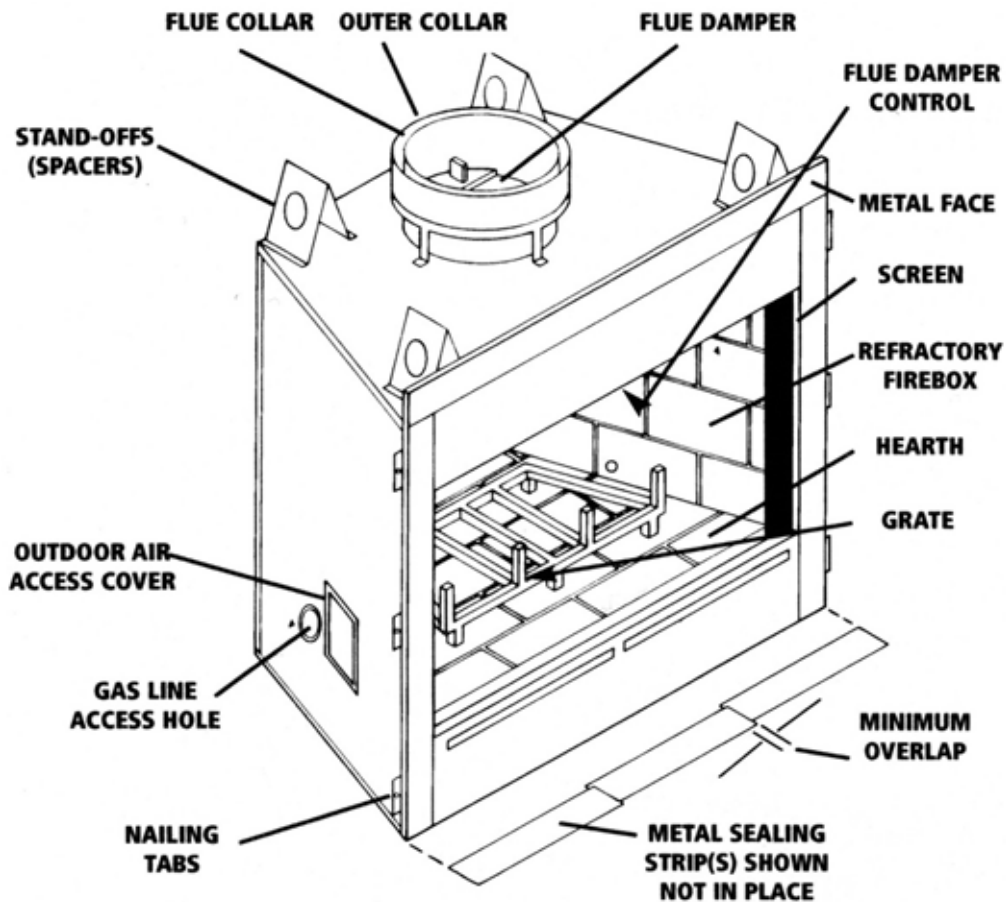
Figure 7.5. Schematic diagram of a factory-built fireplace [HEF].  
 [From *HEARTH Handbook for Building Officials: Solid Fuel Hearth Systems*, where it appeared as “Guidelines for typical firebox installation” on pg. 10, courtesy of the HEARTH Education Foundation.]

Figure 7.5 through Figure 7.9 illustrates components of a factory-built fireplace/chimney:

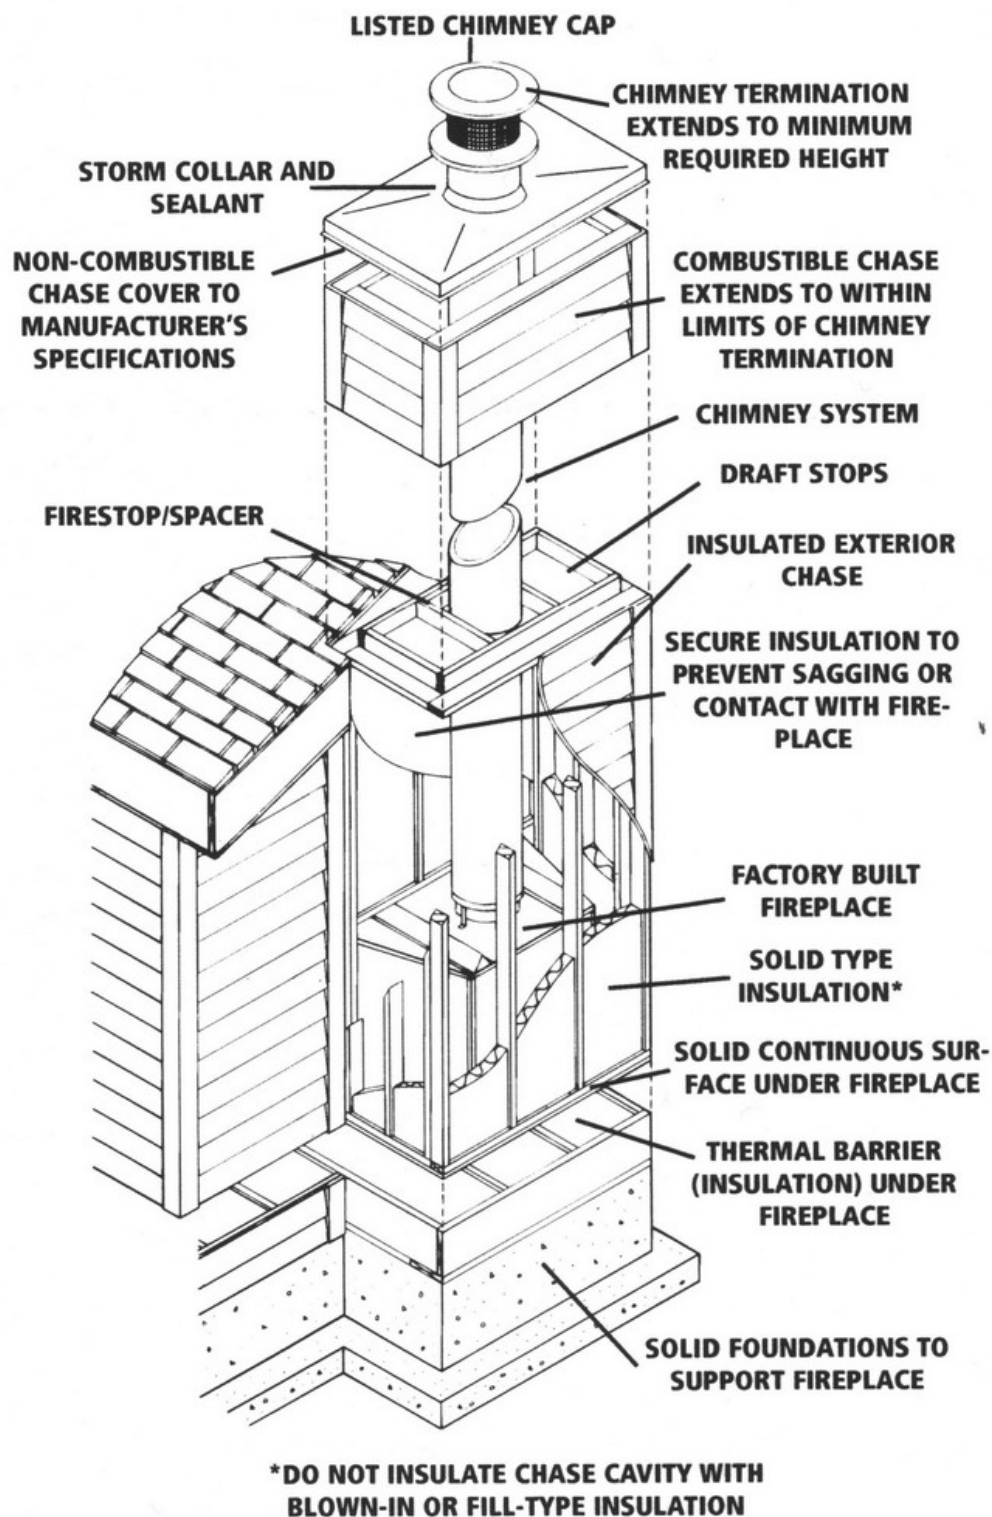
Figure 7.6. Schematic diagram of a factory-built fireplace and chimney assembly [HEF].  
 [From *HEARTH Handbook for Building Officials: Solid Fuel Hearth Systems*, where it appeared as "Guidelines for typical firebox installation" on pg. 19, courtesy of the HEARTH Education Foundation.]

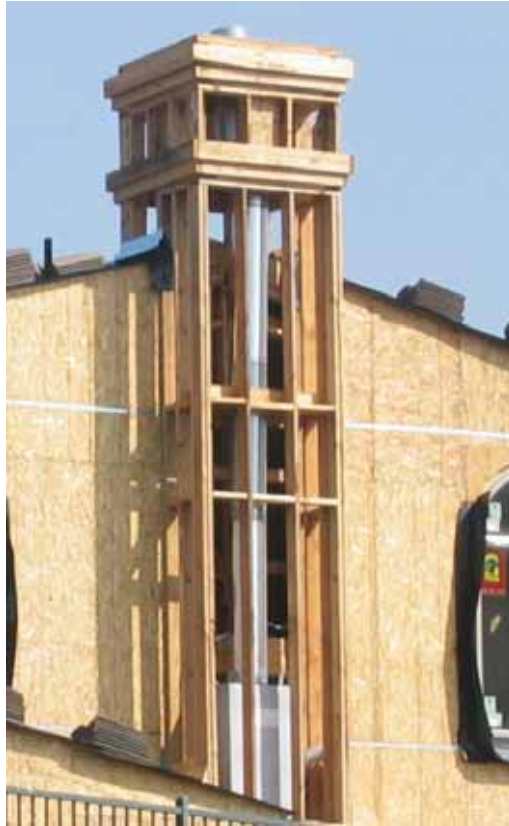
Figure 7.7. Factory-built fireplace and metal flue in woodframe chase during construction (no damage) [Exponent].

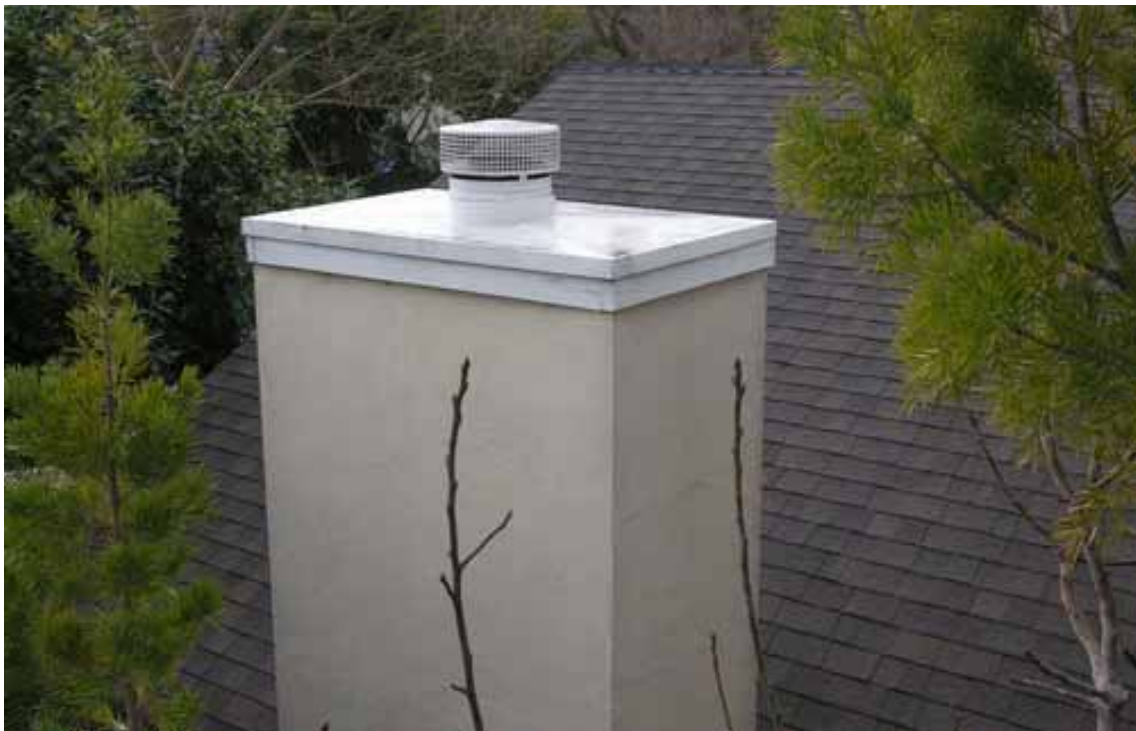
Figure 7.8. Stucco-clad, woodframed chimney chase (no damage) [Exponent].

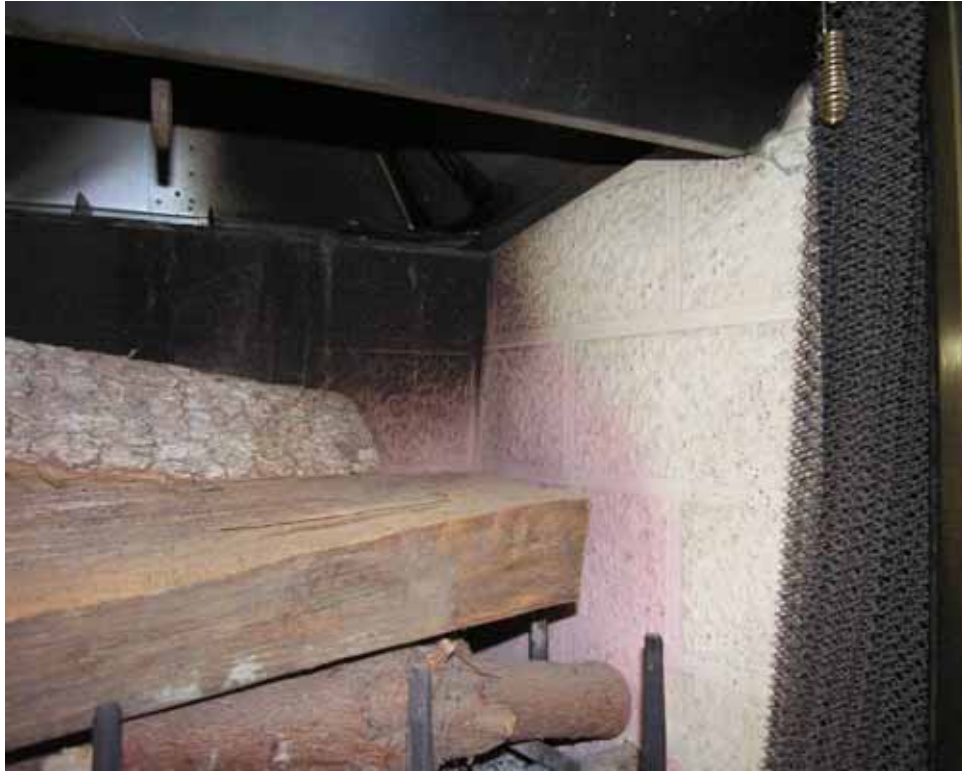
Figure 7.9. Firebox of factory-built fireplace with brick patterned refractory panels (no damage) [Exponent].

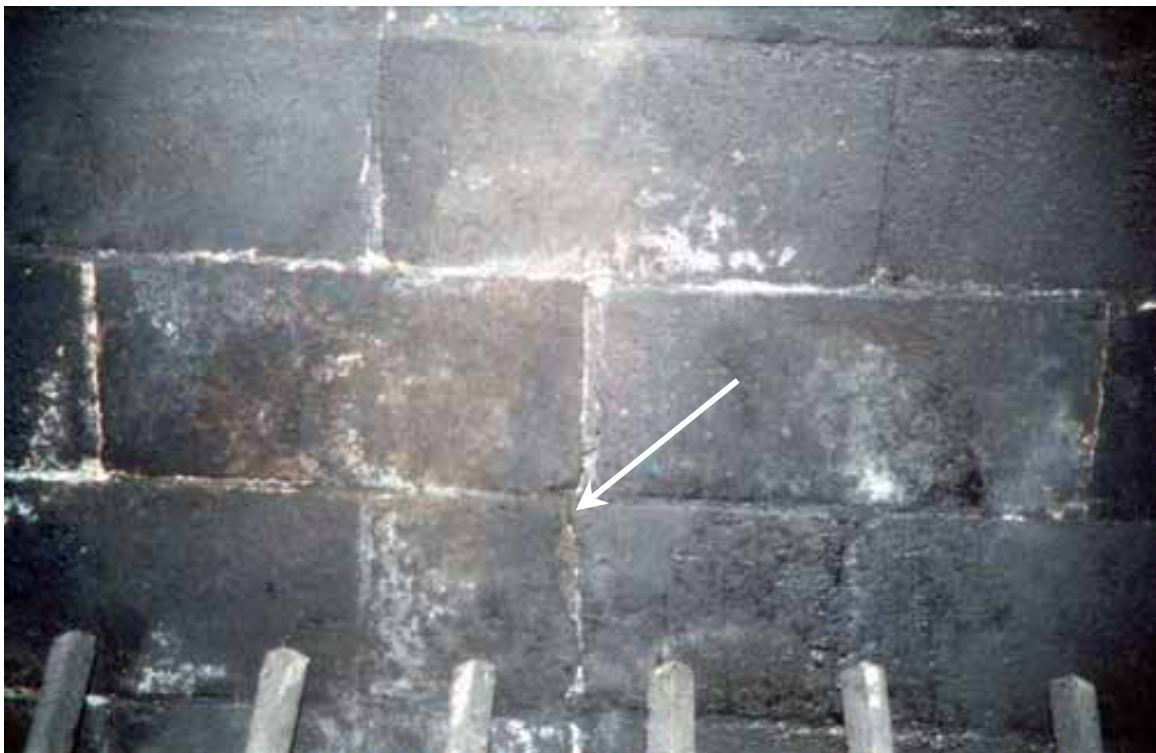
Figure 7.10. Typical thermal cracking of firebrick and mortar lining hearth and firebox of a masonry fireplace (not earthquake damage) [Exponent].

It is extremely common to observe cracked masonry firebrick in the hearth from thermal-related stresses. This cracking can occur along mortar joints and through the firebrick (Figure 7.10). Such cracking generally has rounded edges and is limited in size and extent. Most of the thermal cracks are less than 1/16-inch wide.

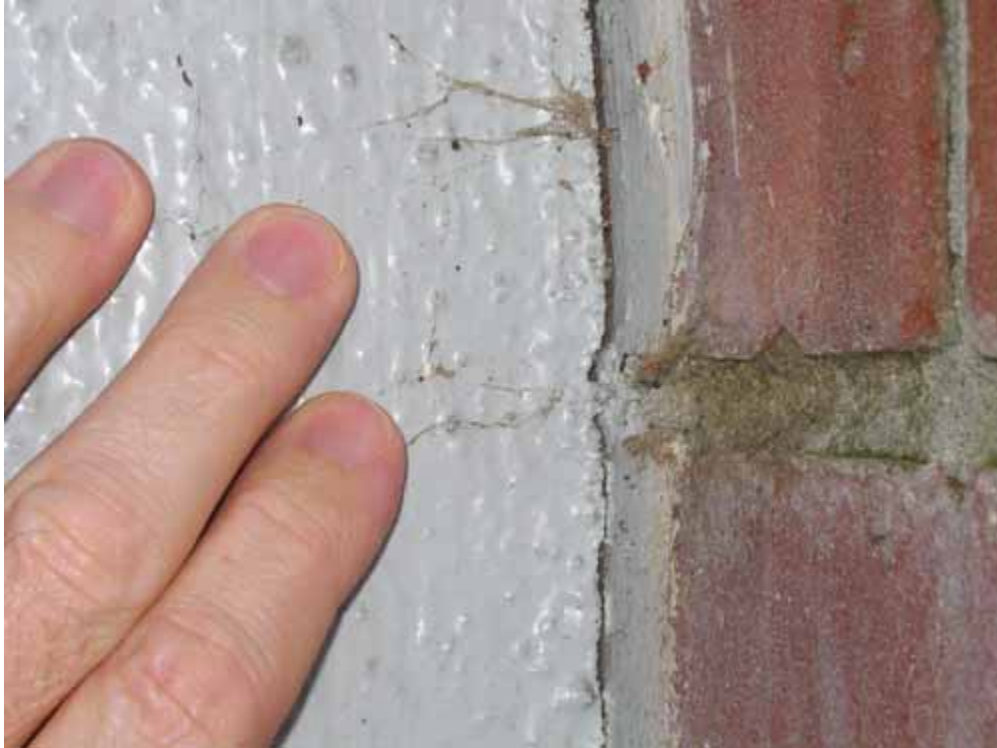
Figure 7.11. Normal crack between masonry fireplace/chimney and exterior stucco wall (not earthquake damage) [Exponent].

- Hairline crack between masonry and exterior wall: A cold joint or discontinuity exists between masonry fireplace/chimneys and the surrounding wall finishes. Hairline cracking at the joint is normal (Figure 7.11).

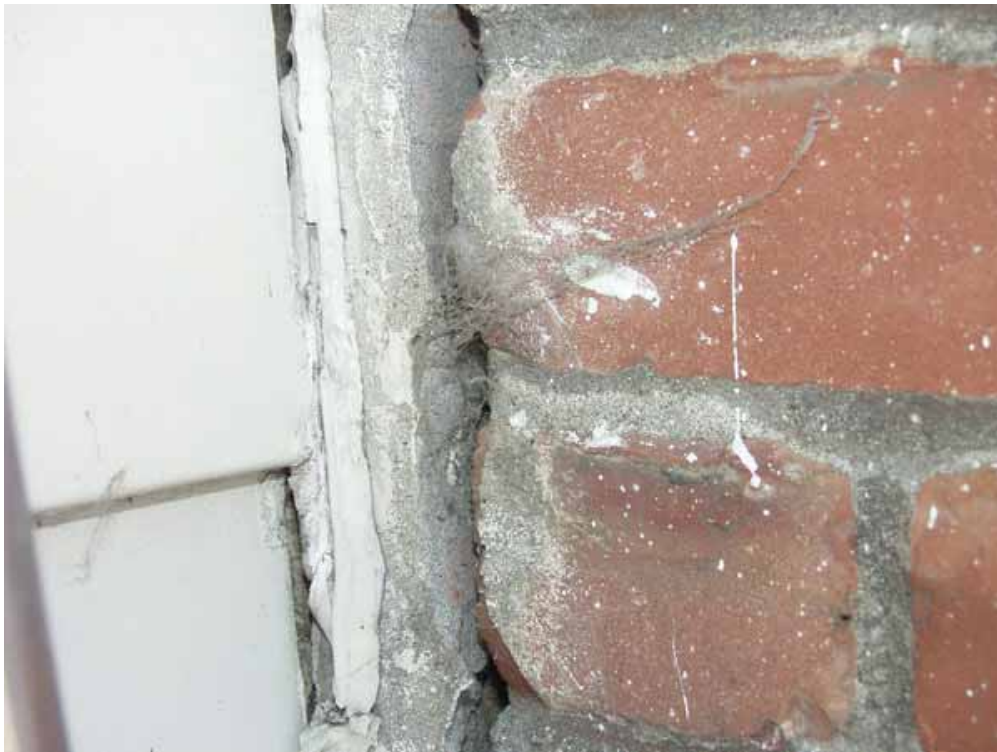
Figure 7.12. Gap between chimney and house – note mortar filler used to fill previous gap, movement since that repair, paint in gap, cobweb spanning gap (not earthquake damage) [Exponent].

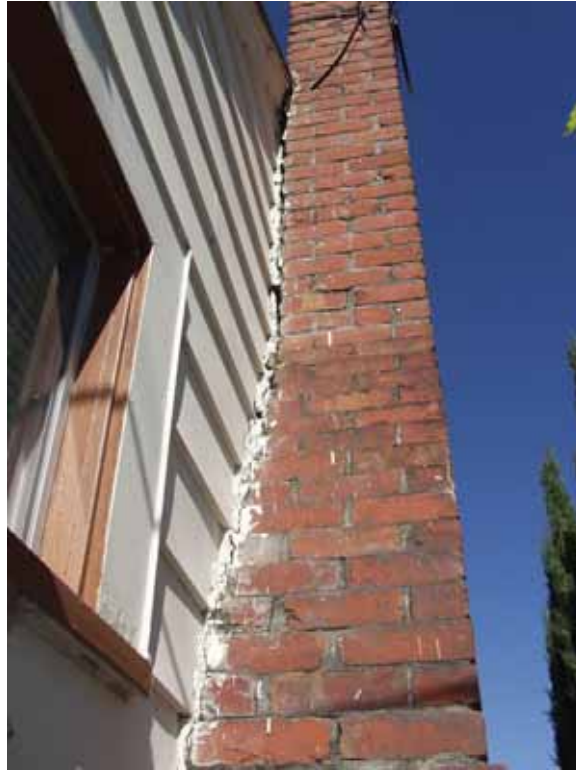
Figure 7.13. Tapered gap between chimney and house that has resulted from long-term differential settlement of fireplace foundation; note mortar filler used to fill previous gap (not earthquake damage) [Exponent].

- Long-term settlement: Compared to the adjacent woodframe building, masonry fireplaces and chimneys are relatively heavy structures, and are often supported on independent, shallow concrete foundations. Differential settlement can occur between the chimney and the house, resulting in distress to the roof flashing and exterior siding or finishes at their interface with the chimney. For a chimney located on an exterior wall, the differential settlement of a chimney foundation can result in gaps (Figure 7.12) between the chimney and house that gradually increase in width towards the top of the chimney (Figure 7.13).

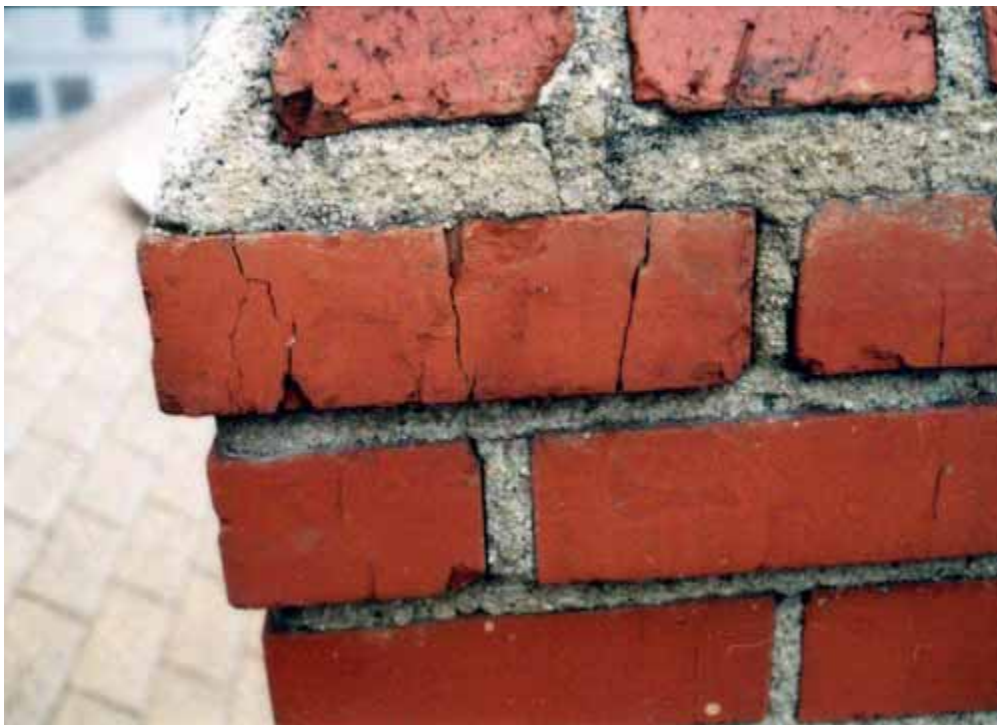
Figure 7.14. Random isolated cracking of brick and mortar joints commonly found on masonry fireplaces and chimneys (not earthquake damage) [Exponent].

- Isolated cracks: Random cracking of individual bricks (Figure 7.14) and random, isolated cracking of mortar joints are commonly found on most chimneys.

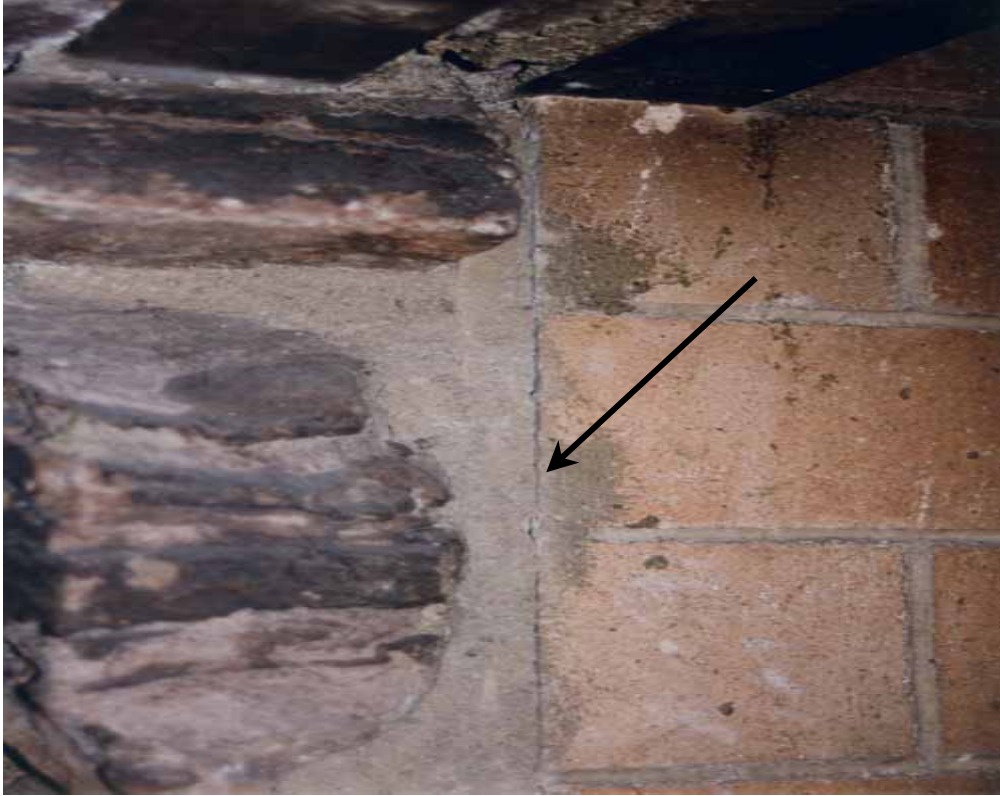
Figure 7.15. Mortar joint between firebox and masonry facing where hairline cracks are frequently found (not earthquake damage) [Exponent].

Interior masonry facings are generally not well secured to either the wall or firebox. As a consequence, hairline cracks are commonly found at the mortar joint between the facing and the firebox (Figure 7.15) and at the intersection or mortar joint between the facing and wall finishes. Isolated random cracking of the brick or stone and mortar joints of the facing is also common.

Examine fireplace facings for signs of recent separation from or movement relative to, the adjacent wall and relative to the firebox (Figure 7.15).

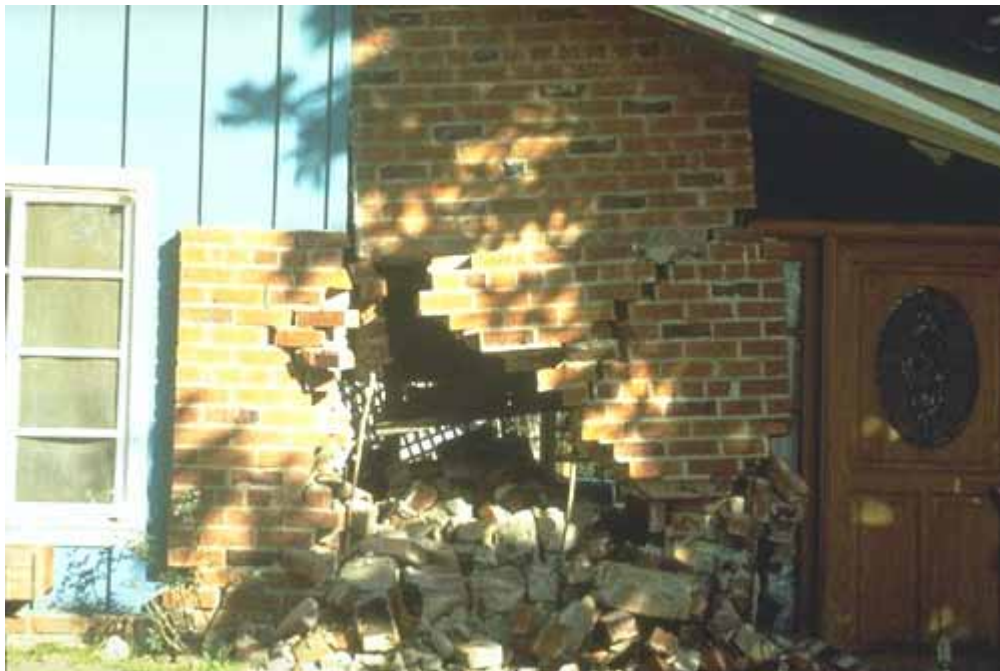
Figure 7.16. Failure of masonry fireplace at firebox level caused by 1994 Northridge Earthquake [Reitherman].

The firebox of masonry fireplaces typically will not be damaged during an earthquake, but will, in general, exhibit cracking as a result of thermal stresses that develop during normal usage. Earthquake-related cracking of the firebrick requires significant and obvious damage to the surrounding masonry structure (Figure 7.16).

- “Bending” failures where horizontal cracks develop (generally at the roof line or shoulder at the top of the fireplace) and the upper portion of the chimney may shift or topple (Figure 7.17 through Figure 7.22).
- Failures at and below the firebox (Figure 7.16 and Figure 7.23) are less common and often associated with movement of the entire building relative to the foundation.
- Relative movement between the chimney and the woodframe building that may create a gap between the chimney and wall (Figure 7.1, Figure 7.24, and Figure 7.25), damage flashings (Figure 7.26), and possibly damage framing where straps from the chimney are attached (Figure 7.24).
- Separations of outer masonry layers (also called wythes) from inner layers of the chimney masonry.

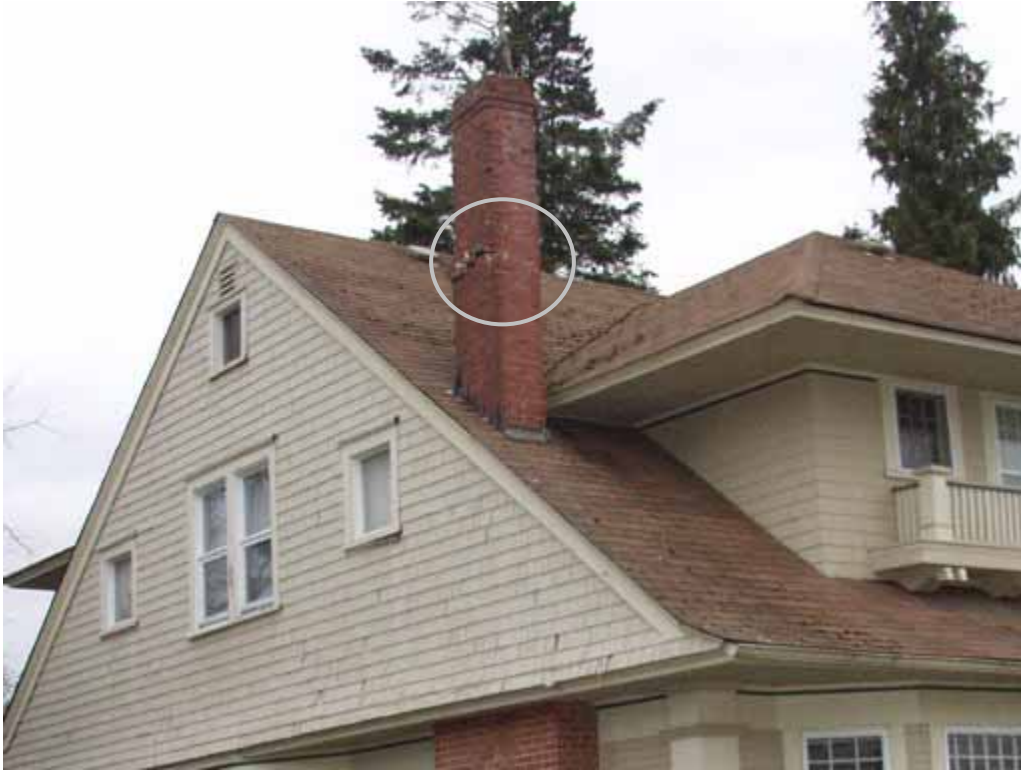
Figure 7.17. Failure of masonry chimney above roofline caused by the 2001 Nisqually Earthquake [Exponent].

When surrounded by the building, the most common location for earthquake damage to masonry chimneys is at the roofline. Unreinforced chimneys have a tendency to either crack or overturn at the roofline during strong ground shaking (Figure 7.17). Chimneys constructed of lime mortars have a tendency to break apart into smaller units of masonry due to the weak strength properties of this mortar (Figure 7.28). Chimneys constructed with Portland cement mortars, although exhibiting higher bond strengths than lime mortars, break apart into larger elements. Reinforced chimneys typically do not suffer serious damage when confined by the building.

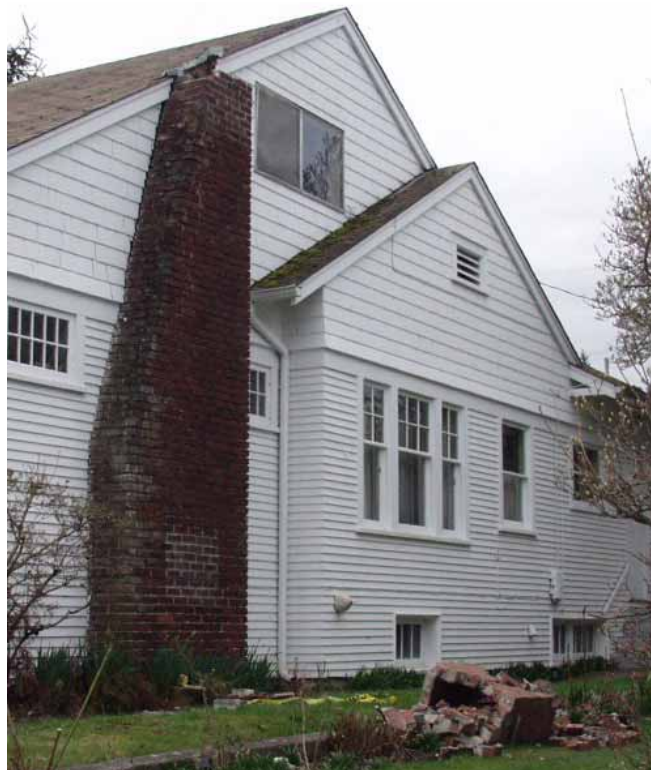
Figure 7.18. Failure of masonry chimney at roofline caused by the 2001 Nisqually Earthquake [Exponent].

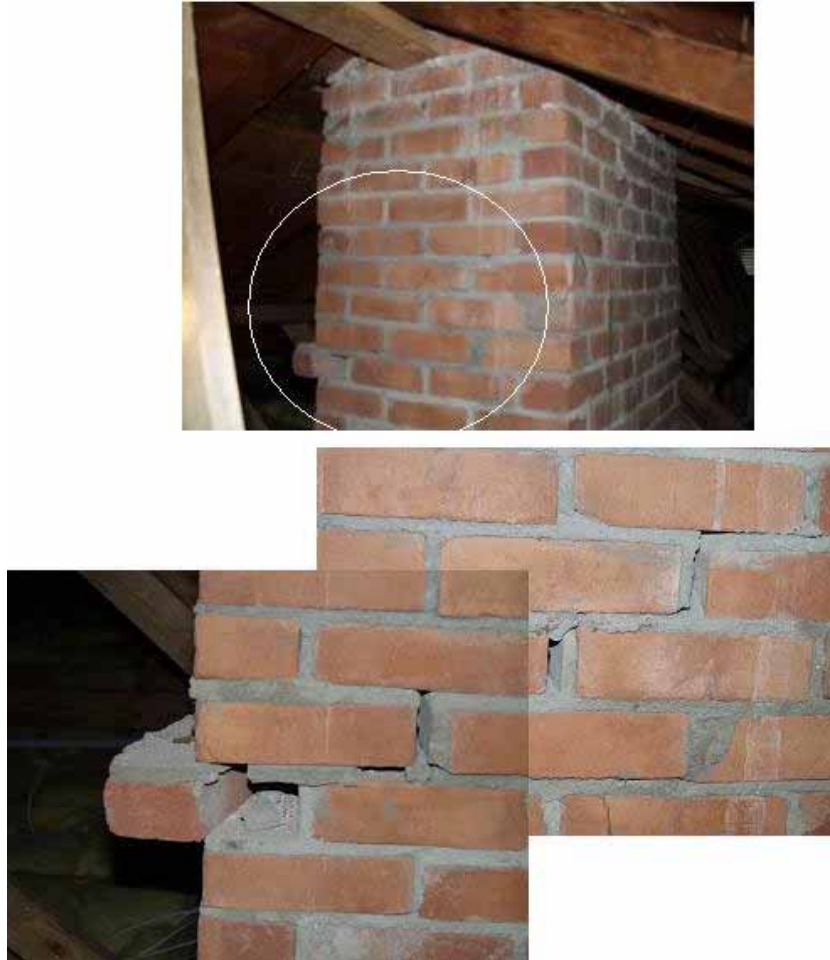
Figure 7.19. Failure of masonry chimney in attic caused by the 1994 Northridge Earthquake [Exponent].

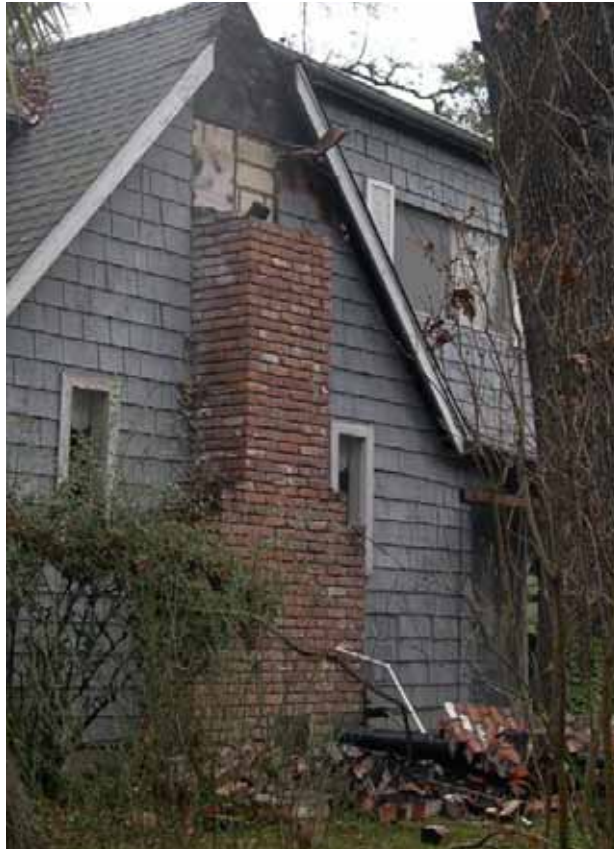
Figure 7.20. Failure of masonry chimney at gable caused by the 2001 Nisqually Earthquake [Exponent].

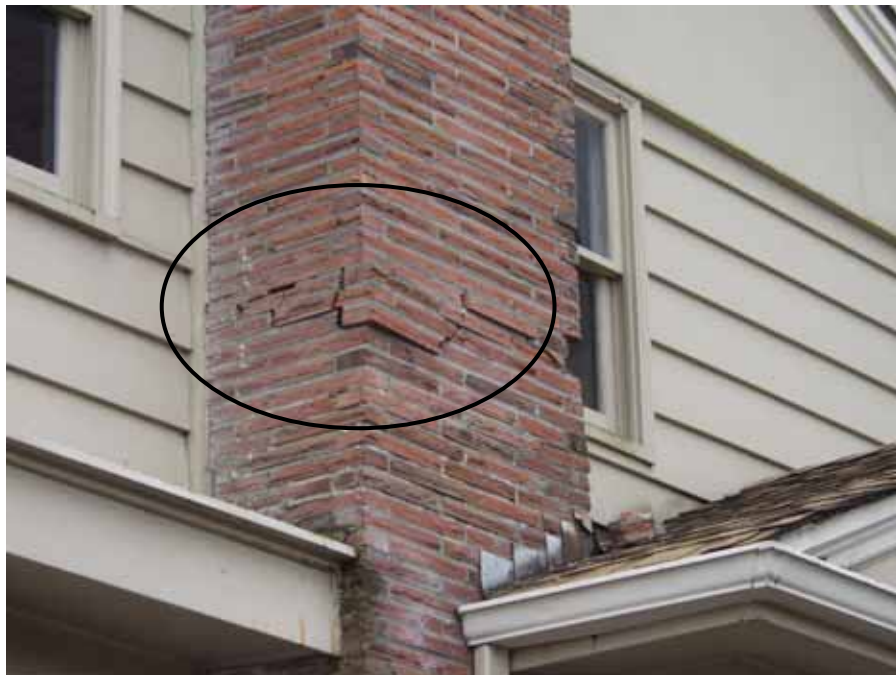
Figure 7.21. Failure of masonry chimney mid-story caused by the 2001 Nisqually Earthquake [Exponent].

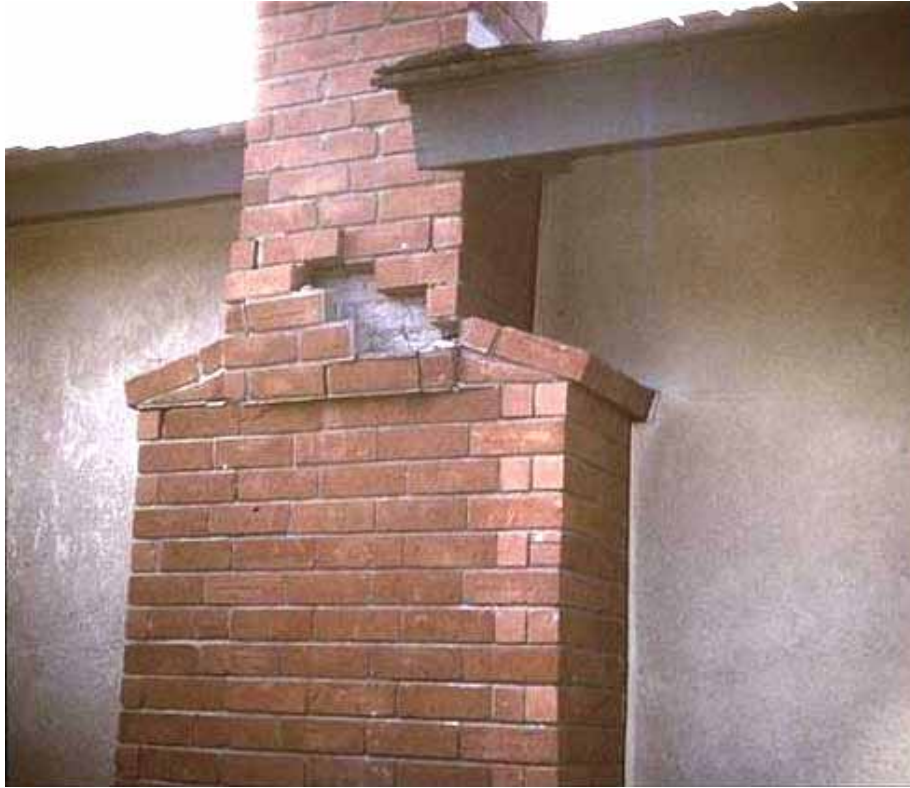
Figure 7.22. Damage to masonry chimney at shoulder.

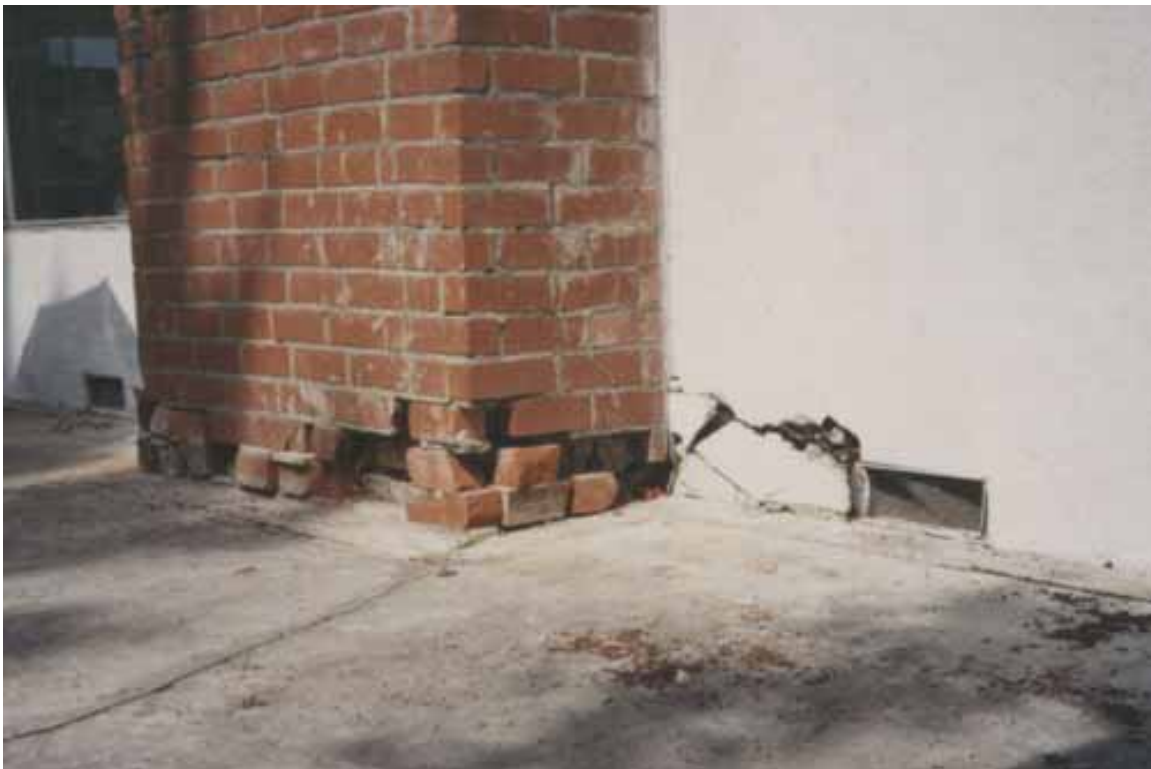
Figure 7.23. Failure of masonry fireplace at foundation level caused by the 1994 Northridge Earthquake [Exponent].

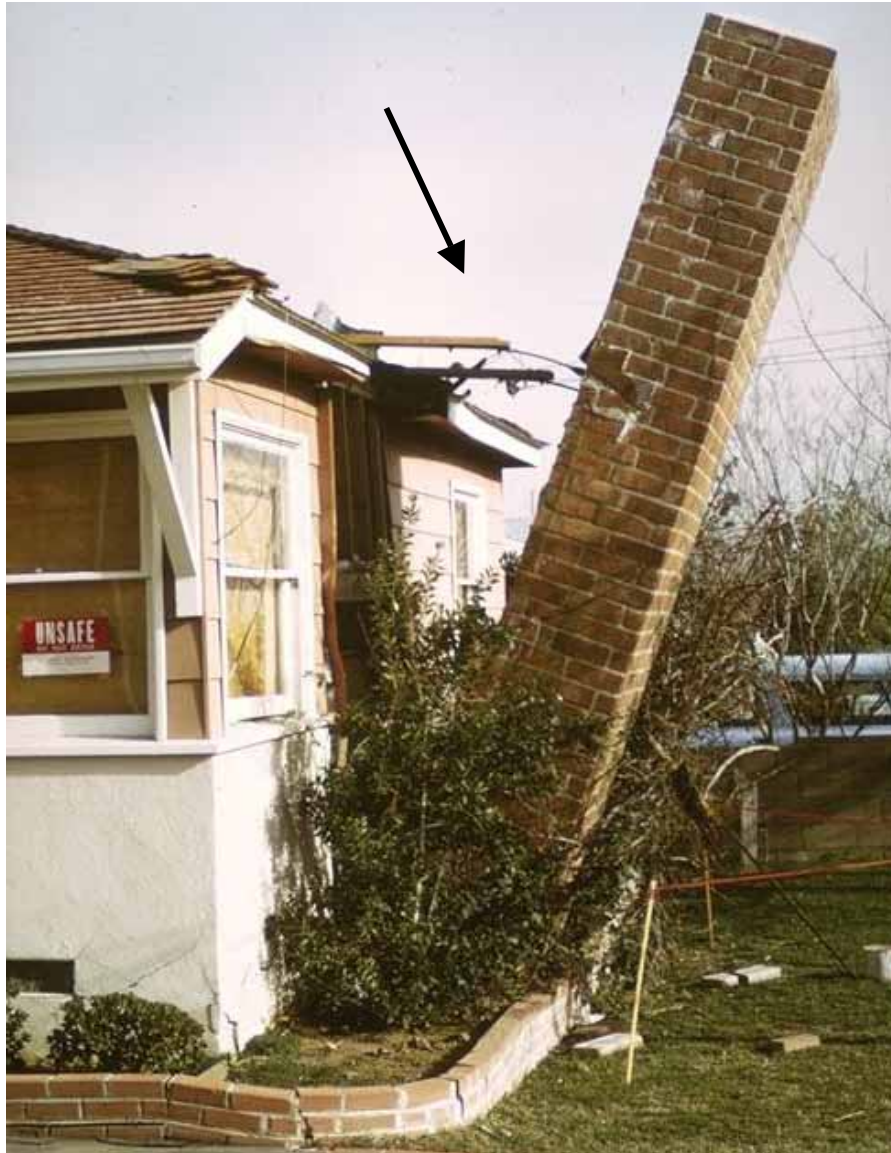
Figure 7.24. Masonry chimney and fireplace that has tilted away from the structure, and torn loose woodframing to which steel tie straps from the chimney were attached – caused by the 1971 San Fernando Earthquake [Cluff].

Chimneys constructed along an exterior wall have a tendency to pull away from the building, either creating a gap between the chimney and building, or completely overturning. Unreinforced chimneys tend to break into smaller sections (Figure 7.29), whereas reinforced chimneys generally hold together and move or overturn about the base as a single unit (Figure 7.24).

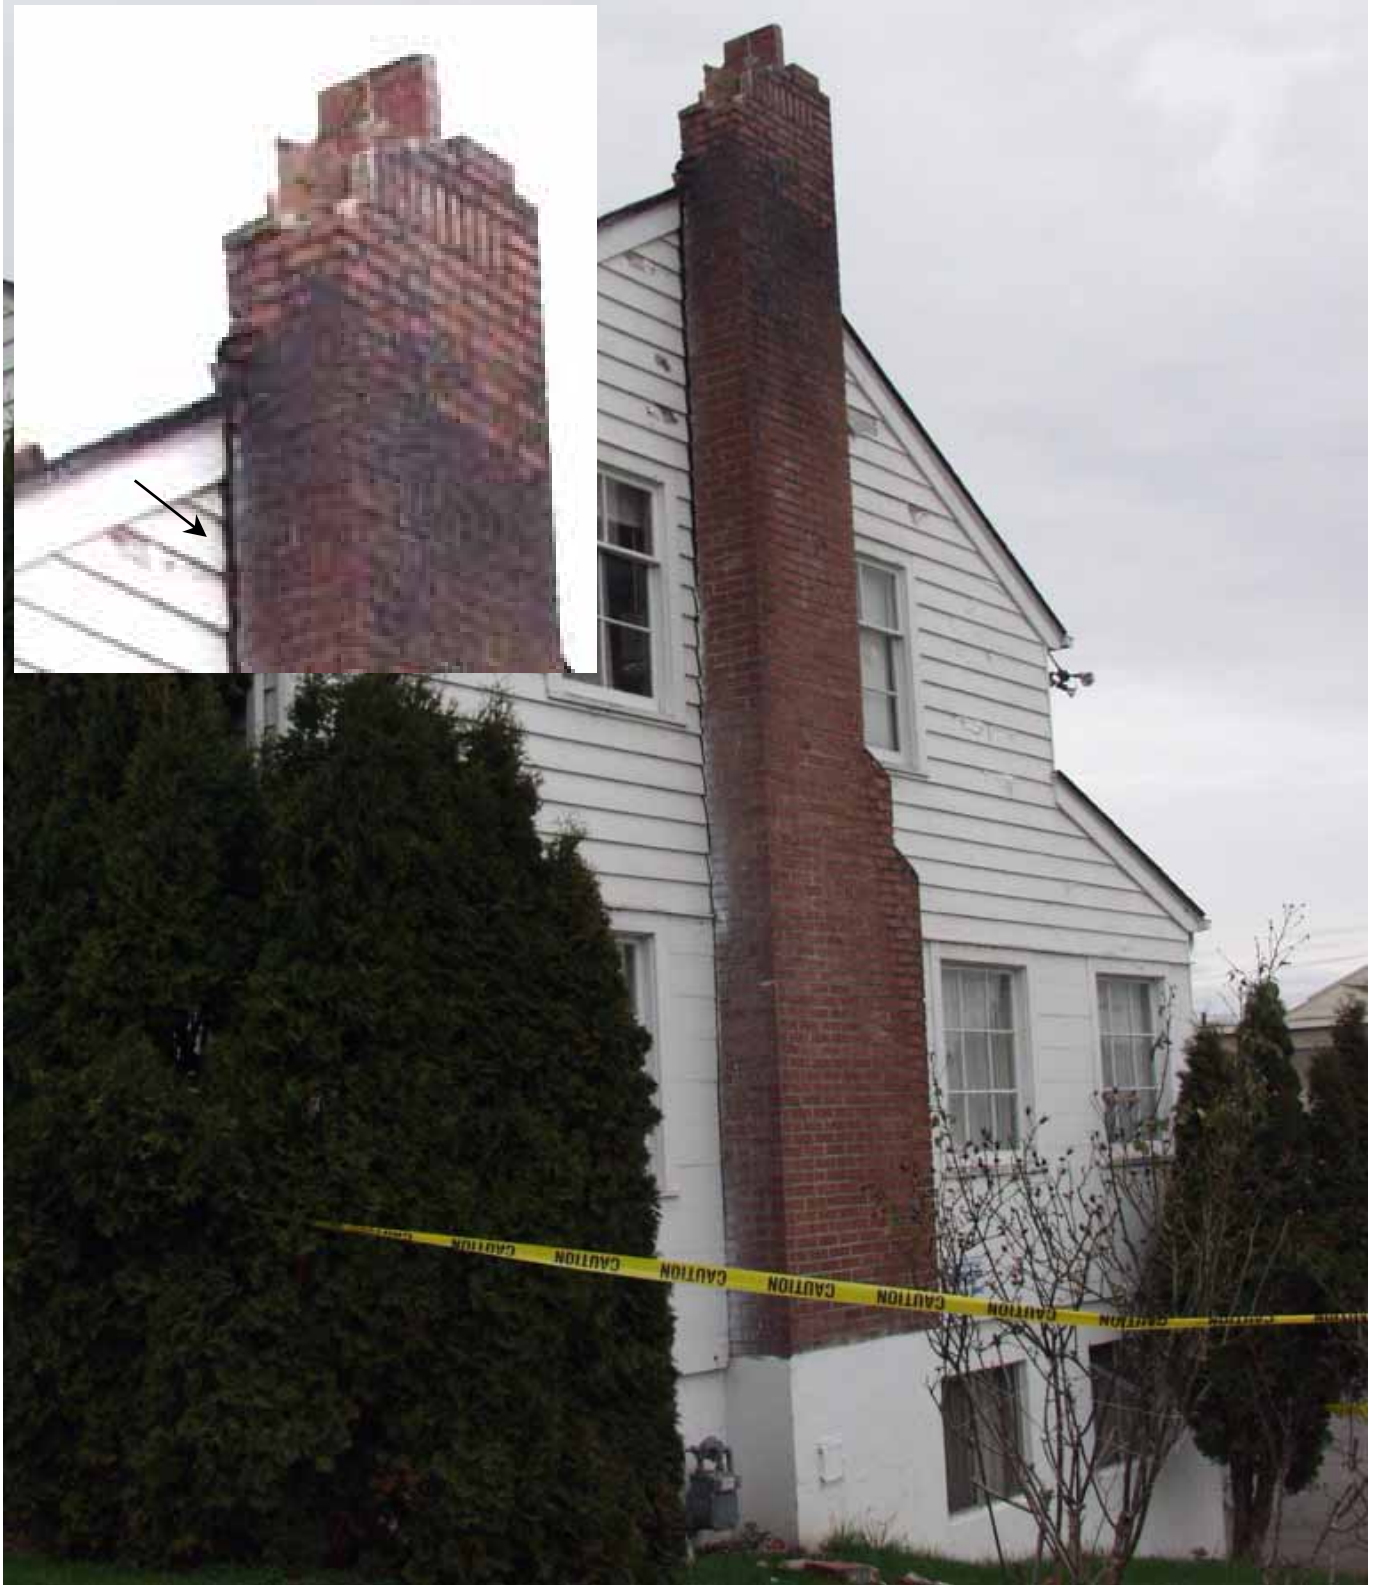
Figure 7.25. Earthquake-induced tapered separation between masonry chimney and exterior wall caused by the 2001 Nisqually Earthquake; note also damage to top of chimney due to deterioration of mortar [Exponent].

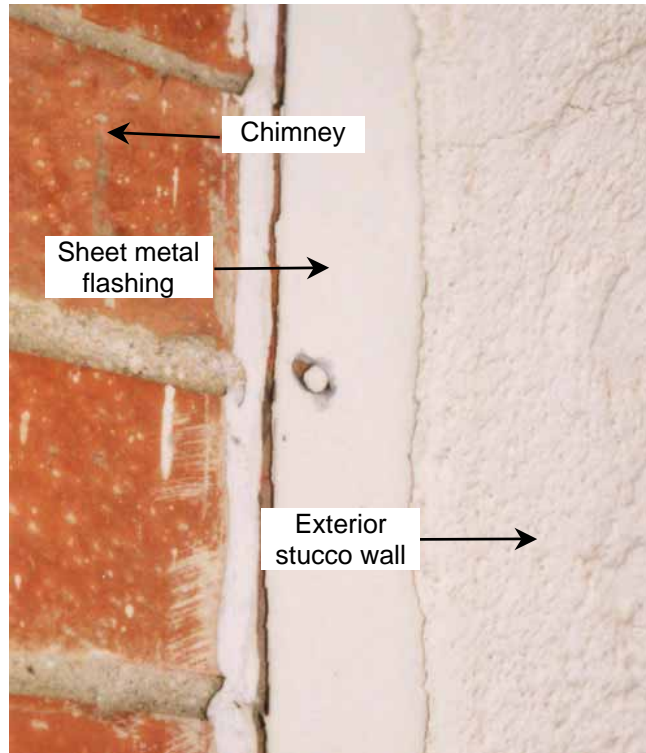
Figure 7.26. Relative cyclic movement between chimney and building during the 1994 Northridge Earthquake indicated by elongated hole in metal flashing and gap between caulking and flashing [Exponent].

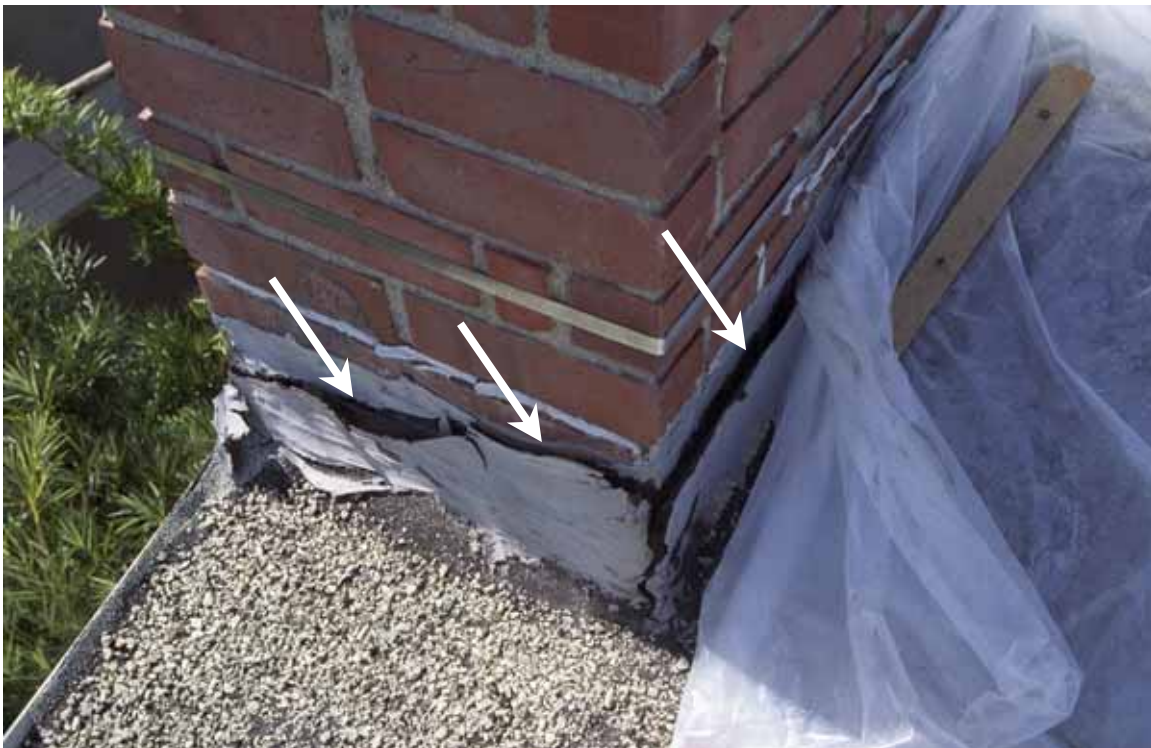
Figure 7.27. Tearing of flashing between chimney and roof caused by relative movement between chimney and building during 1994 Northridge Earthquake [Exponent].

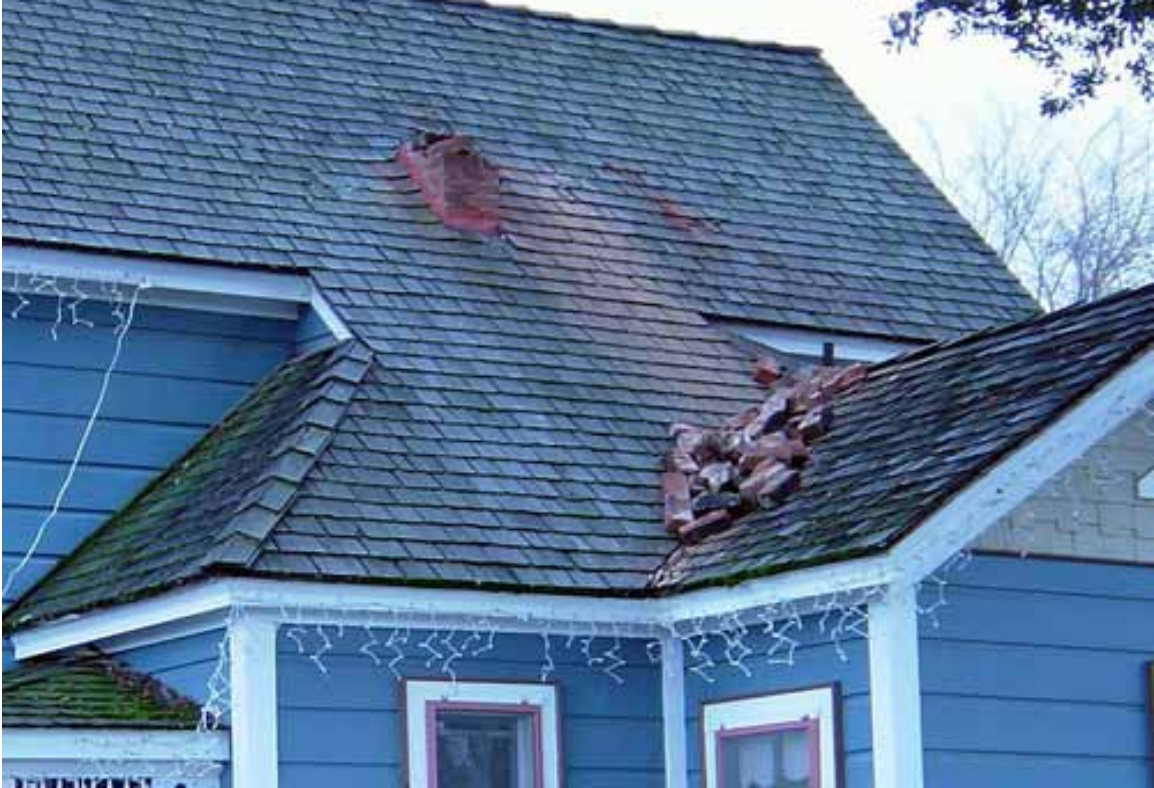
Figure 7.28. Rooftop debris from collapse of masonry chimney during the 2003 San Simion Earthquake [Dyce].

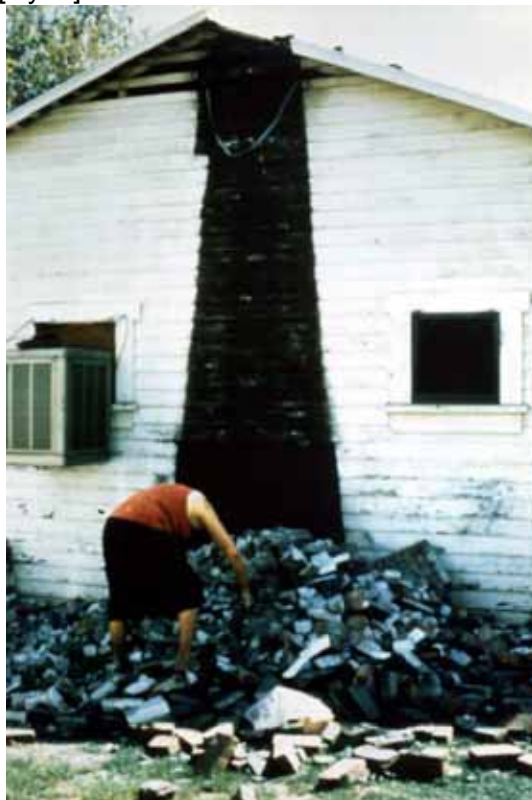
Figure 7.29. Collapsed unreinforced masonry chimney.

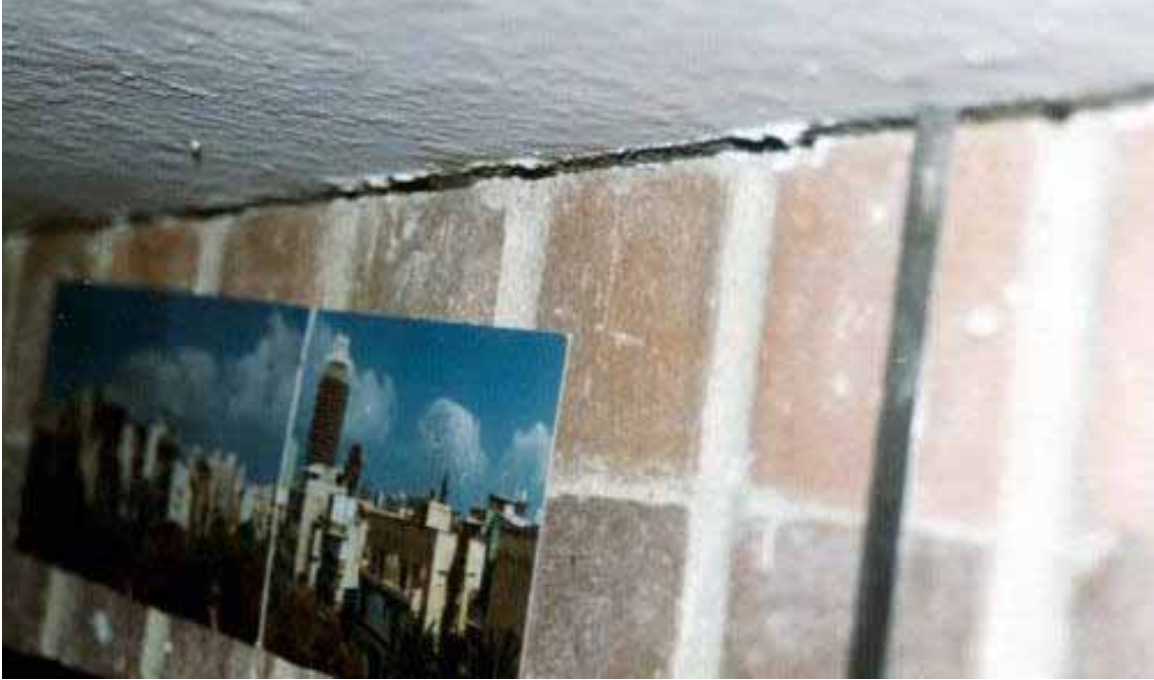
Figure 7.30. Masonry mantle which separated slightly from the wall finish during the 1994 Northridge Earthquake [Exponent].

Interior masonry facings are often not well secured. Consequently, they may pull away from the wall (Figure 7.30) or collapse (Figure 7.31). Hairline cracks at the intersection between the
