GENERAL GUIDELINES  
FOR THE ASSESSMENT AND REPAIR  
OF EARTHQUAKE DAMAGE  
IN RESIDENTIAL WOODFRAME BUILDINGS

Consortium of Universities for Research in Earthquake Engineering

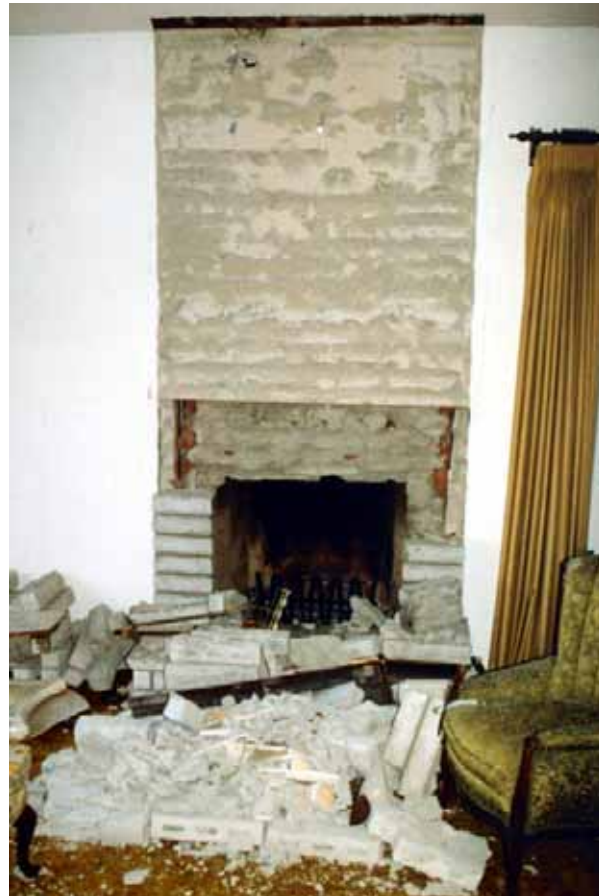
Figure 7.31. Collapsed masonry facing during the 1994 Northridge Earthquake [Exponent].

Interior masonry facings are often not well secured. Consequently, they may pull away from the wall (Figure 7.30) or collapse (Figure 7.31). Hairline cracks at the intersection between the

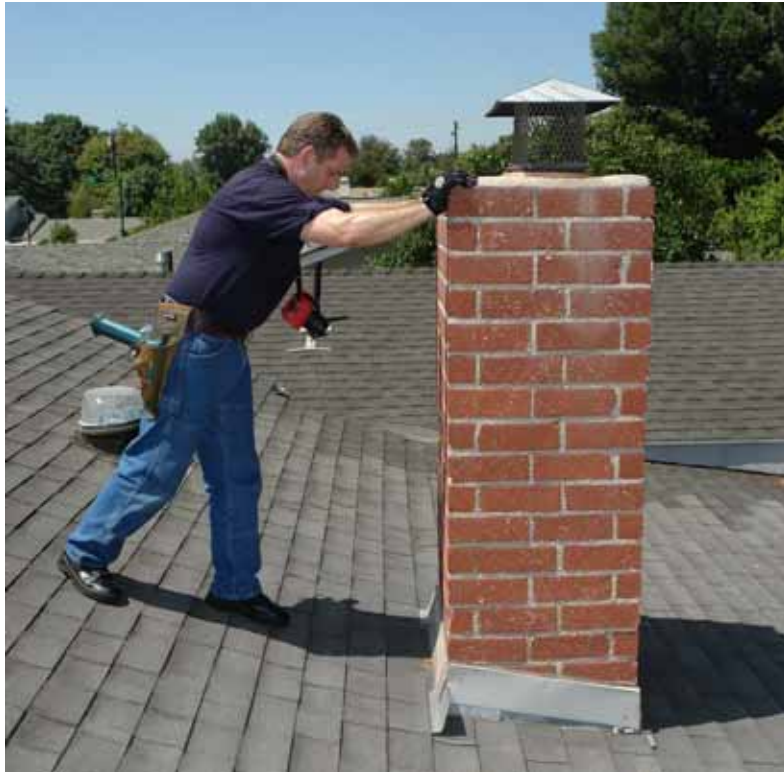
Figure 7.32. Illustration of rocking procedure for checking for chimney for earthquake-induced cracking [Exponent].

- Rooftop: Examine the flashing for evidence of recent movement between the chimney and building. Inspect the flue lining for displacement or damage. Check for cracking by attempting to rock the chimney.
- Attic: Inspect the chimney for evidence of cracking or shifting. Inspect steel straps (if present) at the connections to the framing for signs of distress and movement. Check metal flues for displacement or damage.

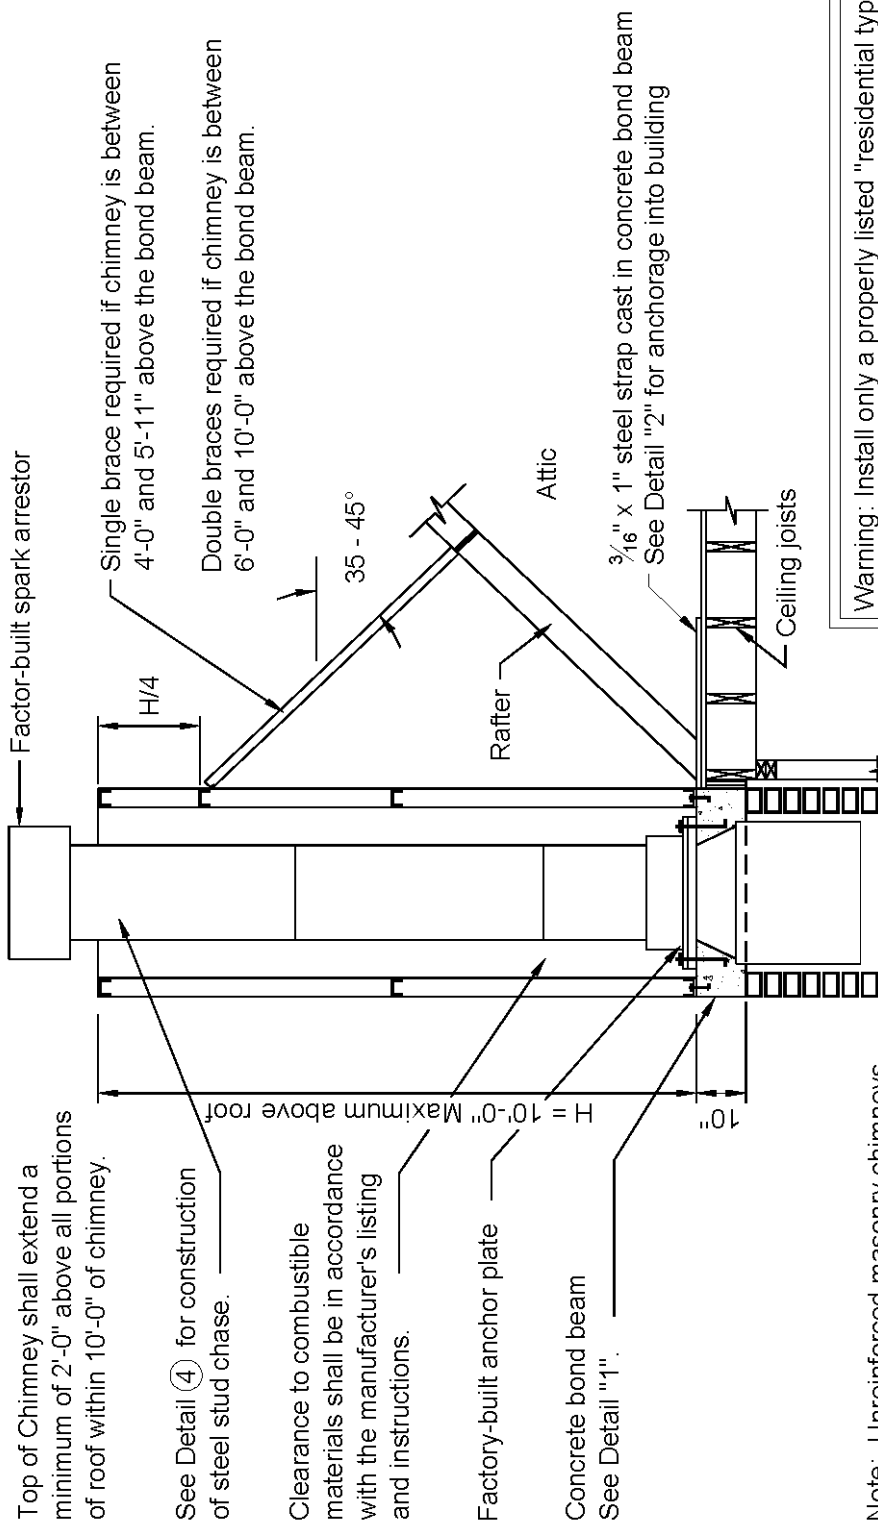
Note: Unreinforced masonry chimneys shall be removed down to the throat.

Warning: Install only a properly listed "residential type and building heating appliance Chimney on wood burning fireplaces. Chimneys for fireplaces with a closed air-tight combustion chamber shall be "TYPE HT" designation. Any other type of chimney may create a potential fire or safety hazard.

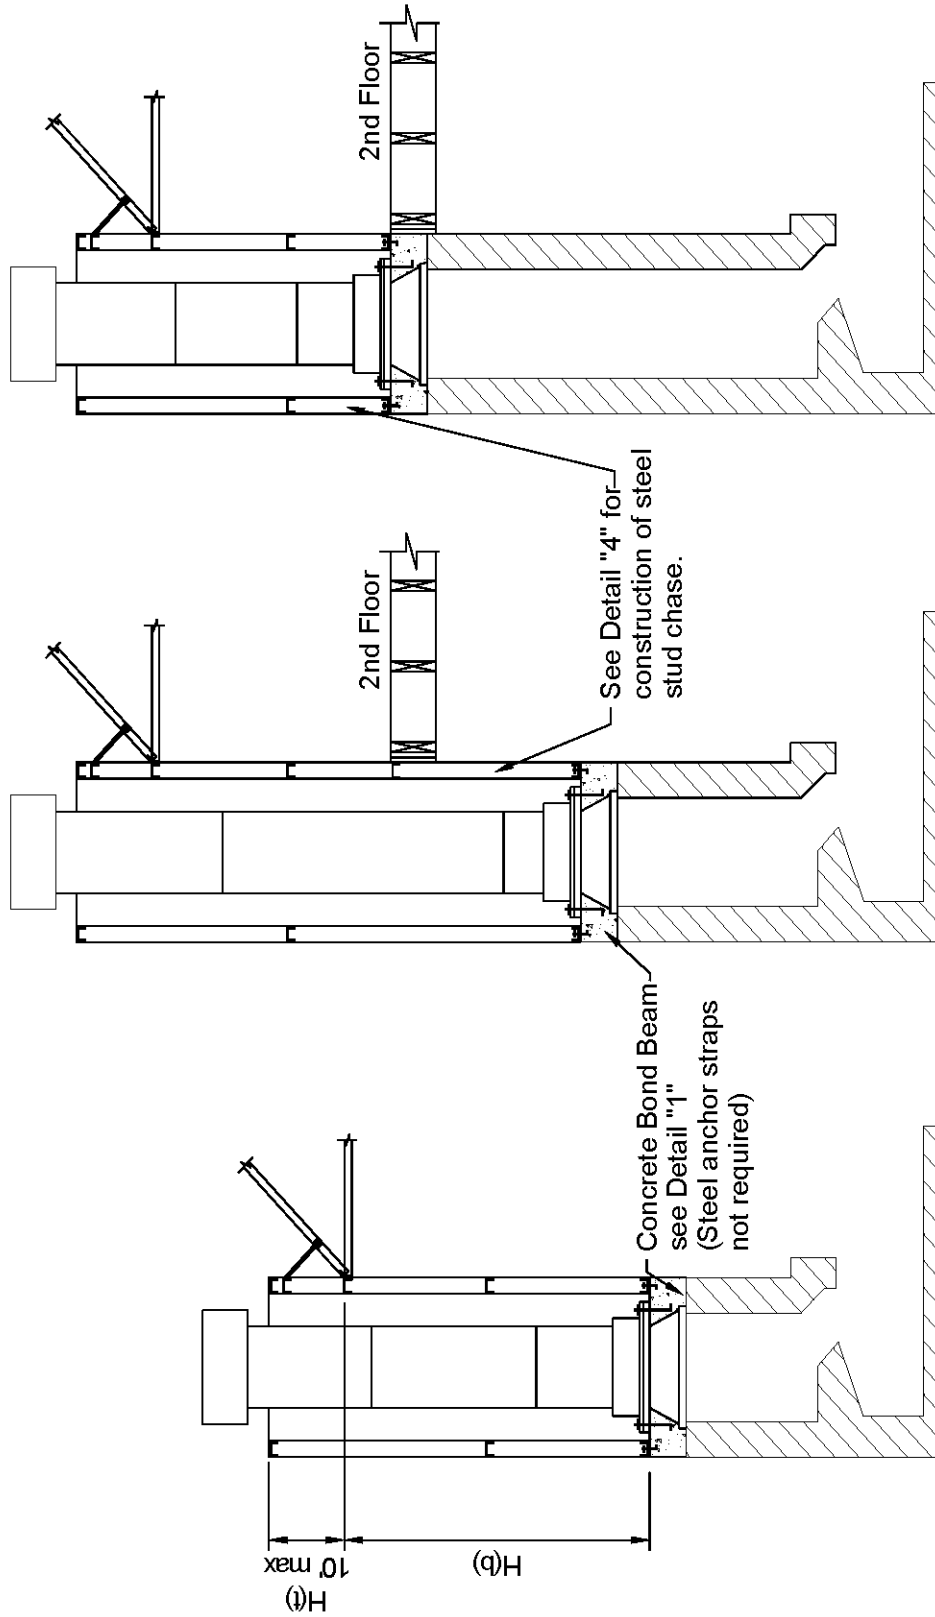
### SECTION

Top of chimney shall extend a minimum of 2'-0" above all portions of roof within 10'-0" of chimney.

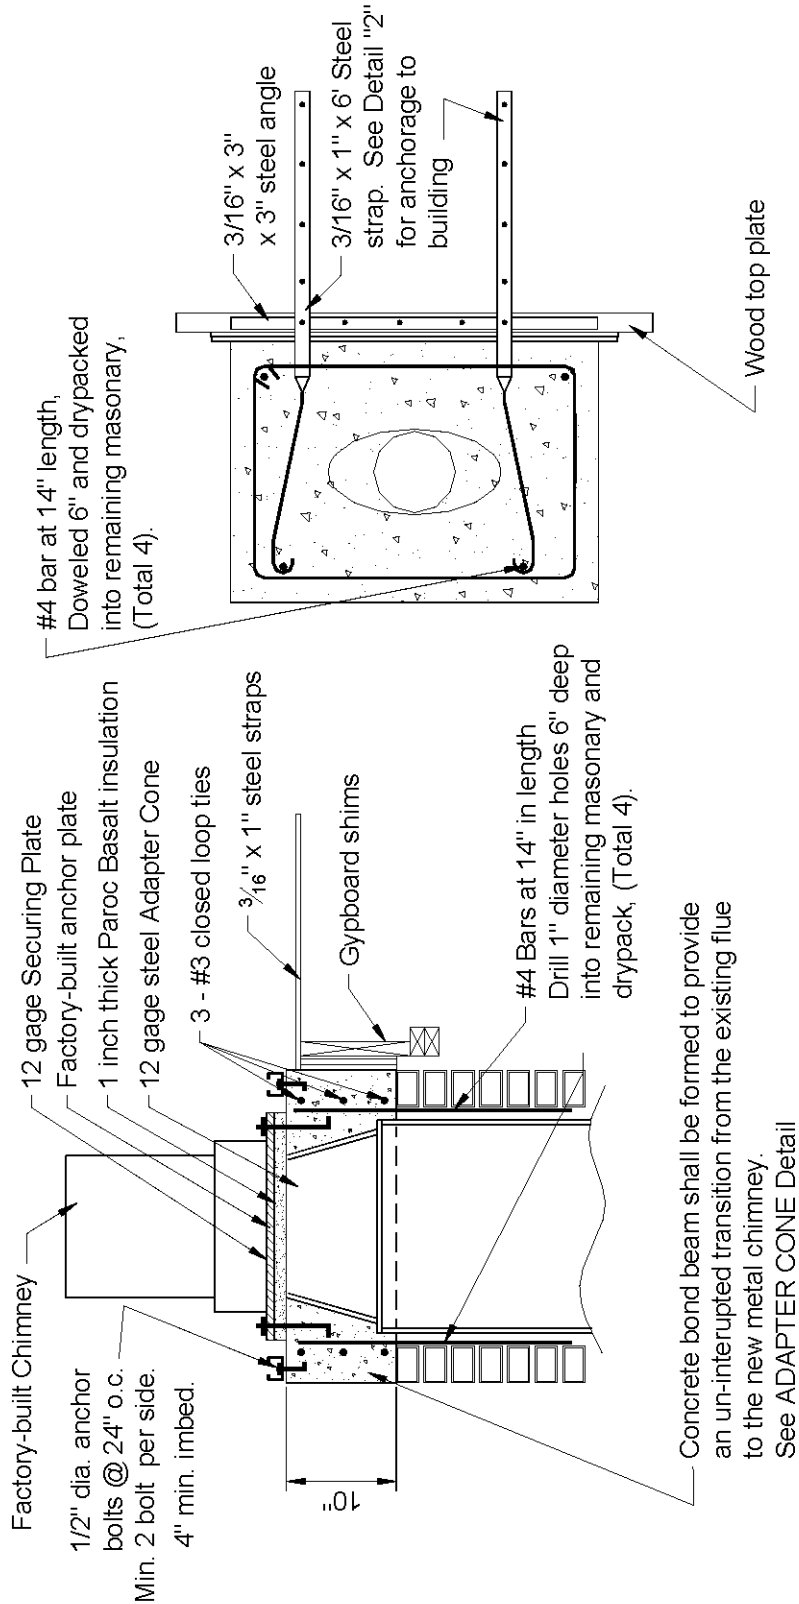
**DETAIL 1**

**Section at Bond Beam**

**Plan View**

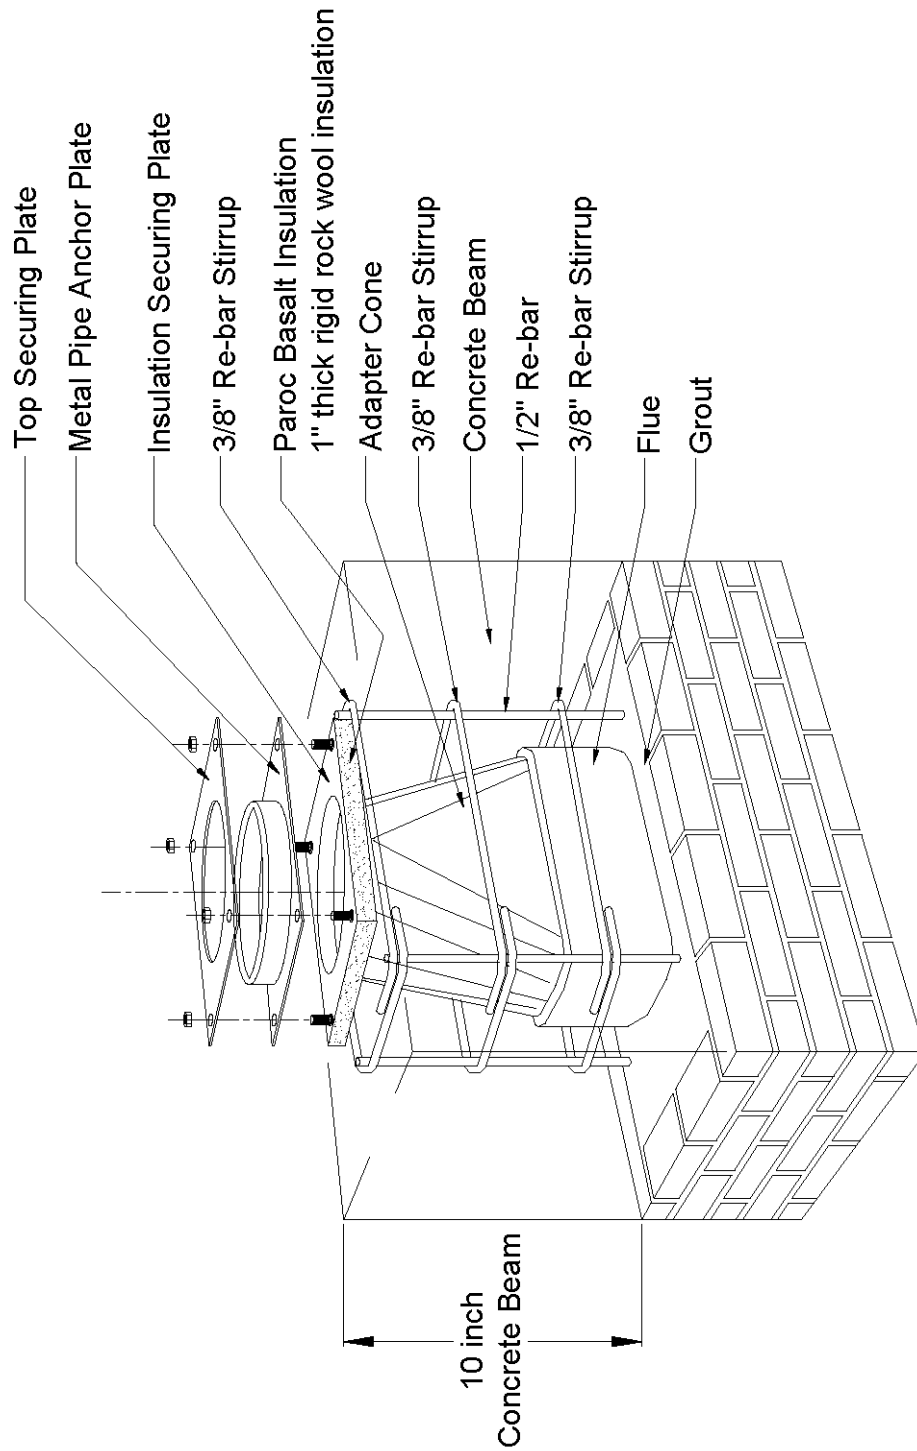
**DETAIL A**  
TRANSFORMATION FROM MASONRY  
FIREPLACE TO METAL CHIMNEY

Adapter Kit

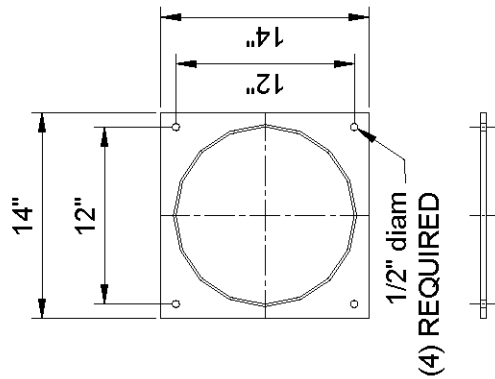
SECURING PLATE  
MATERIAL: 12 GAGE STEEL  
FINISH: BLACK PAINT

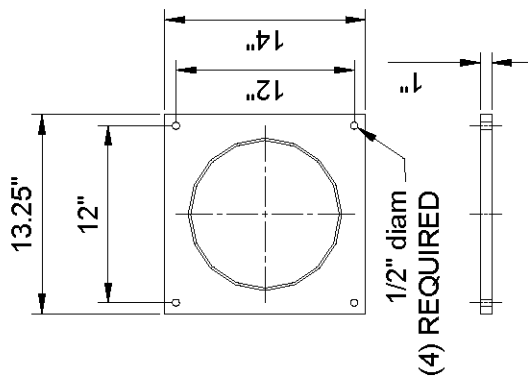
INSULATION  
MATERIAL: PAROC BASALT  
INSULATION

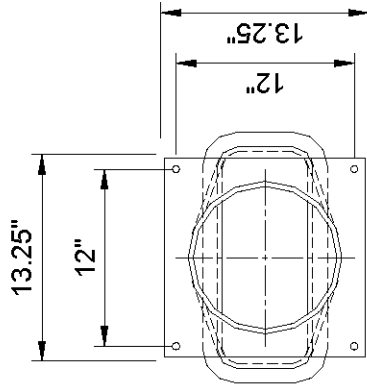
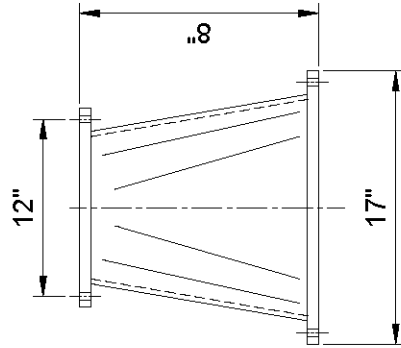
## ADAPTER CONE

ADAPTER ONE  
MATERIAL: 12 GAGE STEEL  
FINISH: BLACK PAINT  
MEASUREMENT IN INCHES

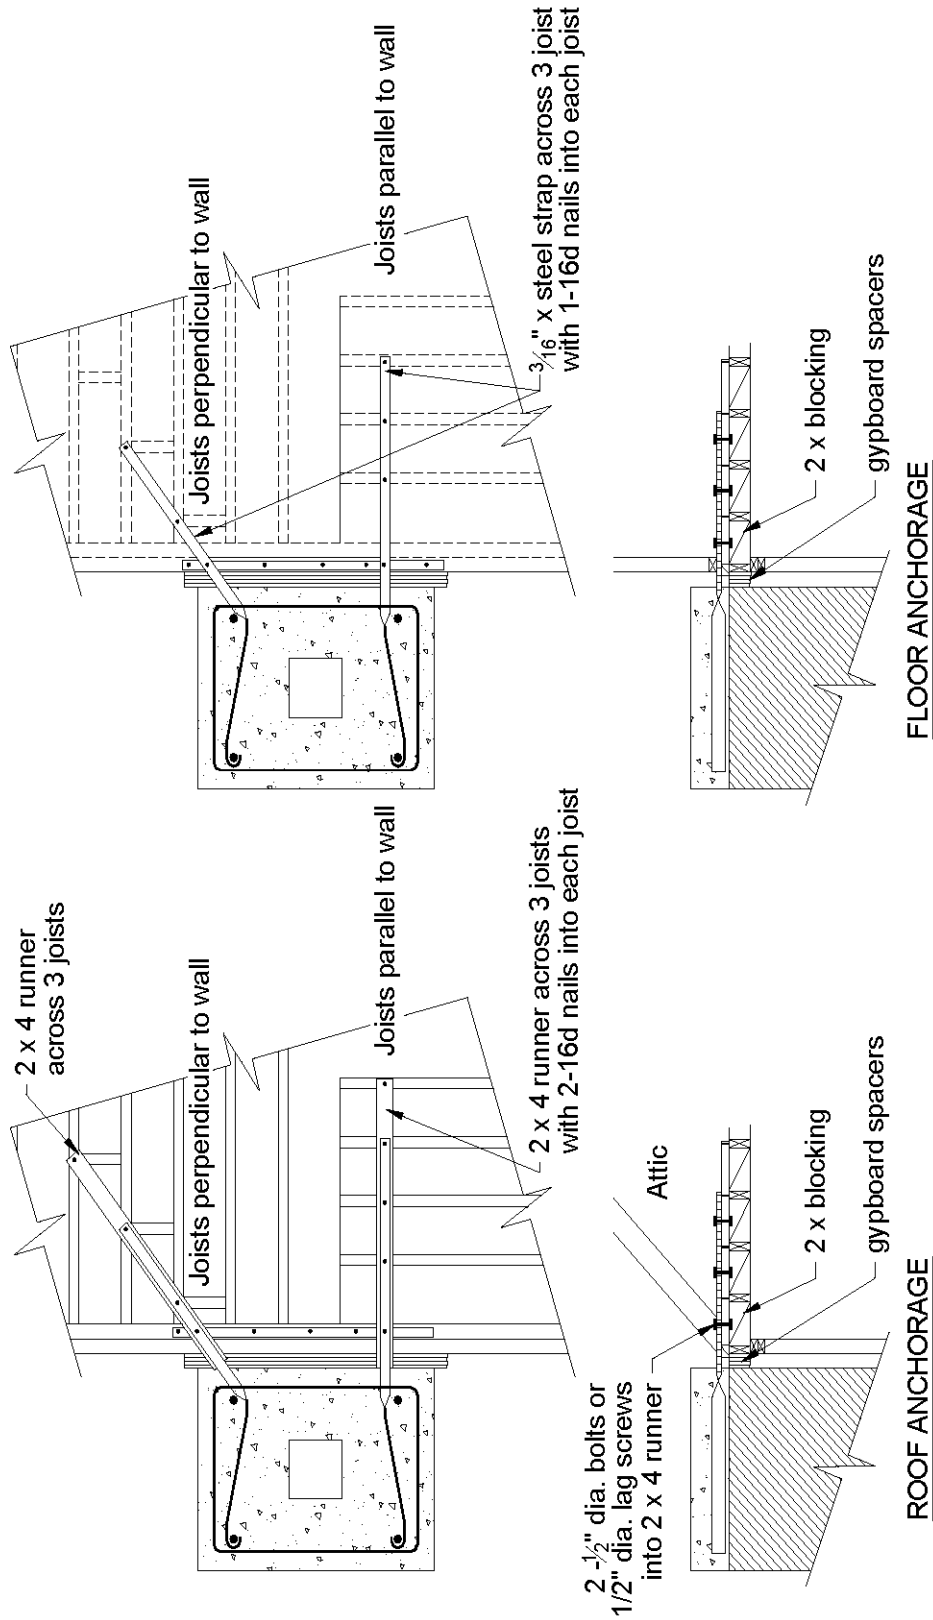
**DETAIL 2**  
**(Concrete Bond Beam Anchorage Into Building)**

Single brace required if chimney is between 4'-0" and 5'-1" above the bond beam. Double brace required if chimney is between 6'-0" and 10'-0" above bond beam.

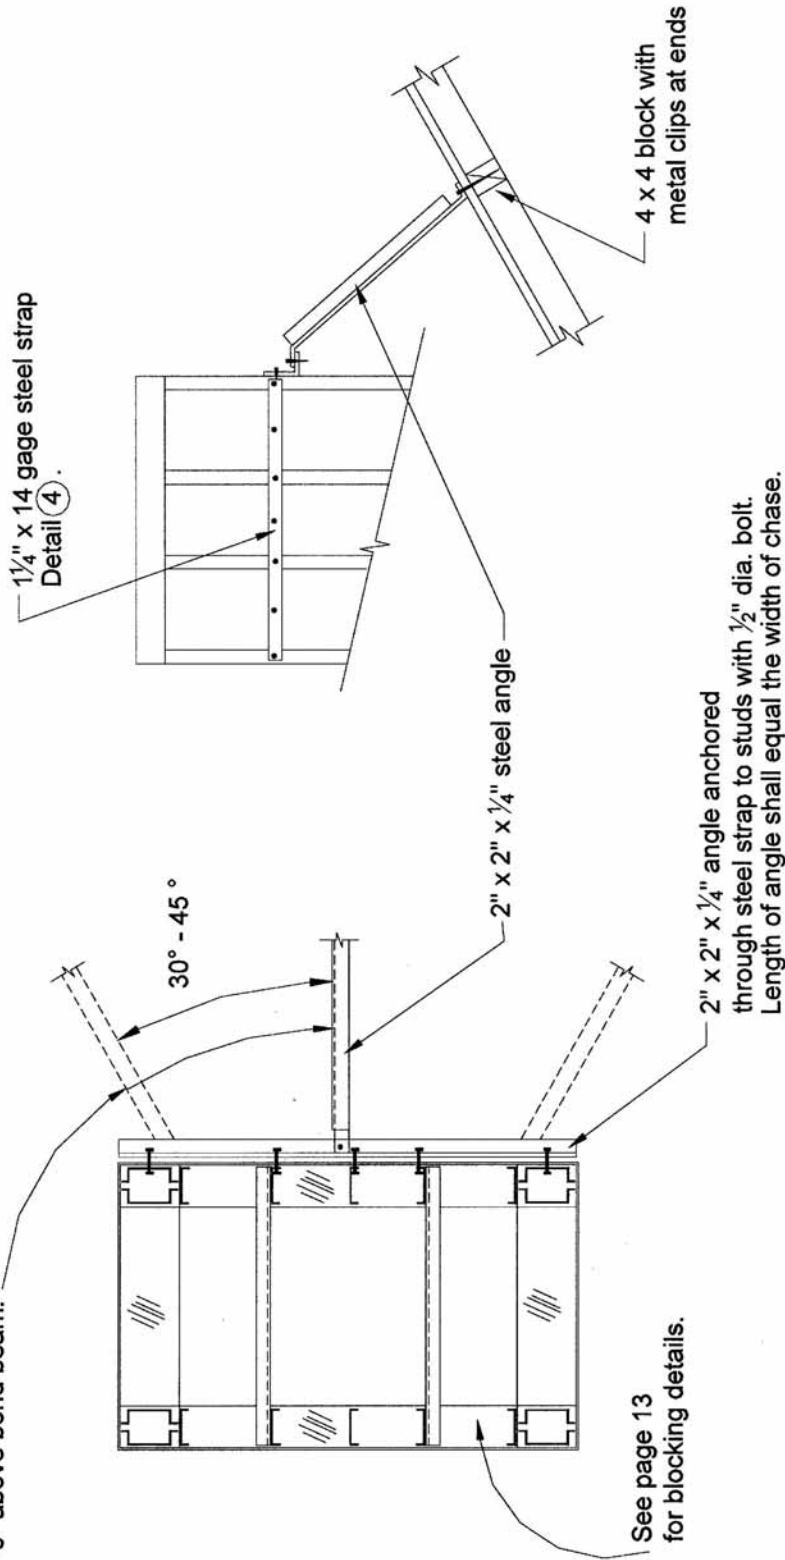
**DETAIL 3**  
(Roof Brace)

Covering Material	Fasteners
Laths for stucco	No. 8 x 5/8" sheet Metal screws at 6" o.c.

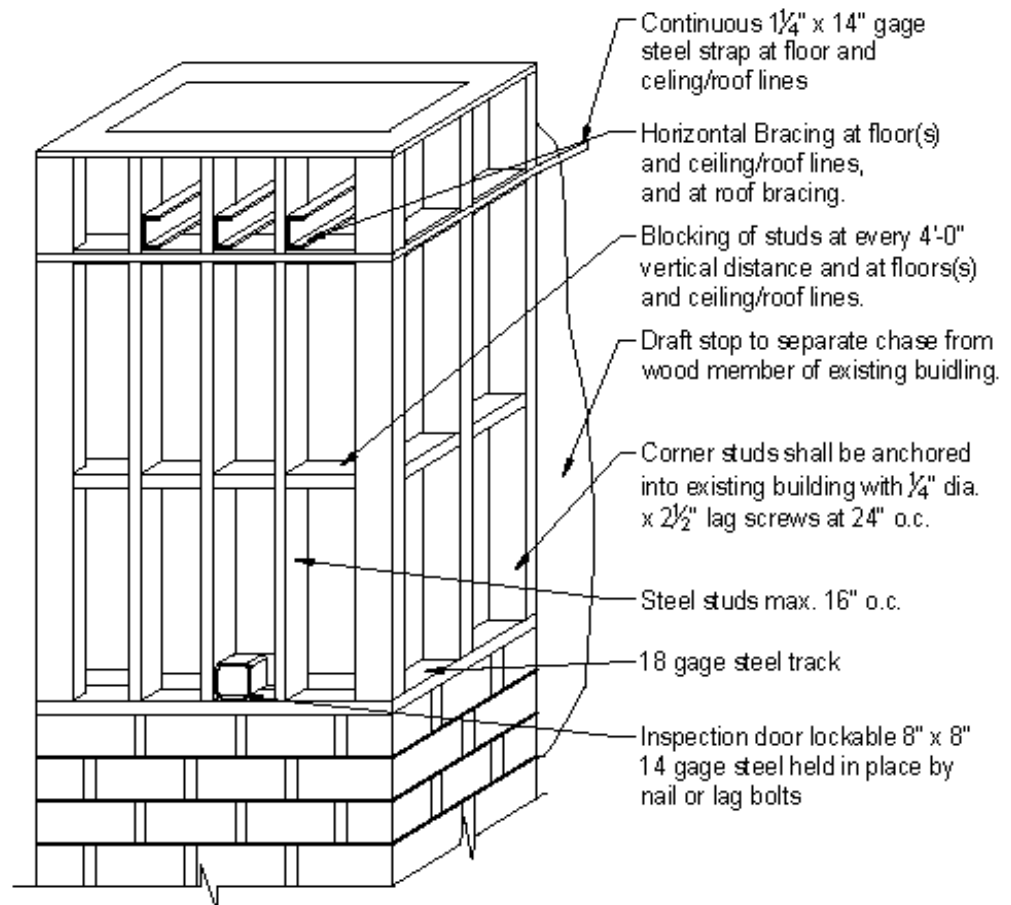
**Detail ④**

Steel stud chase may be covered with stucco or adhered veneer.

Note: Adhered veneer shall be a max. 1" with plywood backing (⅝" min.) and shall be installed per division 30 of the L.A. building code.

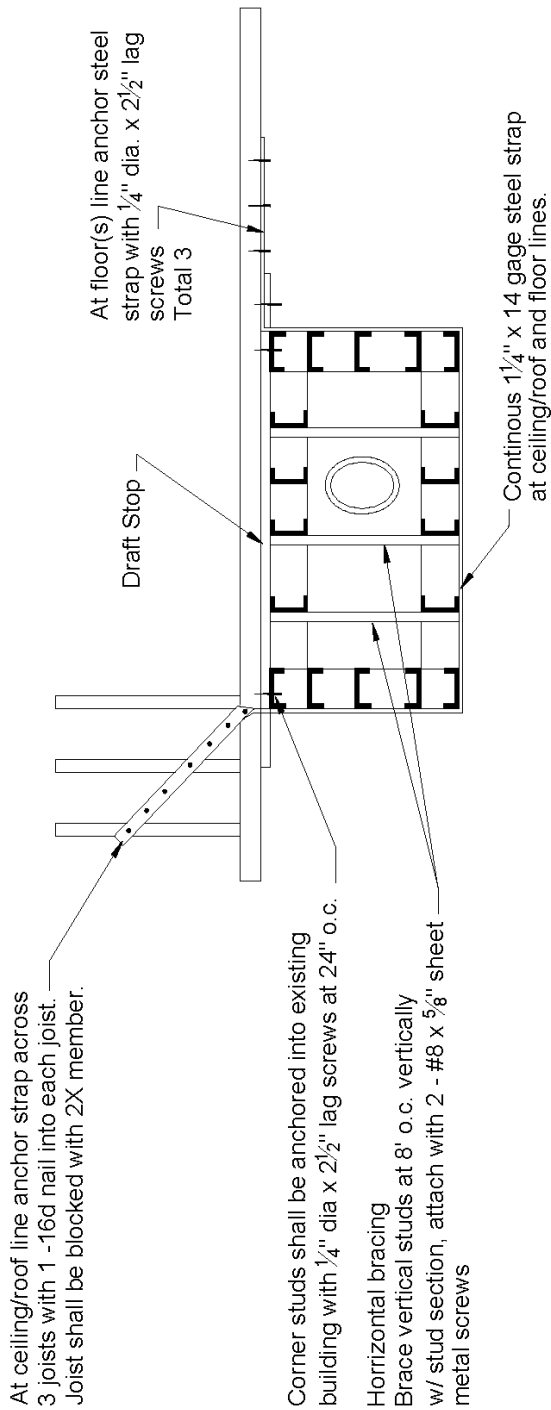
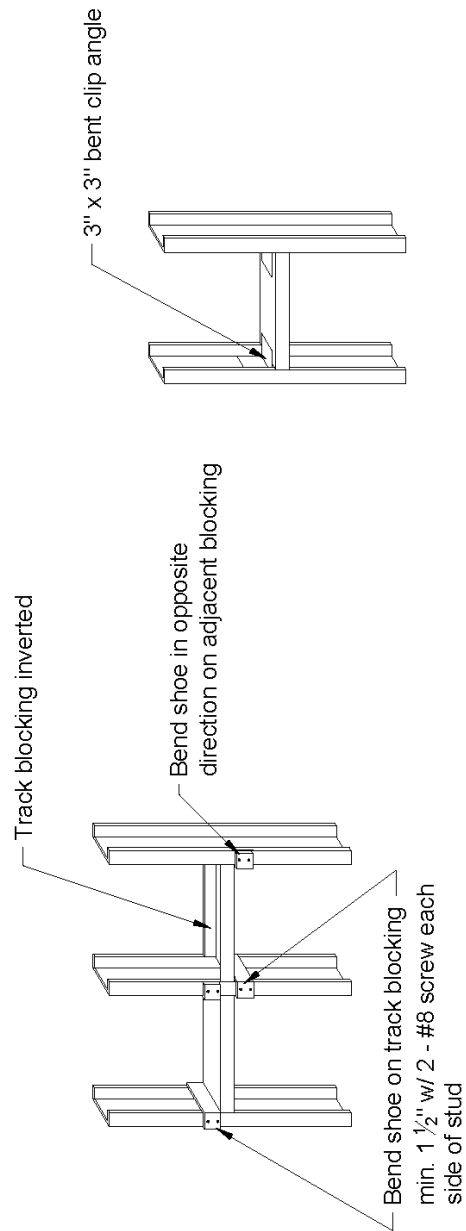
## Strapping & Bracing Detail @ Ceiling/Roof and Floors

Bent Shoe Option

Angle Clip Option

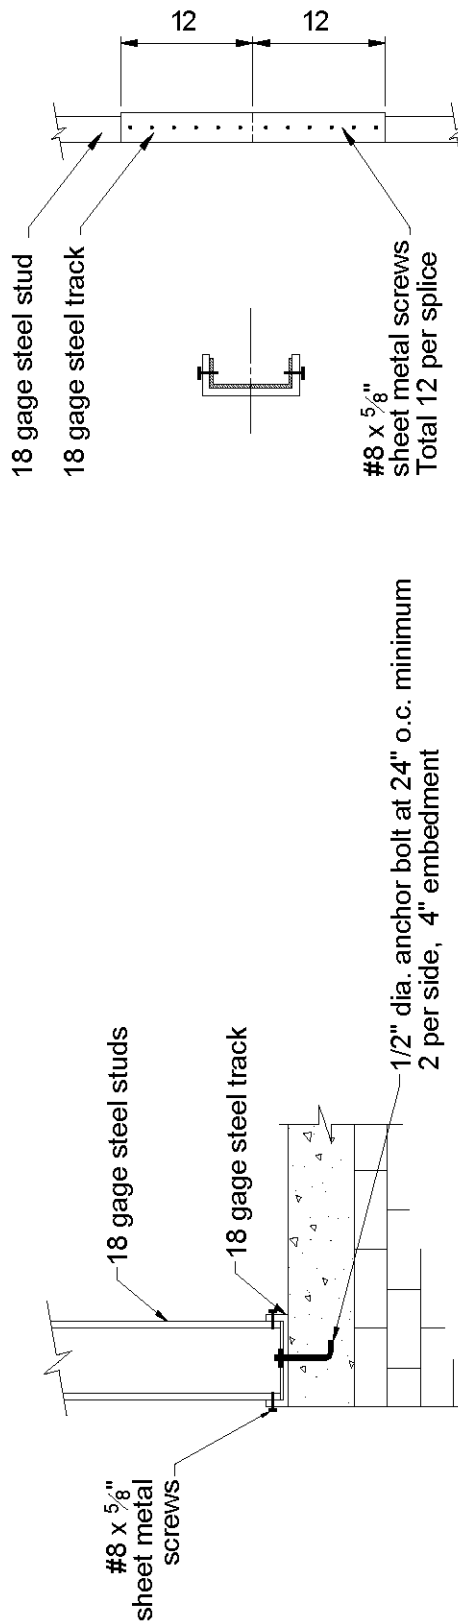
Splice shall be staggered a minimum of 12" vertically.  
Maximum one splice per stud.

Track Detail

Splice Detail

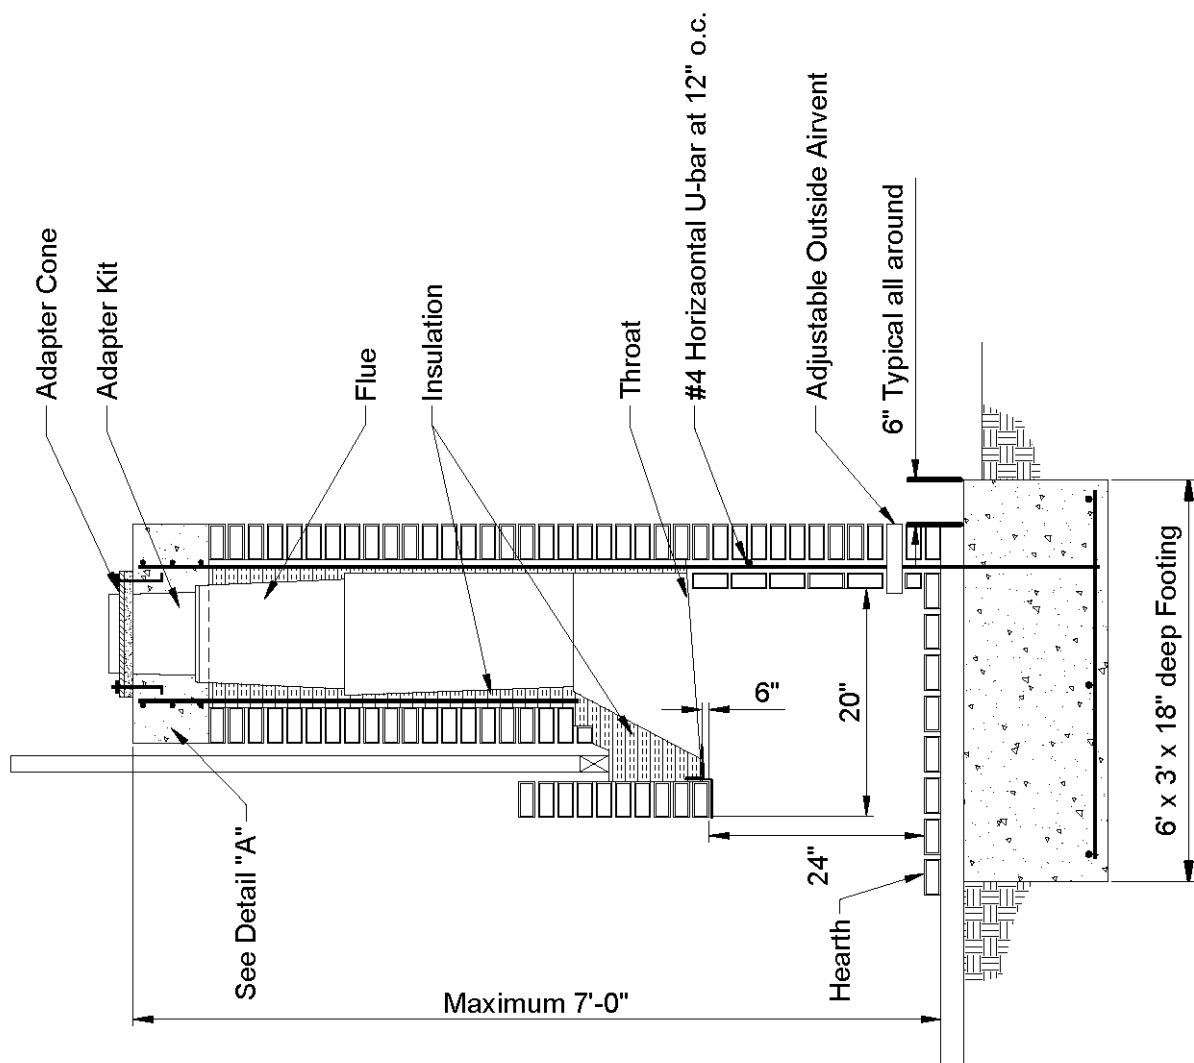
**New Firebox - Cross Section Typical 36" Fireplace**

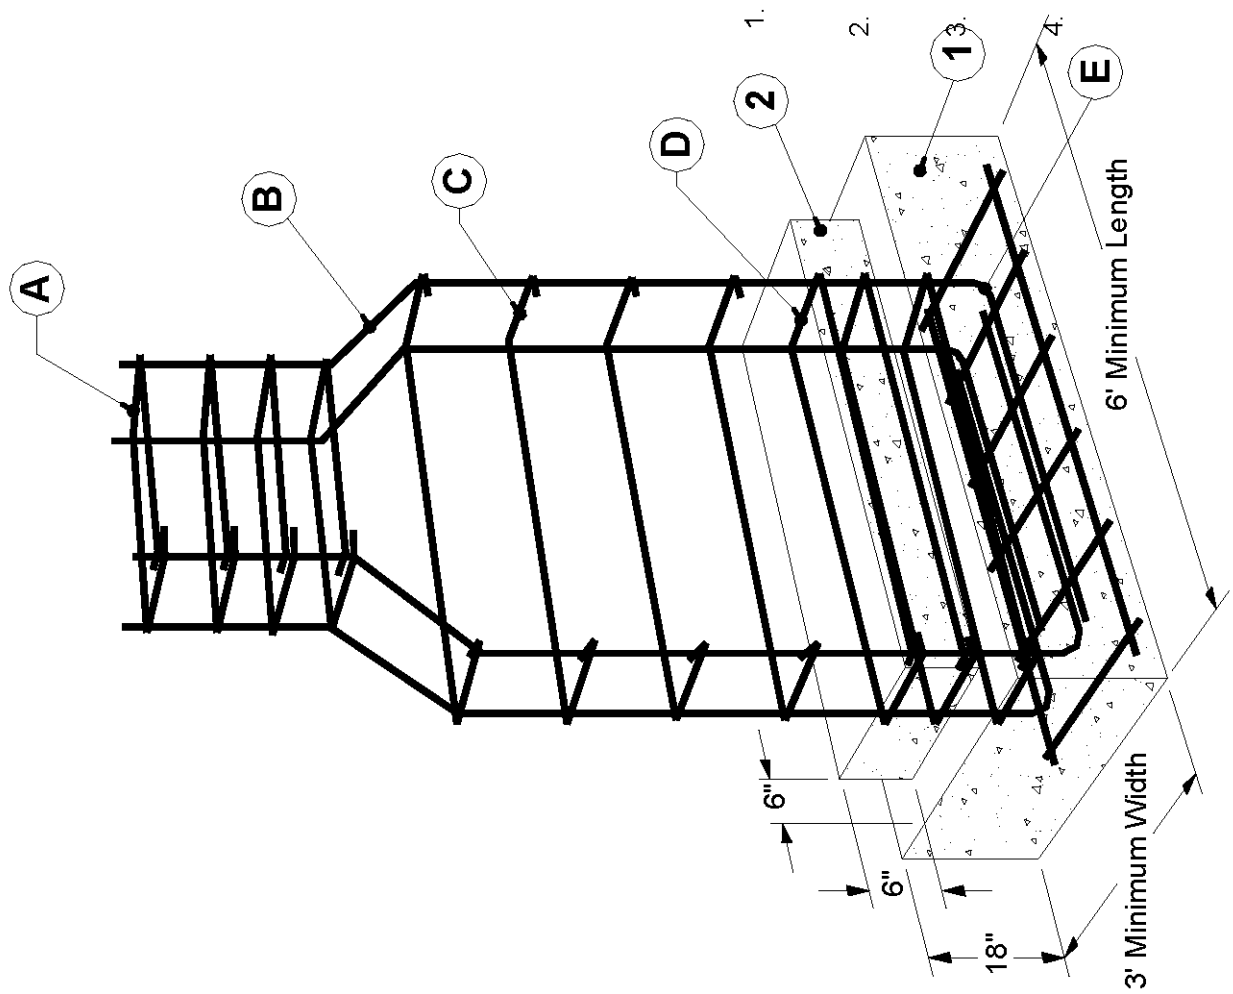
## Detail (B)

### Typical 36" Fireplace

- A. #3 Stirrup @ 6" o.c.
- B. 4 - #4 Rebar
- C. 3 - #4 /stirrups in foundation
- E. 6 - #4 Tiebars

The fireplace foundation at ground level. 6'-0" long x 3'-0" x 1'-6" deep Minimum.

The fireplace foundation above ground shall be formed at 5'-4" long x 2'-1" wide x 6" high.

The 4 - #4 vertical bars will have a 4' right angle bend extending across the foundation.

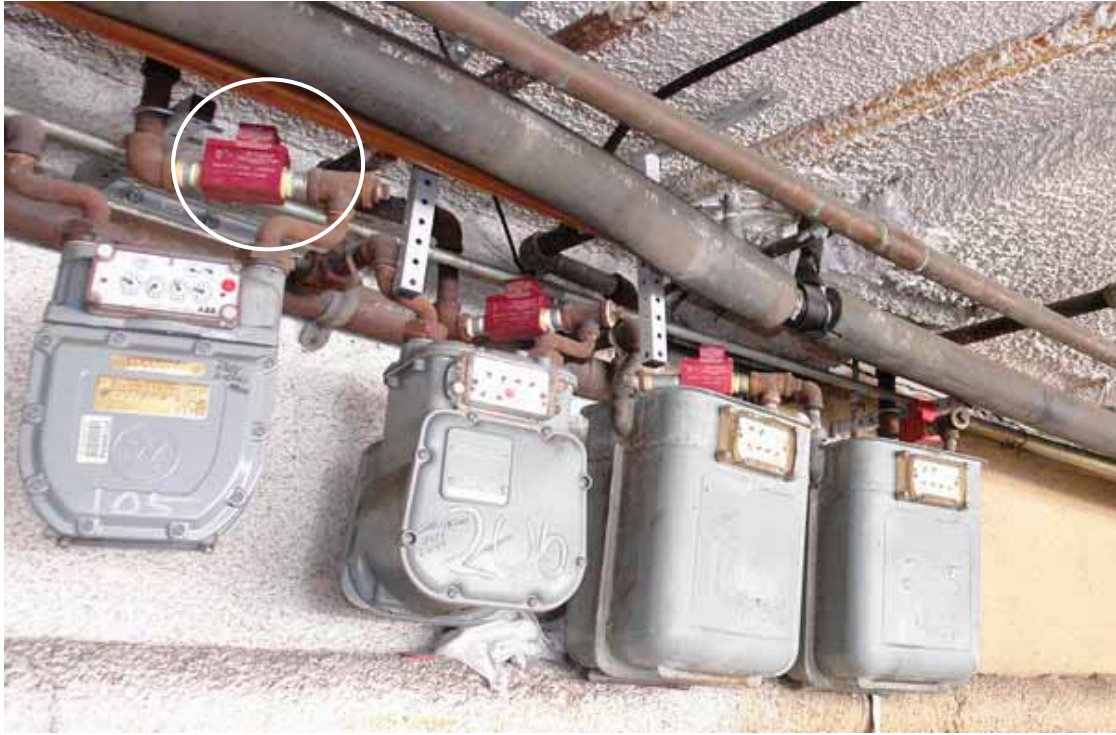
Figure 8.1. Gas meters with seismic shut-off valves [Exponent].

- **IMPORTANT** – Before entering a damaged, vacant building verify that gas is off. Check the gas meter for damage and position of main gas valve, either a manual valve or a seismically-activated gas shut-off valve as shown in Figure 8.1. A closed manual valve will typically have its knob at 90 degrees to the pipe as shown in Figure 8.2. Gas meters are typically outside the home in an accessible area. Do not enter the building if gas odor is detected.

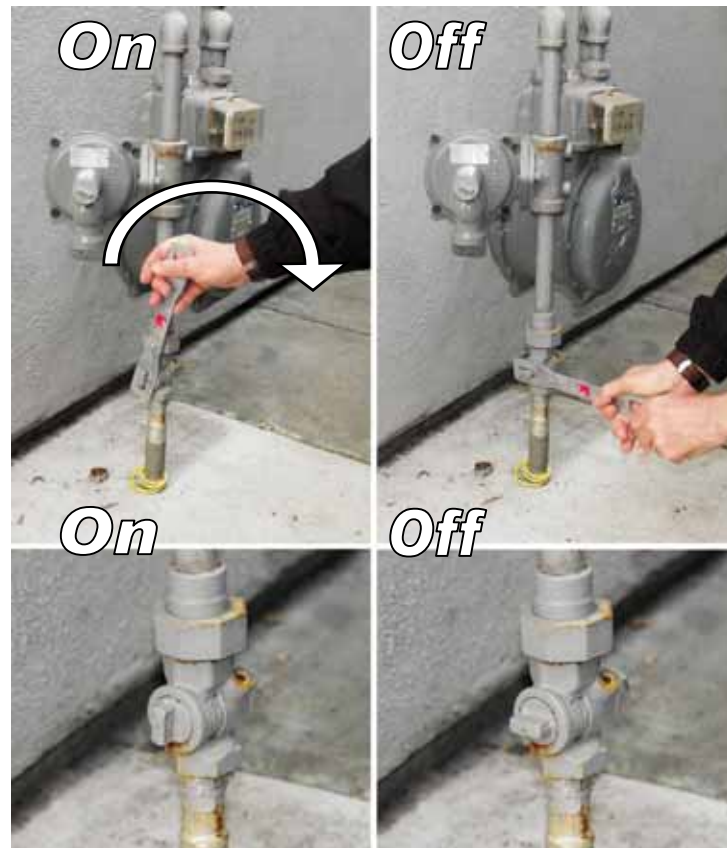
Figure 8.2. Manual gas shut-off valve [Exponent].

- **IMPORTANT** – Immediately following an earthquake, check the entire property, especially near appliances, for the smell of gas. If gas odor is detected, turn off the gas at the meter where it enters the house as illustrated in Figure 8.2. Locate and repair leaks before turning gas back on. If the gas odor persists after the gas has been shut off, vacate the building, and contact the gas utility company immediately.

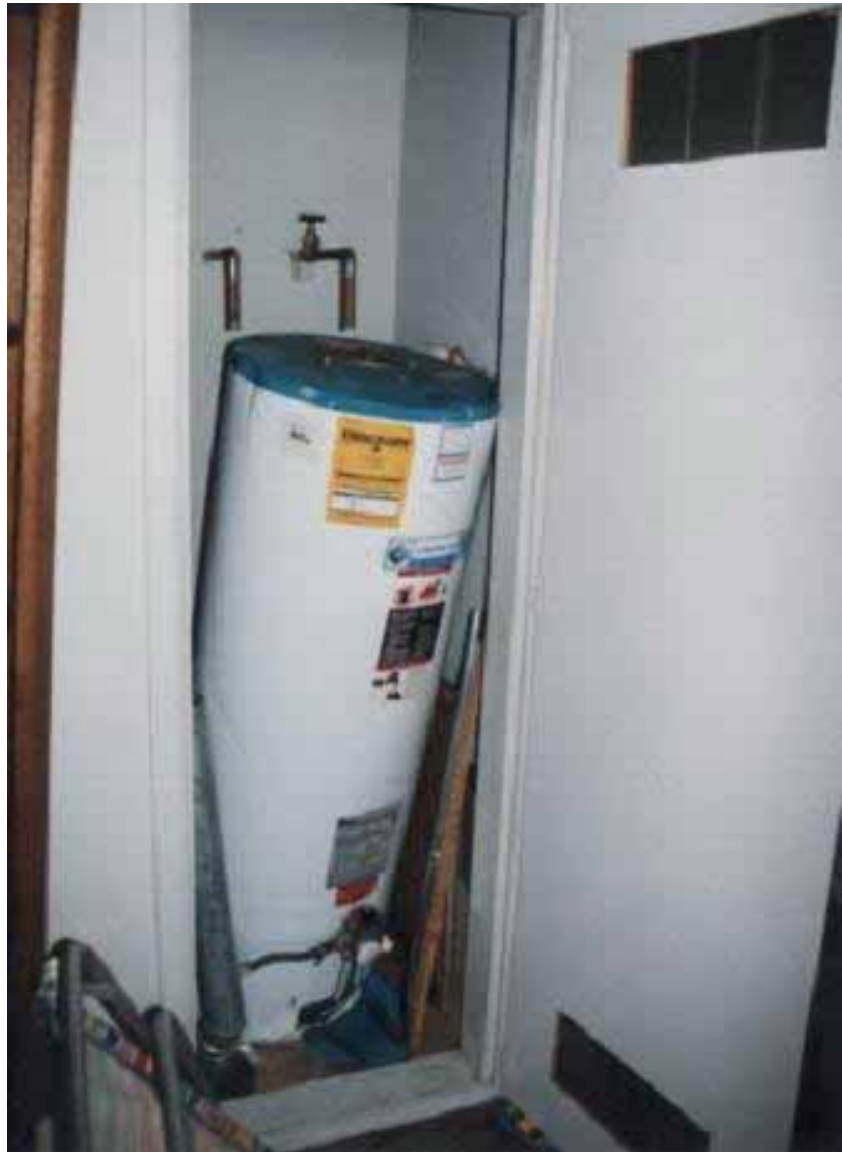
Figure 8.3. Displacement of unsecured water heater during 1994 Northridge Earthquake [Exponent].

- Check overhead electrical service wires (if present) for loose wires, excessive sag, or exposed conductors.
- Check the water heater(s) for toppling, shifting, leakage from tank, leakage from water connections (Figure 8.3), displaced flue connection (as shown in Figure 8.4), and damage/leakage at gas line or electrical connection. Water heaters can typically be found in garages, basements, or closets.

1. Large, heavy pieces of equipment (e.g., water heaters, propane tanks, fuel tanks, etc.) are not properly restrained as shown in Figure 8.3.
2. Rigid water, gas, refrigerant, electrical, or other connections to equipment do not allow relative motion between the equipment and the building.

- Rocking or toppling of water heaters, resulting in damage ranging from dislodged vent piping (Figure 8.4) to breakage of water piping connections (Figure 8.3) and destruction of the water heater. While most water heaters (in California) are now required by code to be “strapped” (as illustrated in Figure 8.10) to reduce the chances of toppling, many of those straps are not sufficient to prevent damaging movements of the water heater during strong shaking. Newer water heaters are also connected to the house piping with flexible tubing (as illustrated in Figure 8.11) that will accommodate minor differential movement of the water heater without failure of the connections. Older installations may be hard piped (as illustrated in Figure 8.12) and are thus much more susceptible to development of leaks in the connecting piping under minor differential movement. Older water heaters (those near the end of their service life) may develop leaks as a result of thermal and pressure cycling as a result of the loss and resumption of water pressure and gas supply following an earthquake.

- Shifting or toppling of water or other liquid tanks. Common examples include water heaters, water tanks, fuel oil tanks, and propane tanks.
- Breakage of gas supply lines to heavy equipment (such as water heaters, furnaces, and stoves) due to differential motion as illustrated in Figure 8.3. These circumstances constitute a safety hazard and the gas company should be contacted to verify proper conditions are present prior to re-establishing gas service to the property.

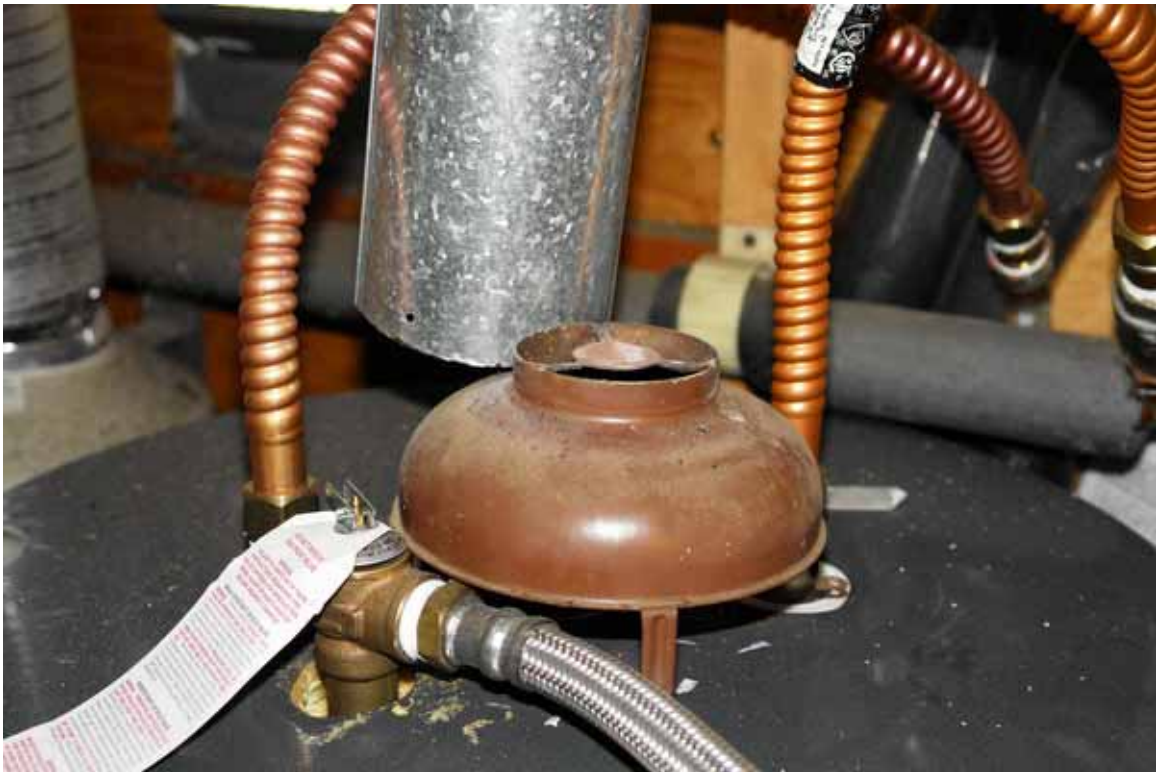
Figure 8.4. Displacement of unsecured water heater vent during 1989 Loma Prieta Earthquake [Exponent].

- Dislocation of exhaust ducts, chimneys, or flues due to motion of equipment as illustrated in Figure 8.4. These situations can constitute a potential safety hazard due to the potential for carbon monoxide and other combustion products to enter the home.

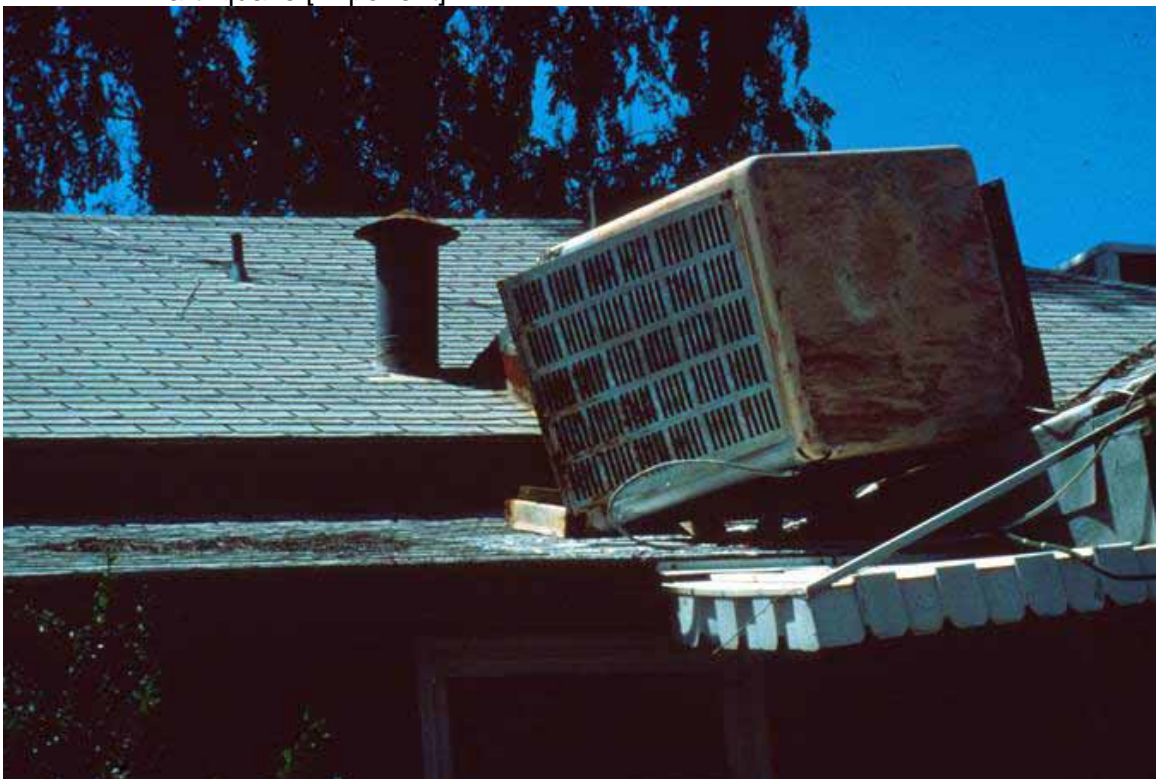
Figure 8.5. Toppled “swamp cooler” due to earthquake [Exponent].

- Check the evaporative cooling unit(s) for toppling, shifting, and damage/leakage at power and water connections. The units are typically found on the roof as shown in Figure 8.5, in attics, garages, basements, or closets.

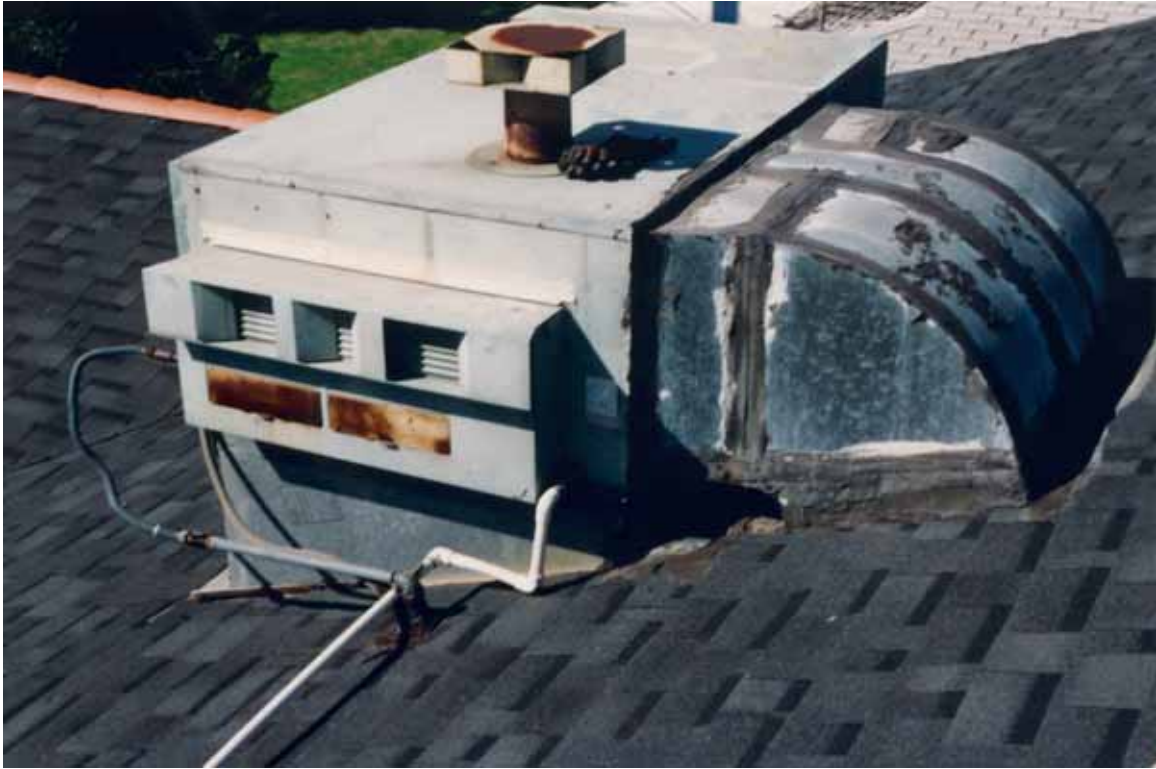
Figure 8.6. Rooftop HVAC unit (no damage) [Exponent].

- Check the furnace(s) for shifting, damage/leakage at gas line, flue connection, electrical connection, and condensate drain connection. Furnace/air conditioning units can be found in garages, basements, attics, closets or on rooftops as shown in Figure 8.6 and Figure 8.7.
