GENERAL GUIDELINES  
FOR THE ASSESSMENT AND REPAIR  
OF EARTHQUAKE DAMAGE  
IN RESIDENTIAL WOODFRAME BUILDINGS

Consortium of Universities for Research in Earthquake Engineering

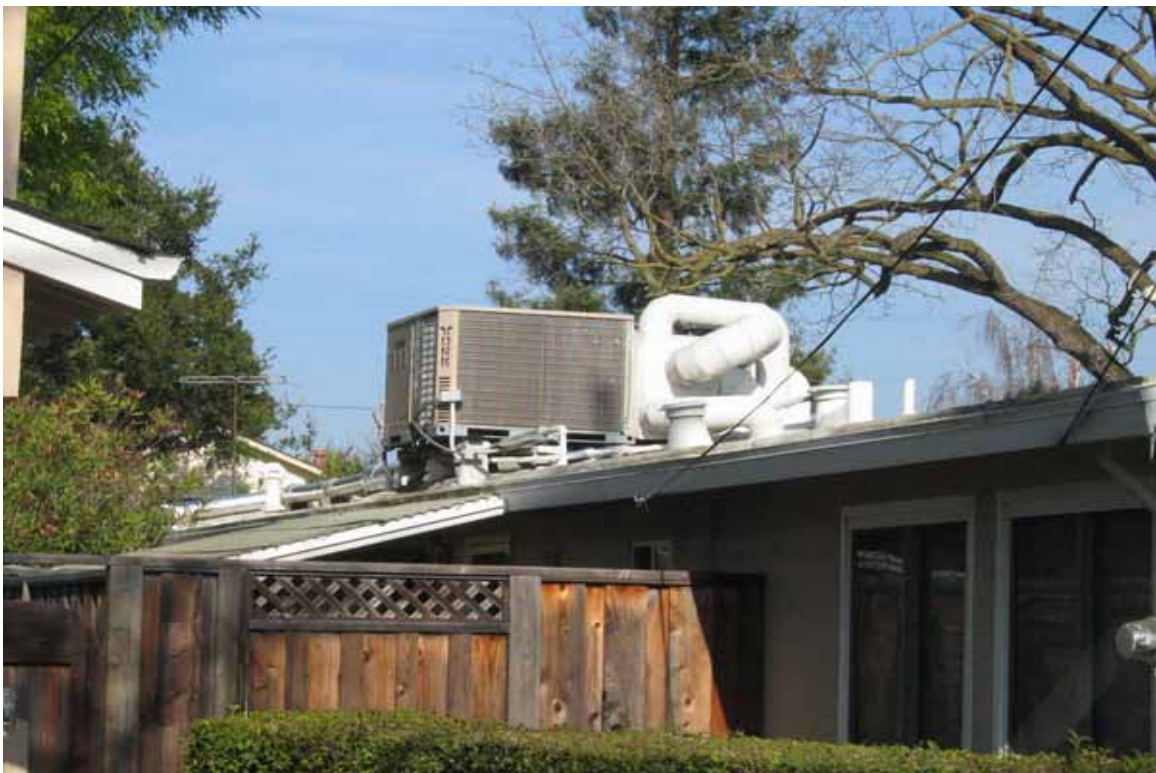
Figure 8.7. Rooftop HVAC unit (no damage) [Exponent].

- Check the furnace(s) for shifting, damage/leakage at gas line, flue connection, electrical connection, and condensate drain connection. Furnace/air conditioning units can be found in garages, basements, attics, closets or on rooftops as shown in Figure 8.6 and Figure 8.7.

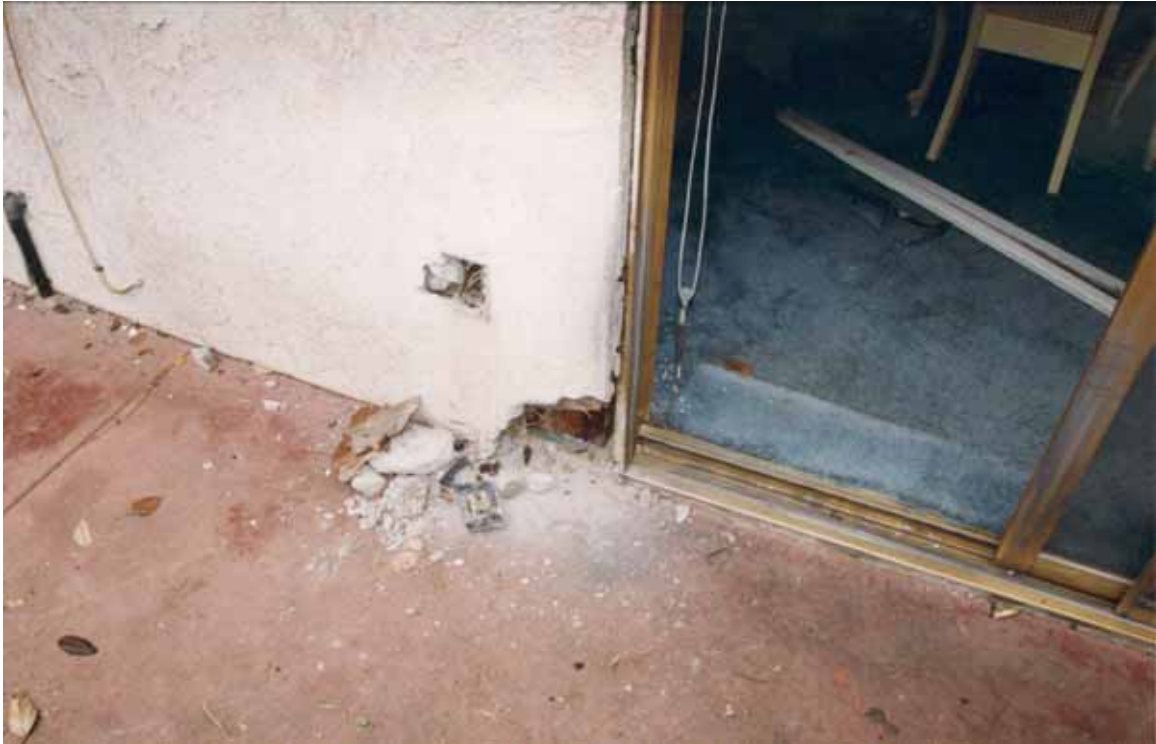
Figure 8.8. Racking and delamination of exterior stucco resulting in damage to electrical outlet during 1994 Northridge Earthquake [Exponent].

- Ground cracking or failure at the property or in the vicinity (see Section 3). A plumber should leak test the sewer lateral and pressure test the underground water piping.
- Seepage or leakage in the basement, crawlspace, utility closets, or at the baseboard in the basement or on the ground floor of the structure.
- Saturated zones of soil adjacent to the perimeter of the structure.
- Contact an electrician if any wiring was pulled loose as a result of shifting of equipment or structural damage as shown in Figure 8.8 and Figure 8.9.

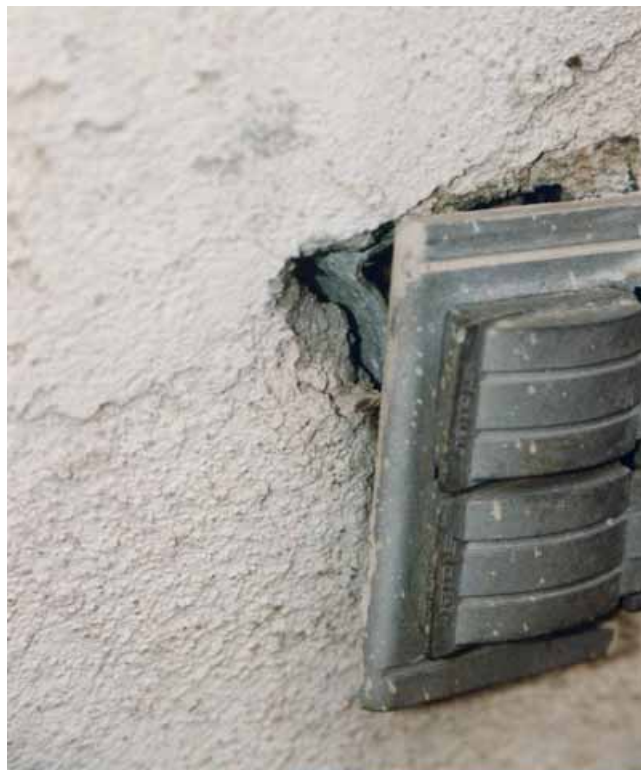
Figure 8.9. Close-up of earthquake damage to electrical outlet box [Exponent].

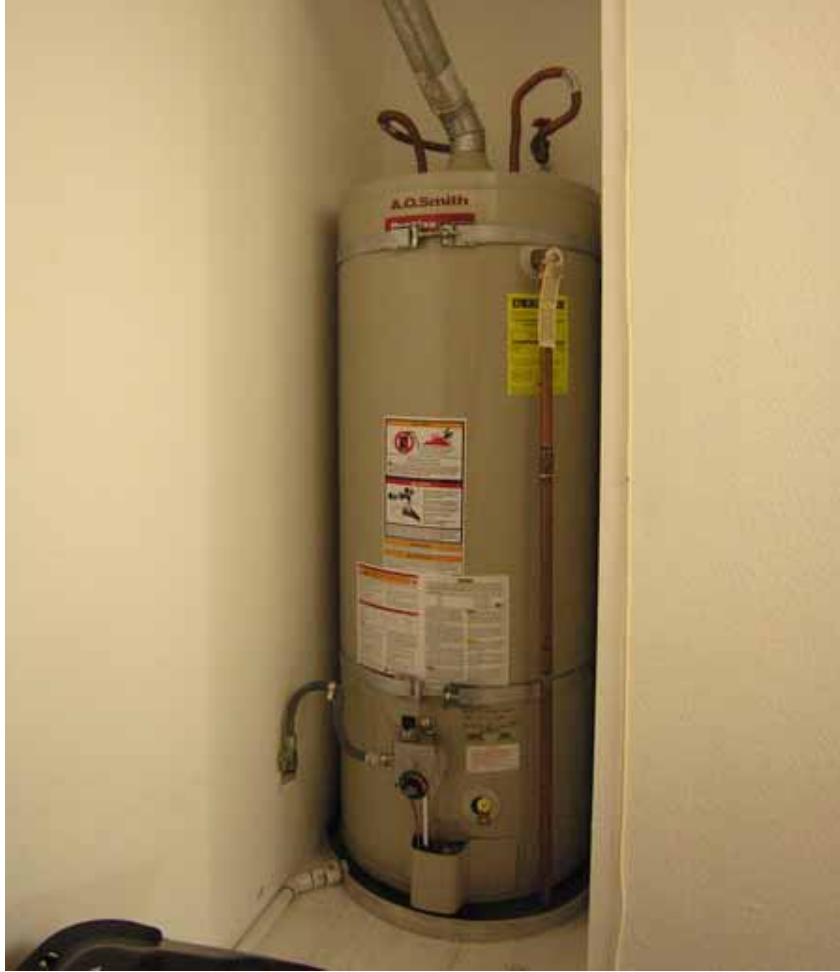
Figure 8.10. Water heater with flexible piping and securing strapping (no damage) [Exponent].

- Rocking or toppling of water heaters, resulting in damage ranging from dislodged vent piping (Figure 8.4) to breakage of water piping connections (Figure 8.3) and destruction of the water heater. While most water heaters (in California) are now required by code to be “strapped” (as illustrated in Figure 8.10) to reduce the chances of toppling, many of those straps are not sufficient to prevent damaging movements of the water heater during strong shaking. Newer water heaters are also connected to the house piping with flexible tubing (as illustrated in Figure 8.11) that will accommodate minor differential movement of the water heater without failure of the connections. Older installations may be hard piped (as illustrated in Figure 8.12) and are thus much more susceptible to development of leaks in the connecting piping under minor differential movement. Older water heaters (those near the end of their service life) may develop leaks as a result of thermal and pressure cycling as a result of the loss and resumption of water pressure and gas supply following an earthquake.

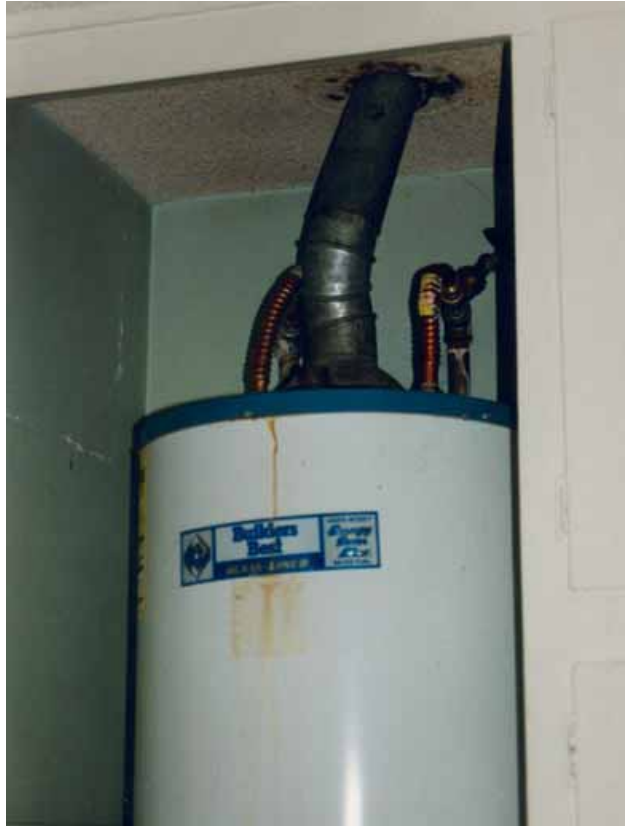
Figure 8.11. Flexible piping between unsecured water heater and house piping (no damage) [Exponent].

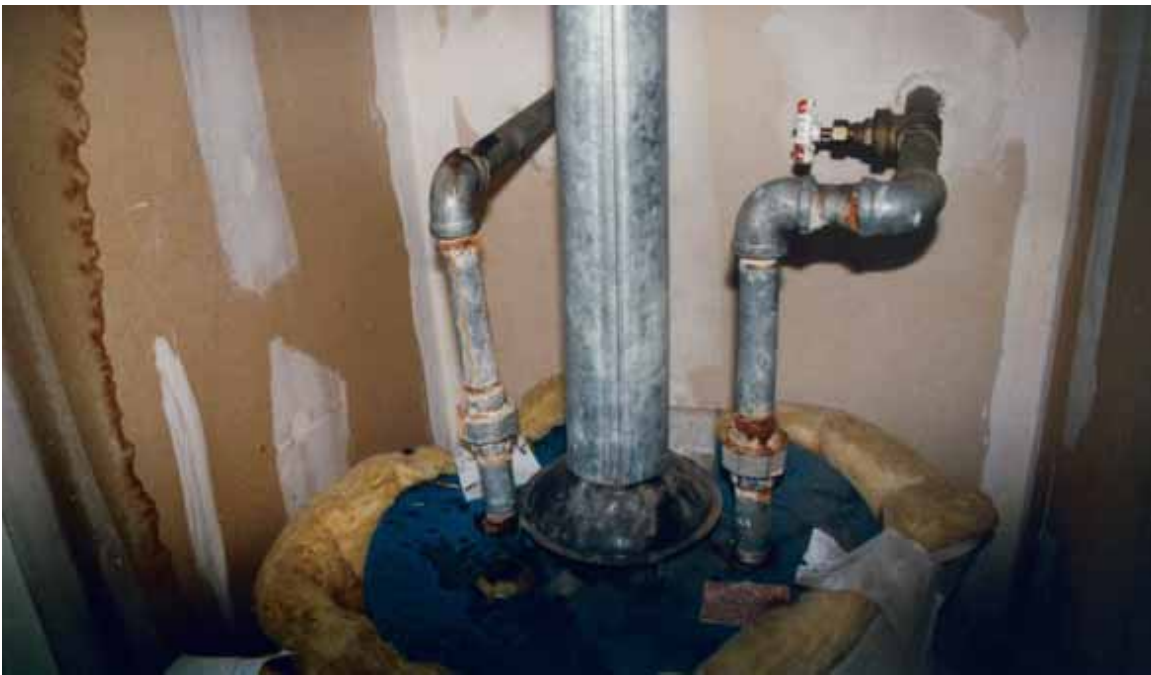
Figure 8.12. Water heater with “hard” piping (no damage) [Exponent].
