Protecting Business Operations

Second Report on Costs and Benefits of **Natural Hazard Mitigation**

FEMA 331
August 1998

Federal Emergency Management Agency
Mitigation Directorate
500 C Street, SW
Washington, DC 20472

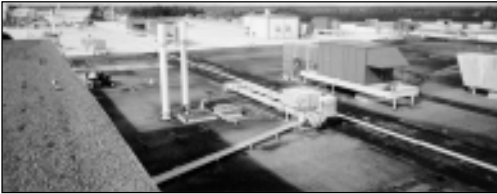
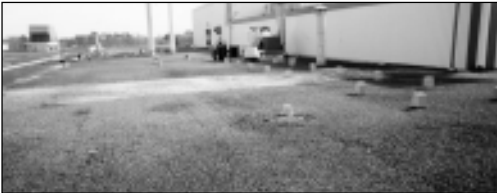
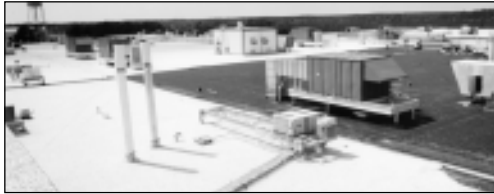
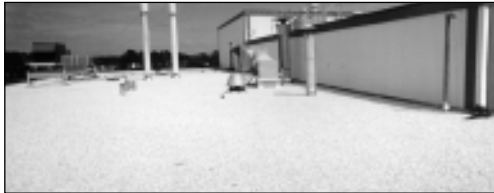
BEFORE

AFTER
