New Bridge

Prevents Flood Damages

Case Studies

ELLICOTTVILLE, NEW YORK

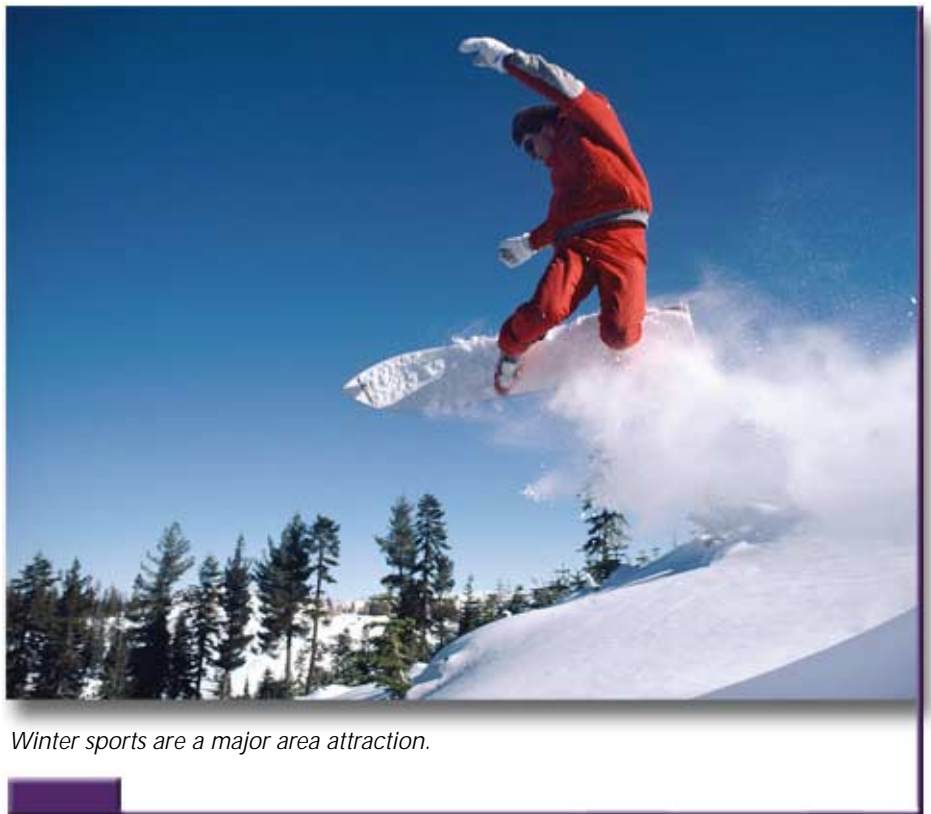
Winter sports are a major area attraction.
