On December 16-17, 1997, Typhoon Paka, noted as one of the most powerful storms of the 20th Century, directly struck the island of Guam with sustained winds of 150 mph and gusts to 185 mph. Paka's winds impacted the island for a full 12 hours, creating a much longer than usual timeframe for wind, rain, and storm surges to cause damage. The northern and central sections of the island sustained severe and widespread damage to homes, the island's power distribution grid and public utilities, privately owned buildings, and many other structures.

More Success in Guam

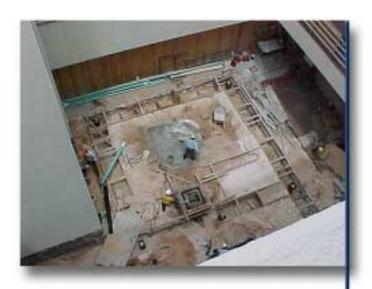
This photo is an overhead view of the rear courtyard of GMH. This project entails hardening/enclosing the rear courtyard and stairwells of GMH.

The courtyard and stairwells, including the entrance to the emergency room and labor and delivery rooms were exposed to the elements creating a major safety hazard to patients and staff of the only civilian hospital on the island. This structure was designed and constructed to meet wind and seismic code.

HMGP funding for this project, under Typhoon Paka was \$4,321,376. This will result in mitigating an estimated \$5 million dollars in damages per 50 year period within the 50 year life of the structure.

Following Typhoon Paka, GMH was awarded Hazard Mitigation Grant Program (HMGP) funds to harden the oxygen storage facility and enclose the exterior corridors and stairwells. By replacing the facility's tin roof with concrete and by building concrete walls around the structure, the hospital eliminated the possibility of storm and debris exposure to the facility and its contents. HMGP funds were also provided to enclose the exterior corridors on the ground floor and the exterior stairwell in order to provide a safe, protected means of access between the ground floor, the second floor emergency room, and the inpatient units on the third and fourth floors.

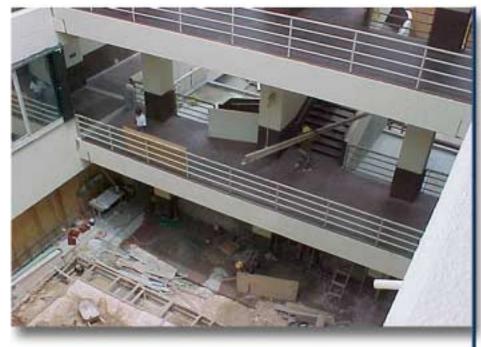
Another view of the rear courtyard and stairwells of GMH. This view clearly shows the exposed walkways between the different wings.

The cost to enclose exterior corridors and stairwells was \$1,868,062; federal mitigation funds totalled \$1,721,671.

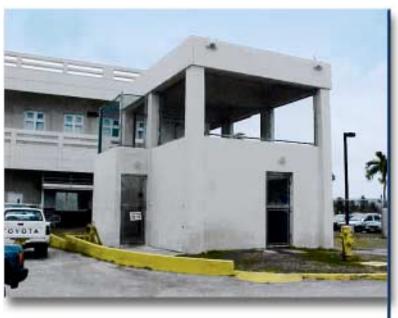
This is the only civilian, medical grade oxygen storage facility on the island of Guam. It is located at the Guam Memorial Hospital. The original facility was a wood and tin structure. By hardening this crucial structure, with concrete, the safety of the islands medical oxygen supply will be increased tremendously. This structure was designed and constructed to meet wind and seismic codes. HMPG funding for this project under Typhoon Paka totaled \$41,350. This expenditure will mitigate over \$2.5 million in potential disaster costs over the life of the structure.

The one-time cost to replace the roof of the oxygen storage facility and the liquid oxygen tank, and to use portable cylinders until the new tank was put in place, was \$988,560. The cost of hardening the oxygen storage facility was \$51,550.

The benefit/cost ratio for this project is 20 to one. The expectation is that there will be minimal or no damage from the next typhoon and thus no further repair or replacement costs.

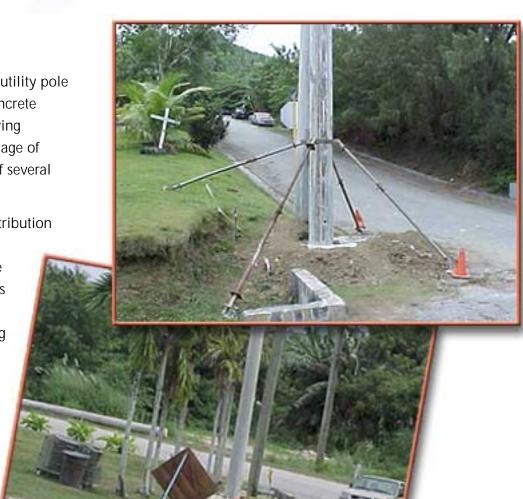
These photos show a concrete utility pole with the footing encased in concrete being supported during the drying process. These are from the village of Santa Rita, but are indicative of several HMGP projects.

By hardening the electrical distribution system, untold dollars will be saved, as well as protecting the health and safety of the citizens of Guam. HMGP funding for two electrical system hardening projects is \$4,825,544.
