# Repair of Earthquake Damaged Concrete and Masonry Wall Buildings

# **FEMA 308**

## **REPAIR OF EARTHQUAKE DAMAGED CONCRETE AND MASONRY WALL BUILDINGS**

**1998**

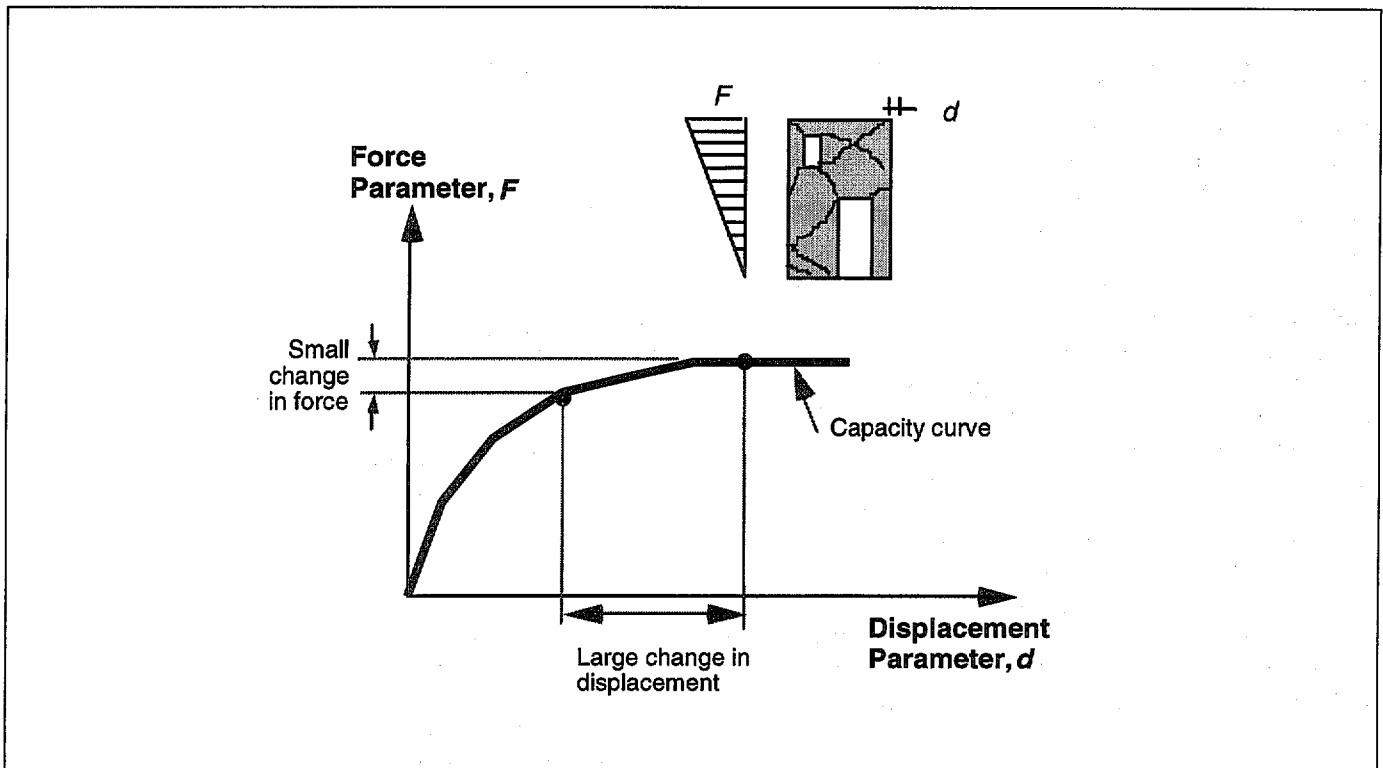
Figure 2-1 Sensitivity of displacement to changes in force

The key to realistic evaluation of the effects of earthquake damage on performance is a methodology that focuses on displacements rather than forces.

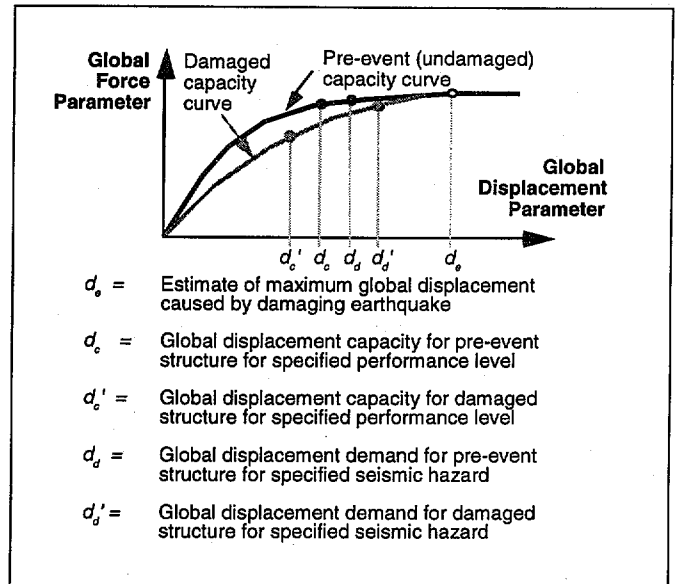
Figure 3-1 Capacity curves from nonlinear static procedures.

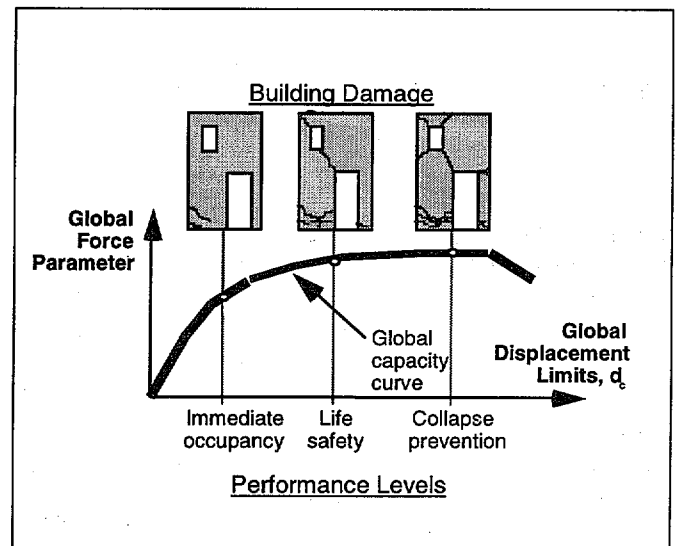
Figure 3-2 Global displacement capacities,  $d_c$ , for various performance levels

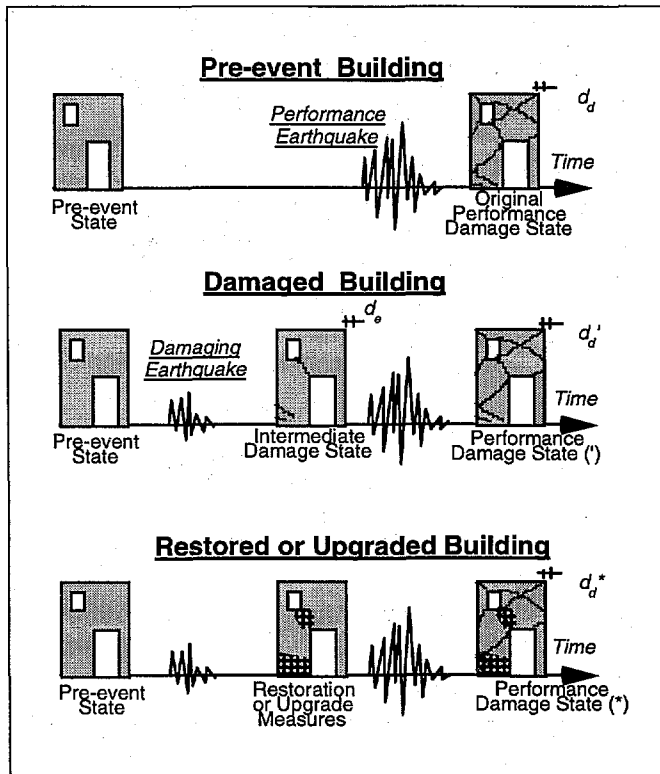
**Figure 3-3** Global displacement demand for undamaged, damaged, and restored/upgraded conditions

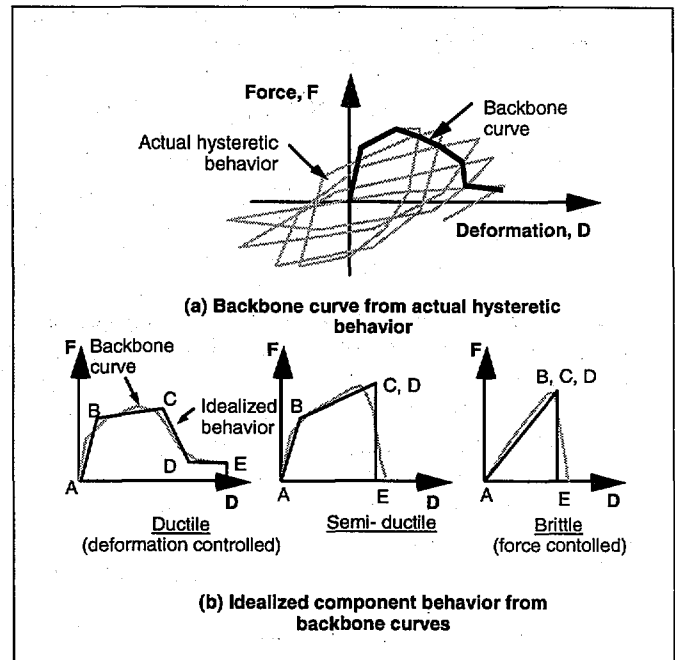
**Figure 3-4** Structural component force-deformation characteristics

conditions (Figure 3-4). For a given global displacement of a structure subjected to a given lateral load pattern, there is an associated deformation for each of the structural components of the building. Since inelastic deformation indicates component damage, then the maximum global displacement,  $d_d$ , to occur during an earthquake represents a structural damage state for the building in terms of inelastic deformations for each of its components. The capacity of a given structure for a given performance level is represented by the maximum global displacement,  $d_c$ , at which the damage is on the verge of exceeding the limit for the specific performance level. For example, the collapse-prevention capacity of a building might be the roof displacement at which the associated damage would result in one or more of the column components being in danger of imminent collapse.

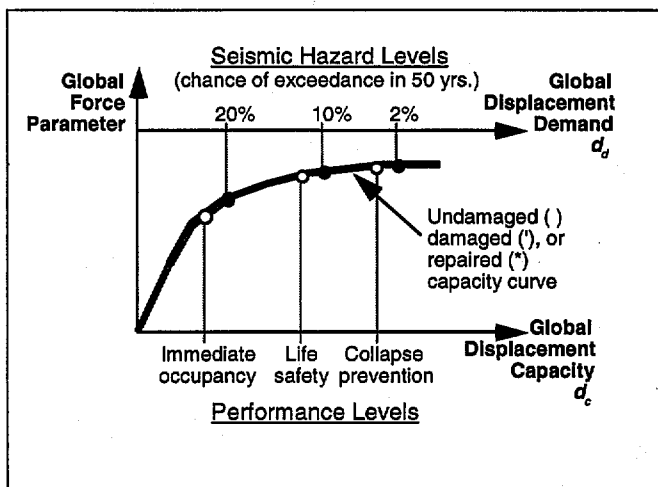
Figure 3-5 Global displacement demands and capacities

displacement demands for various levels of seismic hazard as shown in Figure 3-5. These may be generated using nonlinear static procedures according to the recommendations in FEMA 306, in conjunction with the appropriate capacity curve. In Figure 3-5 these are plotted on the upper horizontal axis noting their chance of exceedance in 50 years. Component acceptability criteria in conjunction with capacity curves also can be

used to define global displacement limits for various performance levels (e.g., immediate occupancy, life safety, collapse prevention). These are shown in Figure 3-5 along the lower horizontal axis. The combined plot provides a complete picture of the risks associated with the particular repair alternative.

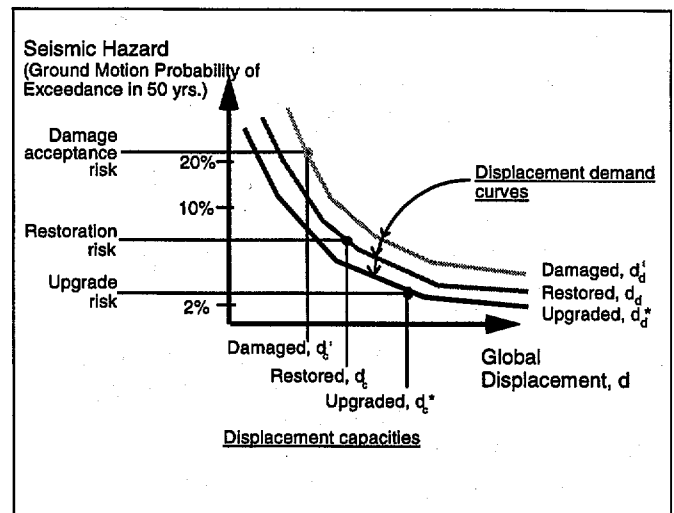
Figure 3-6 Risk associated with damage acceptance, restoration, and upgrade for a specific performance objective

Global displacement demand for various repair alternatives can also be plotted versus a risk parameter as shown in Figure 3-6. The intersection of a global displacement capacity value, for a selected performance level, with the corresponding displacement demand curve allows an estimate of the risk that the performance level would be exceeded for a given repair alternative. Doing this for several repair alternatives, as

shown in Figure 3-6, provides a comparison of the risks associated with each alternative for the selected performance level. For example, suppose that the performance level of interest is life safety. Figure 3-6 illustrates that the chance that the global displacement demand would exceed the life safety capacity of the damaged structure is slightly higher than 20% in fifty years. Restoration of the structure to its pre-event condition would reduce the life safety risk to less than 10%. The upgrade could reduce risk to just above 2% or approximately ten times less than the damaged structure in this illustration.

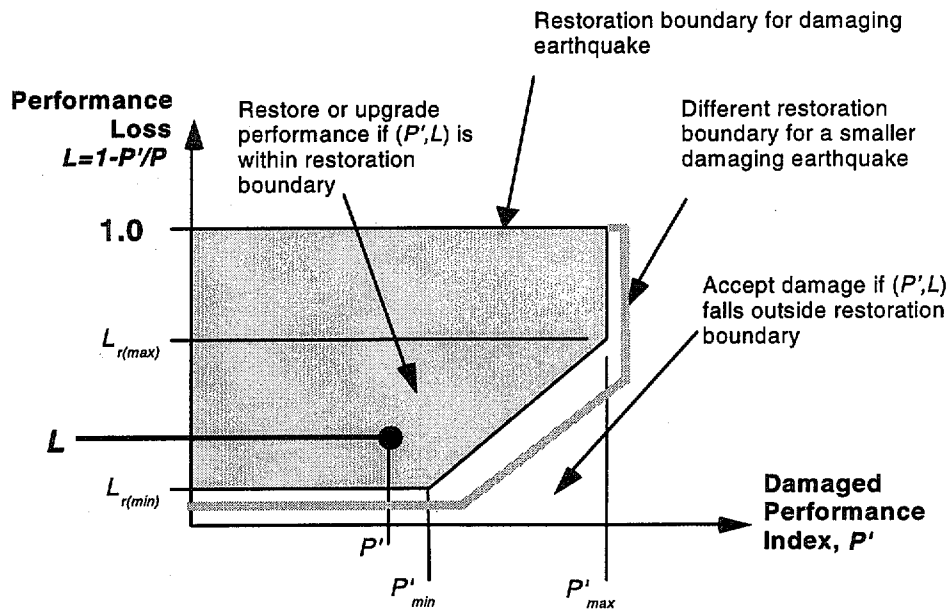
a) Relationship between acceptance of damage versus repair or upgrade

Figure 3-7 Thresholds and performance limits for restoration and upgrade of earthquake-damaged buildings

performance index must be greater than  $P'_{max}$  ( $P' > P'_{max}$ ) if damage is to be acceptable regardless of the loss. If the damaged performance index ( $P', L$ ) is within the restoration boundary, then either restoration or upgrading is required.

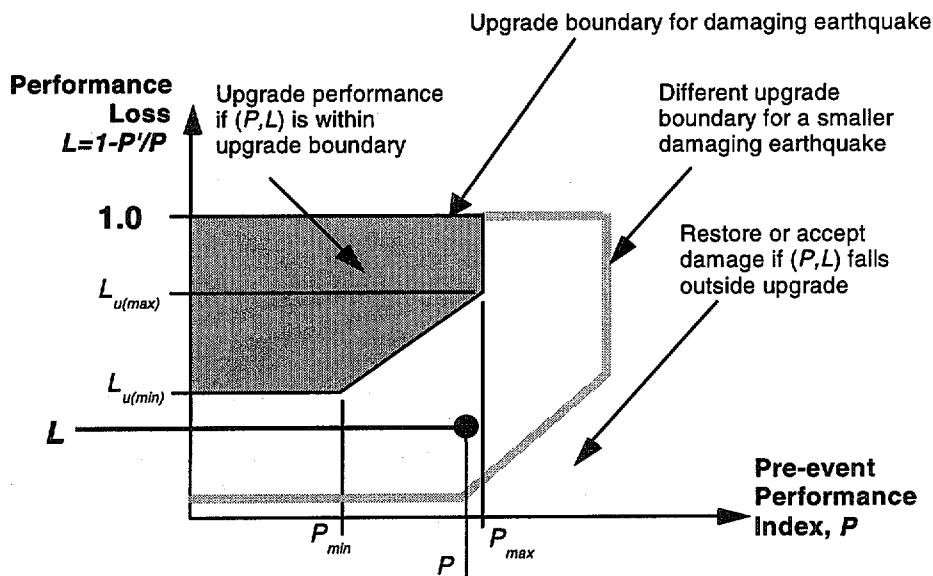
b) Relationship between acceptance of damage or restoration versus upgrade

The parameters affecting the decision between upgrade or restoration are illustrated in Figure 3-7b. The decision between upgrade or restoration is controlled by the loss ( $L$ ) and the pre-event performance index ( $P$ ). The upgrade boundary is delineated similarly to the restoration boundary using the parameters in Table 3-2.
