# **Inventory of Lifelines in the Cajon Pass, California**

Submitted to the Federal Emergency Management Agency  
Washington, D.C.

INTECH Inc.  
11316 Rouen Dr.  
Potomac, MD 20854-3126

Submitted August 1991

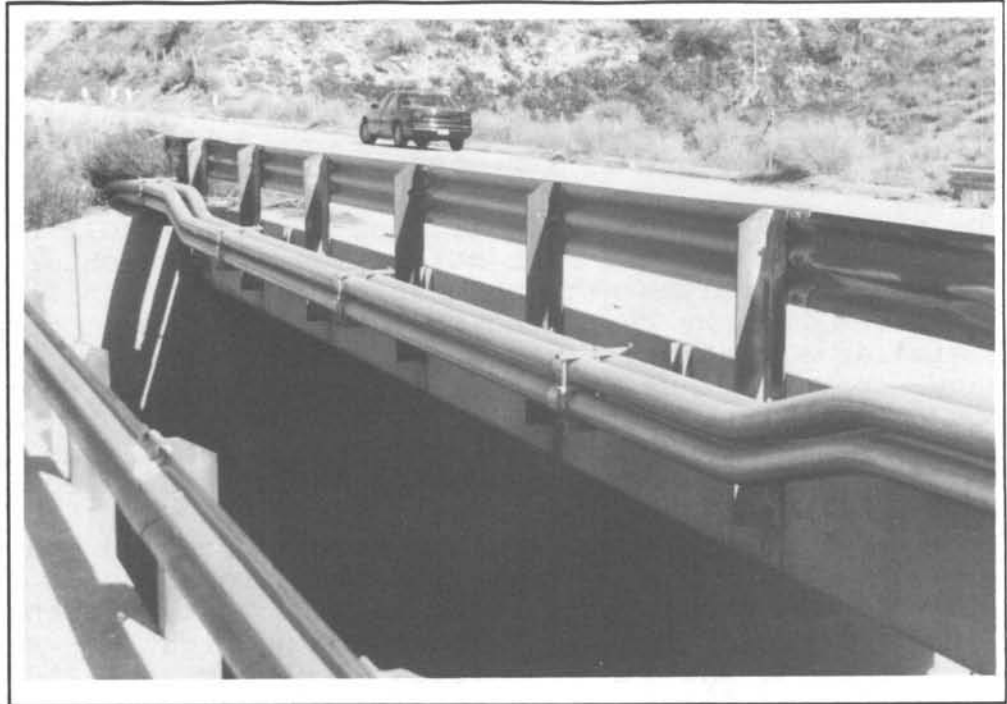
Figure 3.2-3 Fiber Optic Conduits Crossing a Cajon Canyon Road Bridge

However, at bridge or culvert locations they are routed above ground along the bridge or above the culvert but still underground. Figure 3.2-3 is a typical example of the supports used to hang the cable conduits from the bridge. Earthquake criteria were not used in designing these supports. It is noted that this

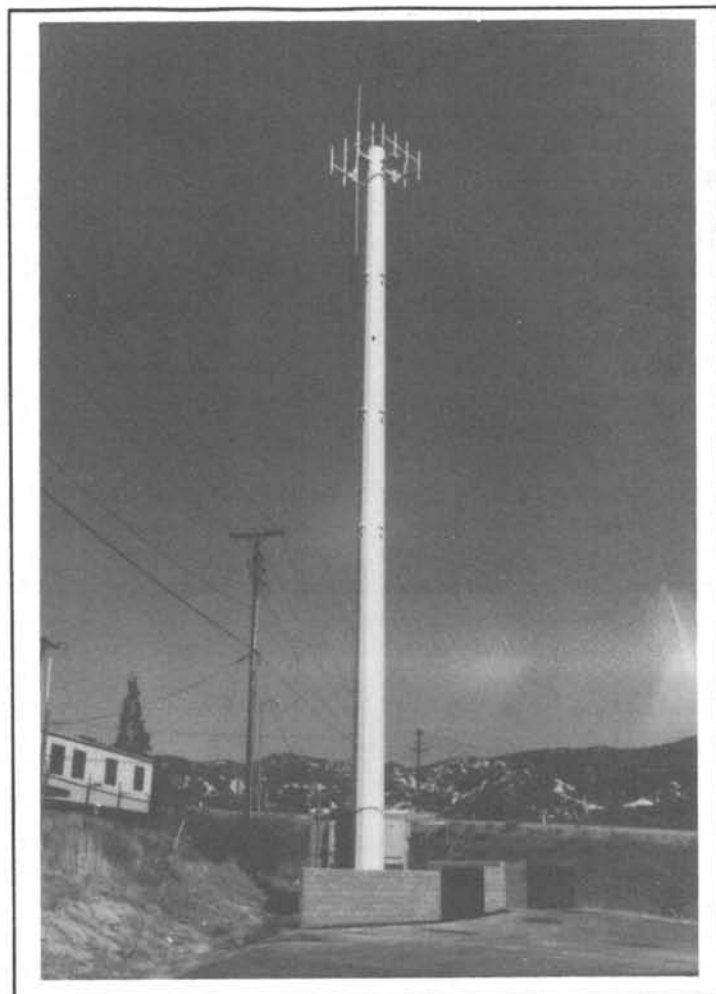
Figure 3.2-9 Cajon Junction Cellular Phone Antenna

The cellular phone antenna is located behind a motel at the Cajon Junction for highways I-15 and 138. Figure 3.2-9 is a photograph of the tower. It is located near to a motel and a large motel water storage tank (which isn't shown in the figure). Seismic design criteria were not specified for the cellular phone antenna or the water storage tank. The tower provides for stationary and mobile cellular phone communications within the Cajon Canyon area, which otherwise would be in a dead band area for such communications.

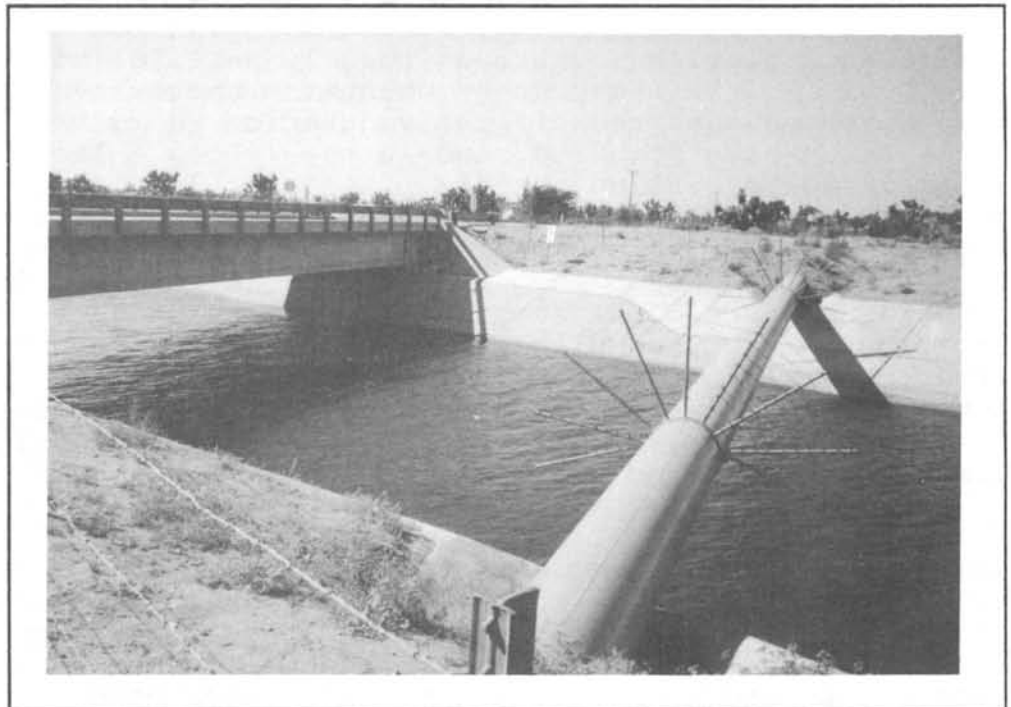
Figure 3.4-6 The Natural Gas Pipeline Crossing the California Aqueduct

North of the study boundary it crosses the California Aqueduct. Figure 3.4-6 shows that crossing.

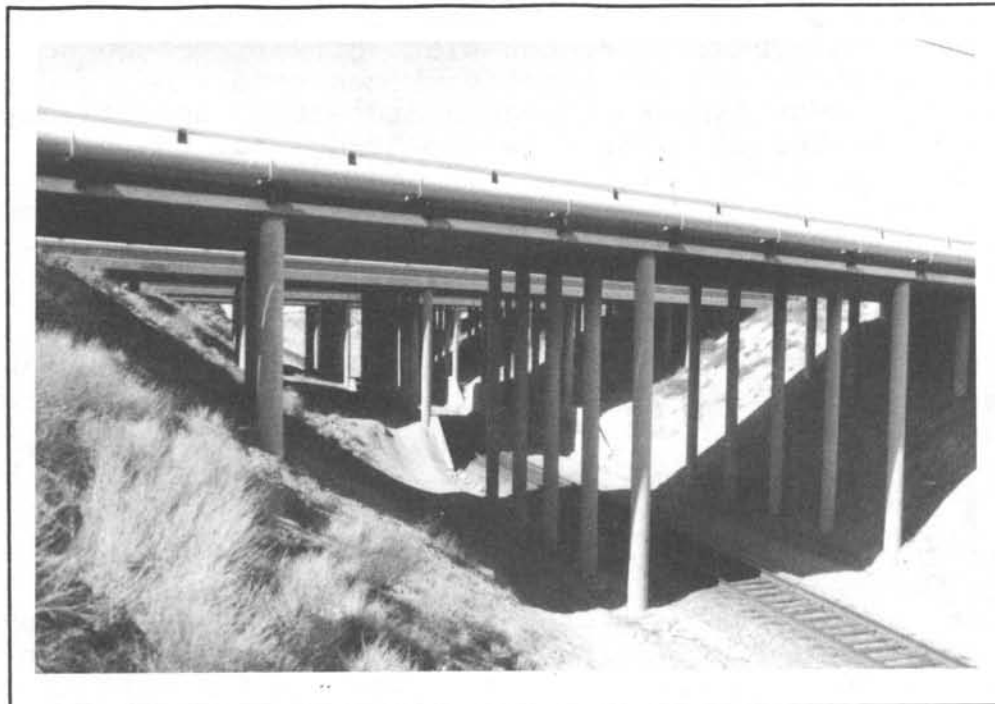
Figure 3.5-7 I-15 and Access Road Bridges Over the Railroad

Bridge No. 54-0664, a continuous slab structure supported on multiple column bents (see Figure 3.5-7). This bridge is flanked by others which carry the service roads over the railroad, the easterly bridge has water pipelines and fiber optic communication conduits attached (see Figure 3.2-8). There is a grade separation structure of welded steel girders (Bridge No. 54-0665) at mile 31.8 which connects the northbound lanes of I-15 to the northbound lanes of I-395 leading north to Adelanto, and 0.5 miles further north, I-15, now reduced to three lanes in each direction, is crossed by Phelan Road on a concrete box girder (Bridge No. 54-0624). Just at the north end of the study area, I-15 and both frontage roads are carried over the California aqueduct on a double box, concrete culvert (Bridge No. 54-0828). I-15 continues northeast out of the study area towards Victorville and Barstow. Route 138 enters the study area from the west, joining the I-15 at Cajon Junction. Approximately one
